COLORADO CULTURAL RESOURCE SURVEY

## Architectural Inventory Form

1. Resource number: 5DA.3002
2. Temporary resource number:
3. County: Douglas
4. City: Castle Rock
5. Historic building name: The Maples
6. Current building name: 422 Front Street LLC
7. Building address: 422 Front Street, Castle Rock, CO Douglas County 80104
8. Owner name and address: 422 Front Street LLC, 422 Front Street, Castle Rock, CO 80104

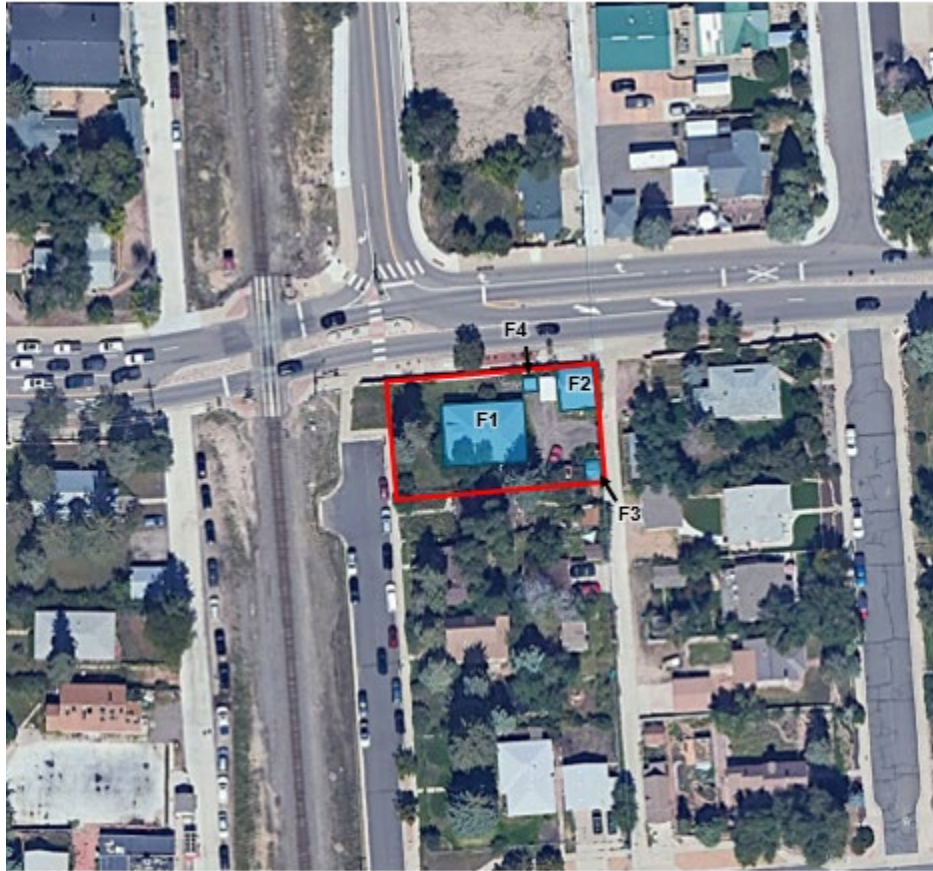
**Map 3.** Sketch Map of 422 Front Street, Castle Rock, Colorado, including rough parcel boundary; see Map 2 for official parcel boundary. September 2023 aerial imagery.

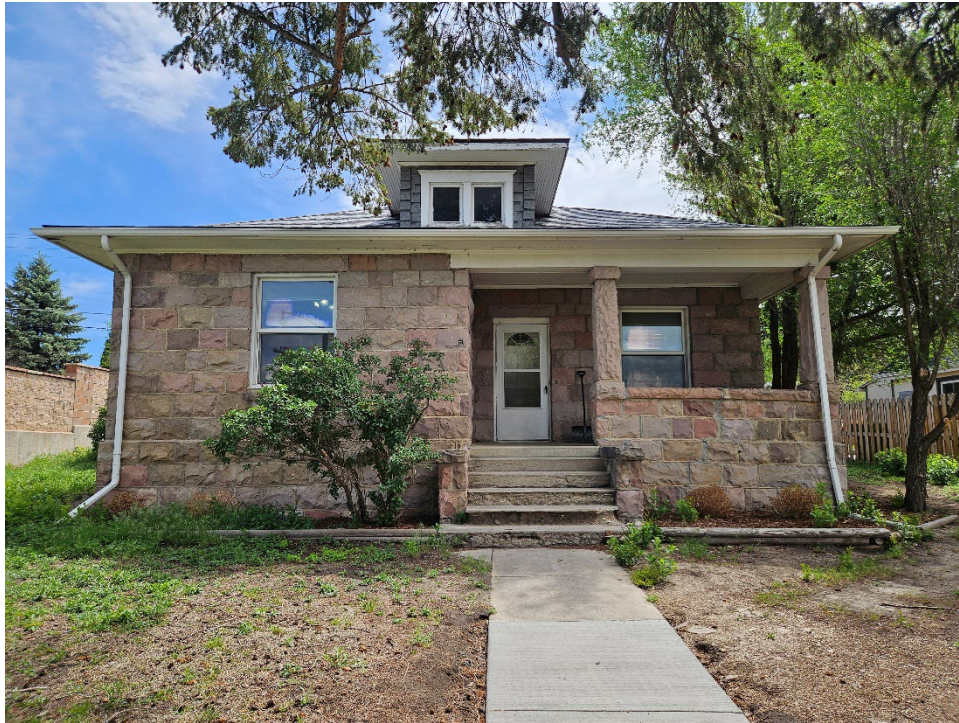
**Primary (west) elevation of the residence, view east**  
(Roll 26-450, image 110136; Emily Wren; 5/22/2026)

The primary elevation faces west and is accessible via a set of centrally located concrete steps. The centrally located entry is a four-panel aluminum door with a window that features a sunburst pattern. The door is fronted by a two-lite metal storm door. The primary (west) elevation features a half-width porch with a rhyolite-clad pony wall and square rhyolite support columns. It is topped by the overhang of the hipped roof. There are two typical windows along the primary (west) elevation. The primary (east) elevation features a central, hipped roof dormer, clad in asphalt shingles; the dormer has a wood, one-by-one window, that appears to be fixed.

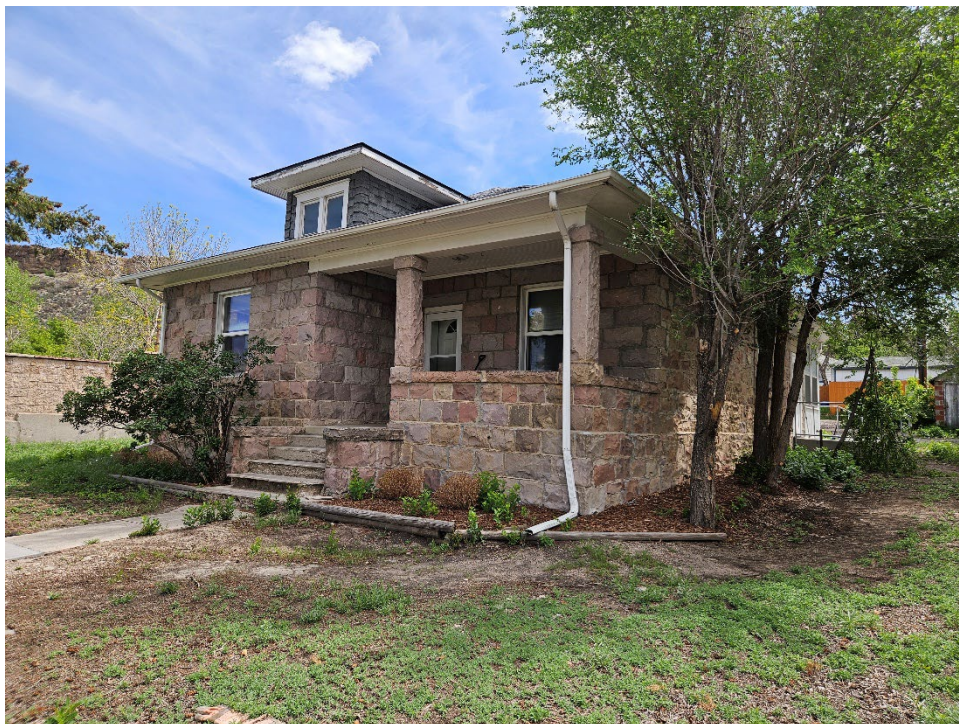
**Primary (west) and south elevations of the residence, view northeast**  
(Roll 26-450, image 110146; Emily Wren; 5/22/2026)

Two typical windows are present along the south elevation. The east end of the south elevation features an enclosed sunroom/porch. It has an additional entrance that consists of a two panel, six-lite door. The exterior wall around the door is clad in horizontal wood siding. To the east of the additional entrance, there is a pair of wood, four-over-four, double-hung sash units fronted by metal framed, storm windows. Beneath the windows, the exterior is clad in vertical wood siding. A concrete wheelchair ramp with a metal railing extends from the east of the residence, providing access to the additional door.

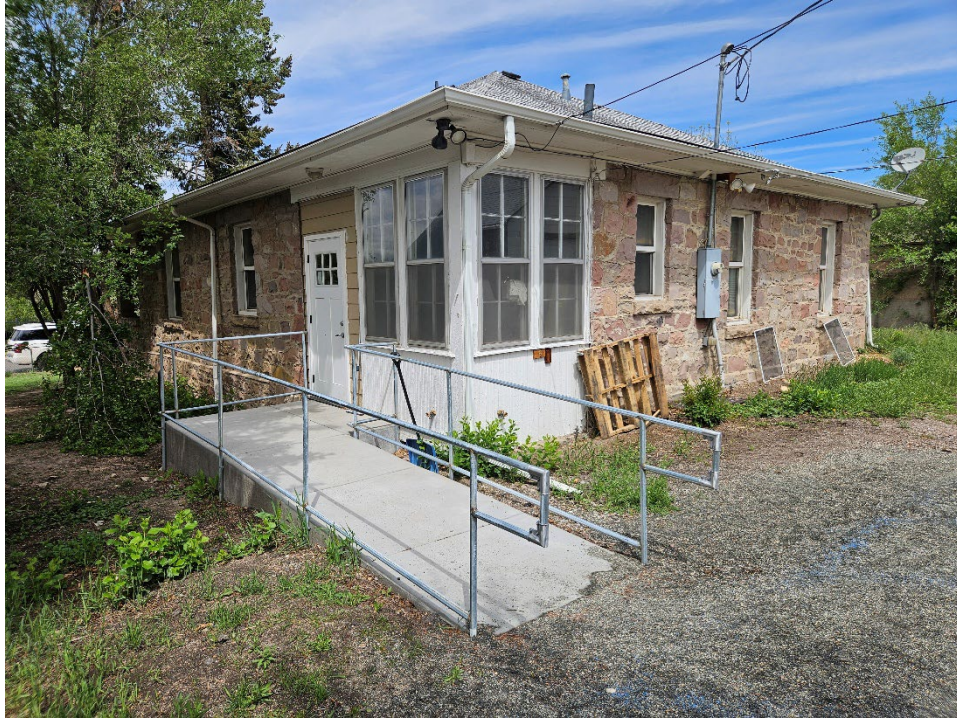
**South and east elevations of the residence, view northwest**  
(Roll 26-450, image 110214; Emily Wren; 5/22/2026)

The south end of the east elevation features an enclosed sunroom/porch. Fenestration includes a pair of wood, four-over-four, double-hung sash units fronted by metal framed, storm windows. Beneath these windows, the exterior is clad in vertically oriented wood siding. The east elevation of the residence's core features three typical windows. There is a window well located on the east elevation that provides access to a crawlspace.

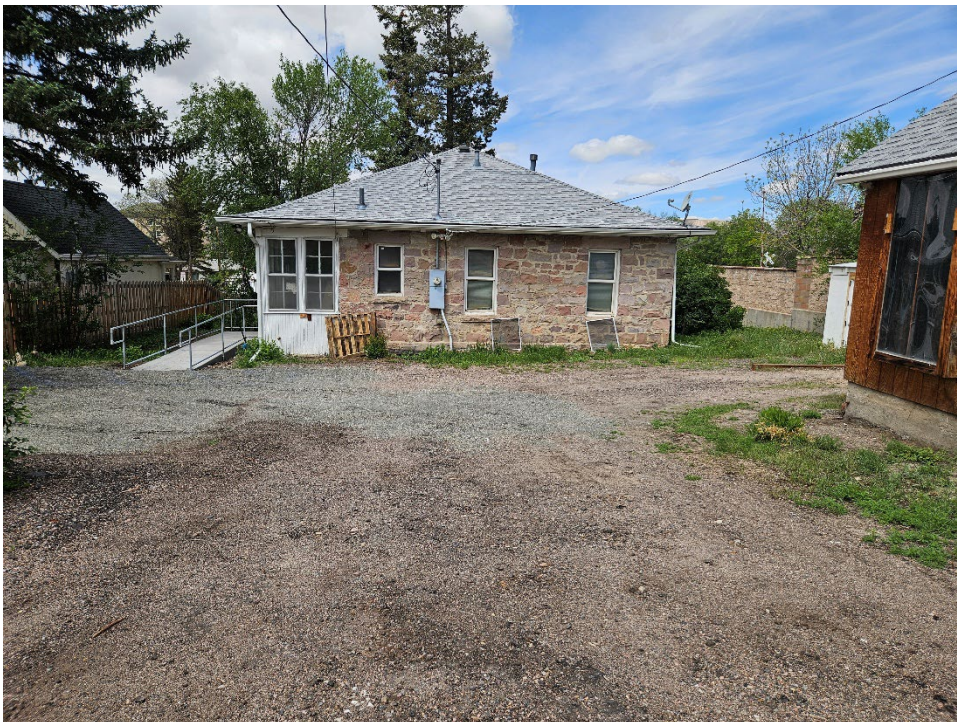
**East elevation of the residence, view west**  
(Roll 26-450, image 110234; Emily Wren; 5/22/2026)

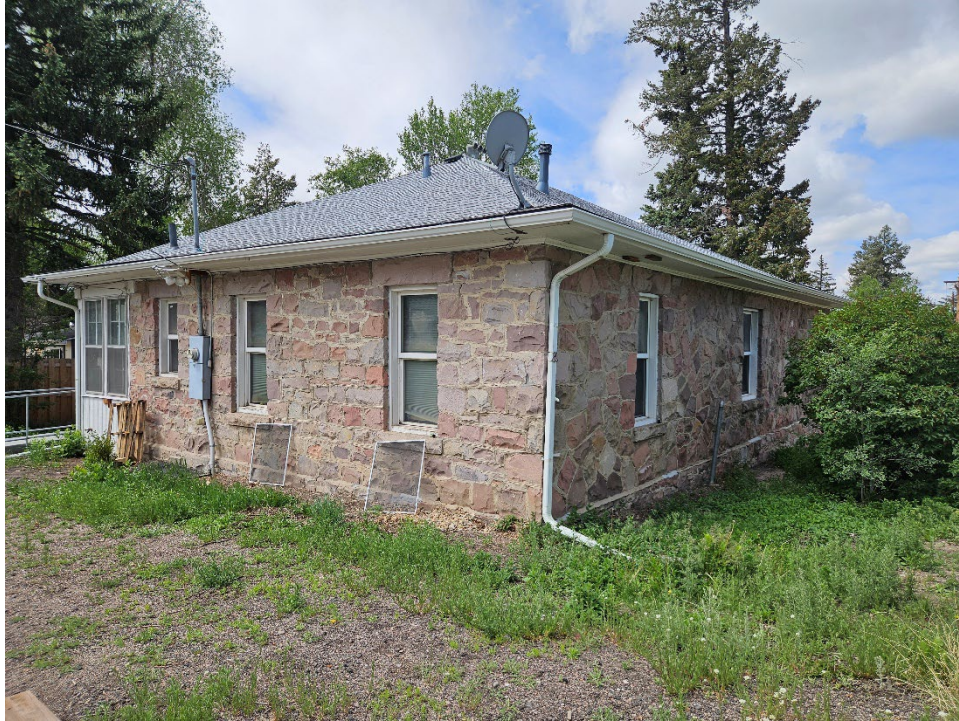
**East and north elevations of the residence, view southwest**  
(Roll 26-450, image 110252; Emily Wren; 5/22/2026)

There are three typical windows along the north elevation. The lower-lite on the west end of the elevation is fronted by a wood frame window.

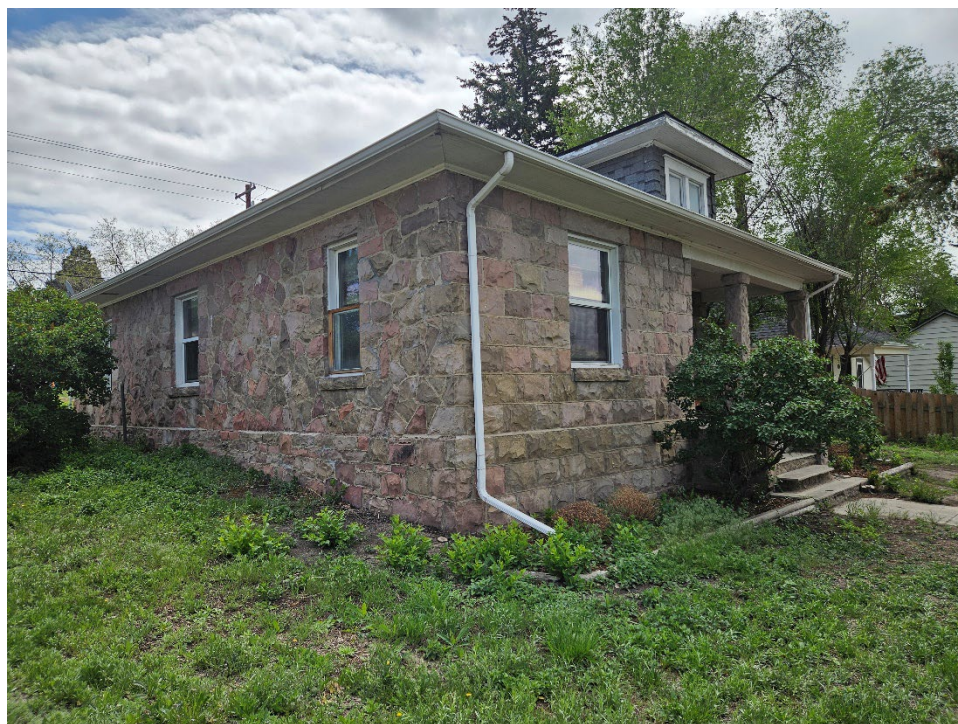
**Primary (west) and north elevations of the residence, view southeast**  
(Roll 26-450, image 110315; Emily Wren; 5/22/2026)

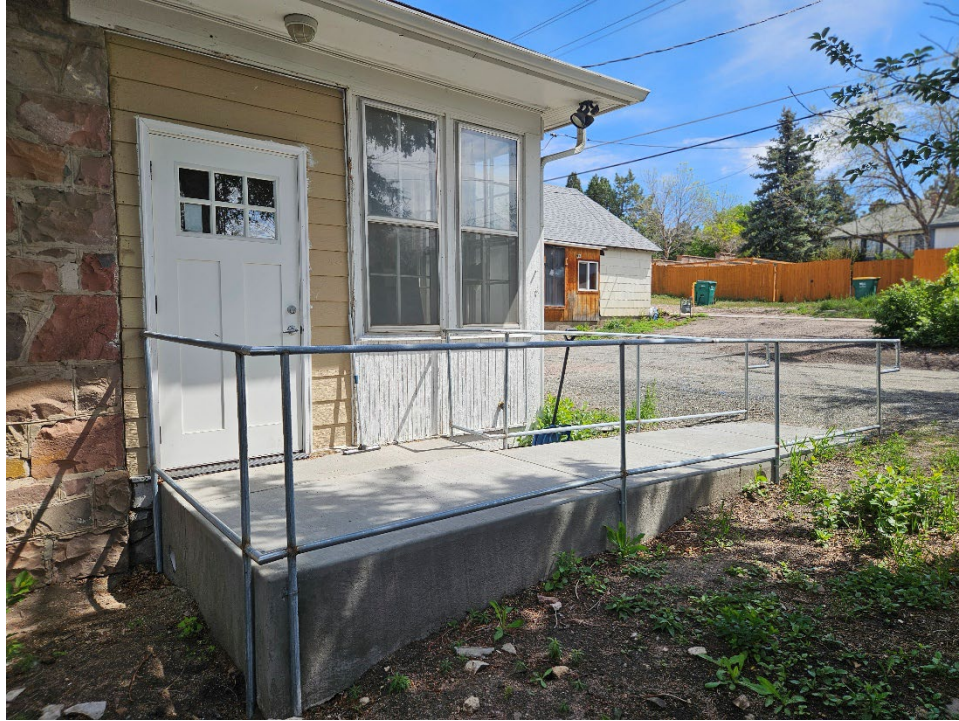
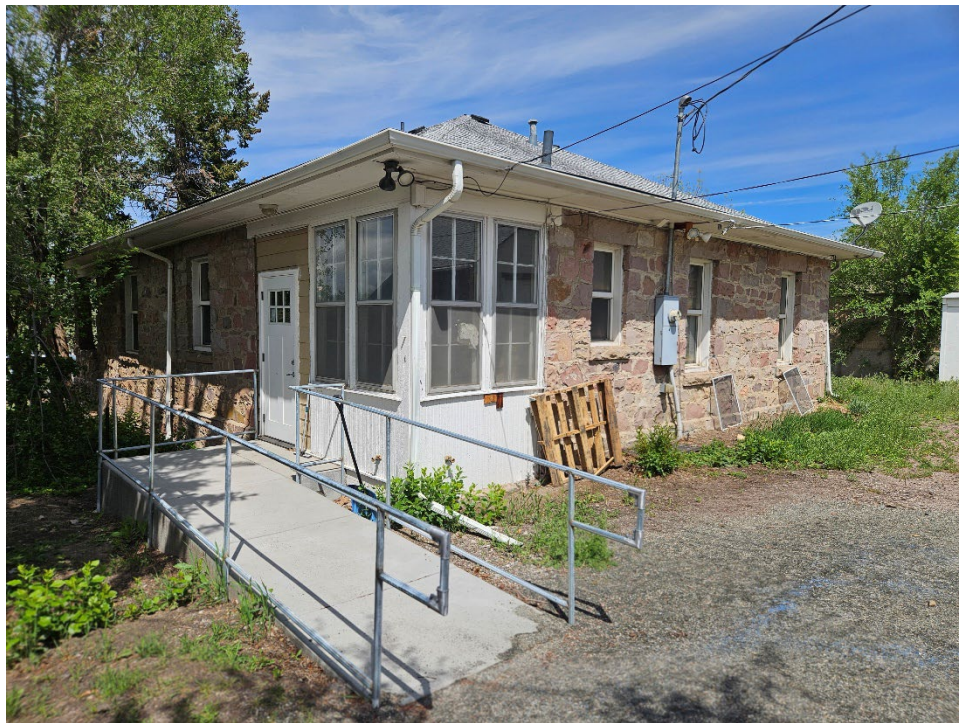
**Close up of enclosed porch and ramp, view northeast**  
(Roll 26-450, image 105153; Emily Wren; 5/22/2026)

**View of enclosed porch and ramp, view northwest**  
(Roll 26-450, image 105208; Emily Wren; 5/22/2026)

Sanborn maps show that the wood-clad portion on the southeast (rear) corner of the residence originally was a porch. The date of its enclosure is unknown.

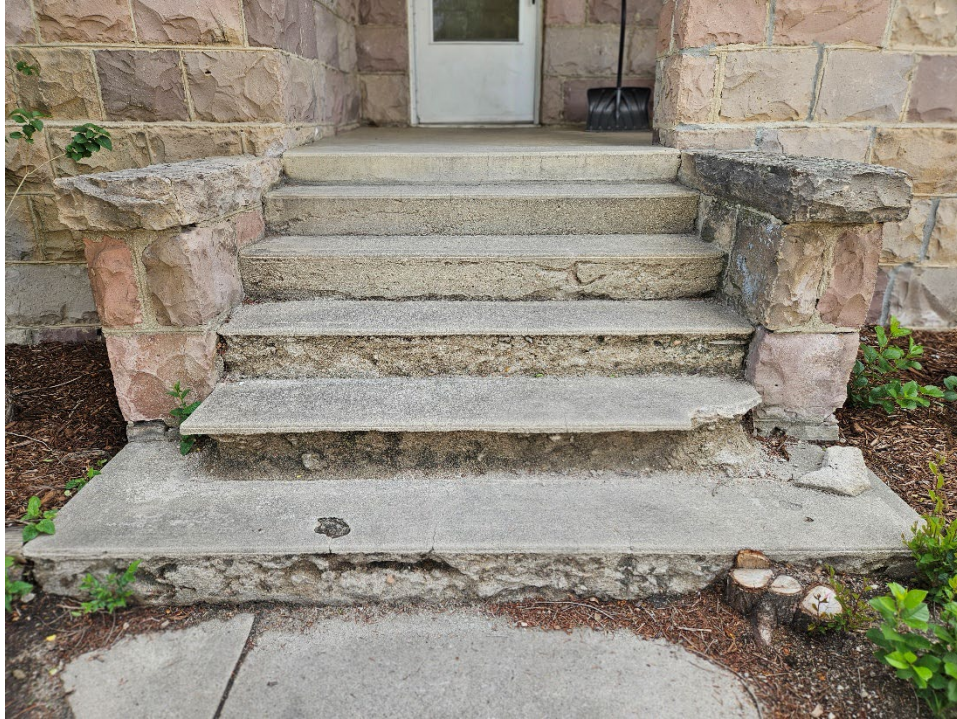
**Close up of porch steps, view east**  
(Roll 26-450, image 105335; Emily Wren; 5/22/2026)

- 2025: The occupants filed for a change of use with the city, converting the building from a single family residence to a business. Along with interior improvements, the additional entry on the south elevation was altered. Stairs were removed and a concrete wheelchair ramp was constructed. A column of windows to the west of the entryway door were also removed with this alteration.

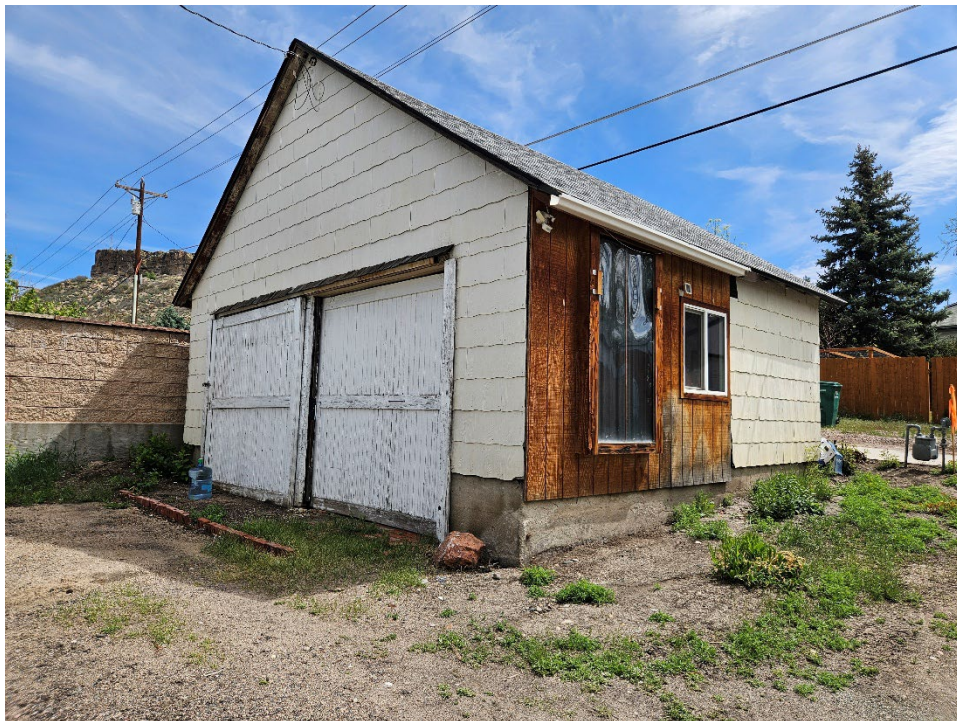
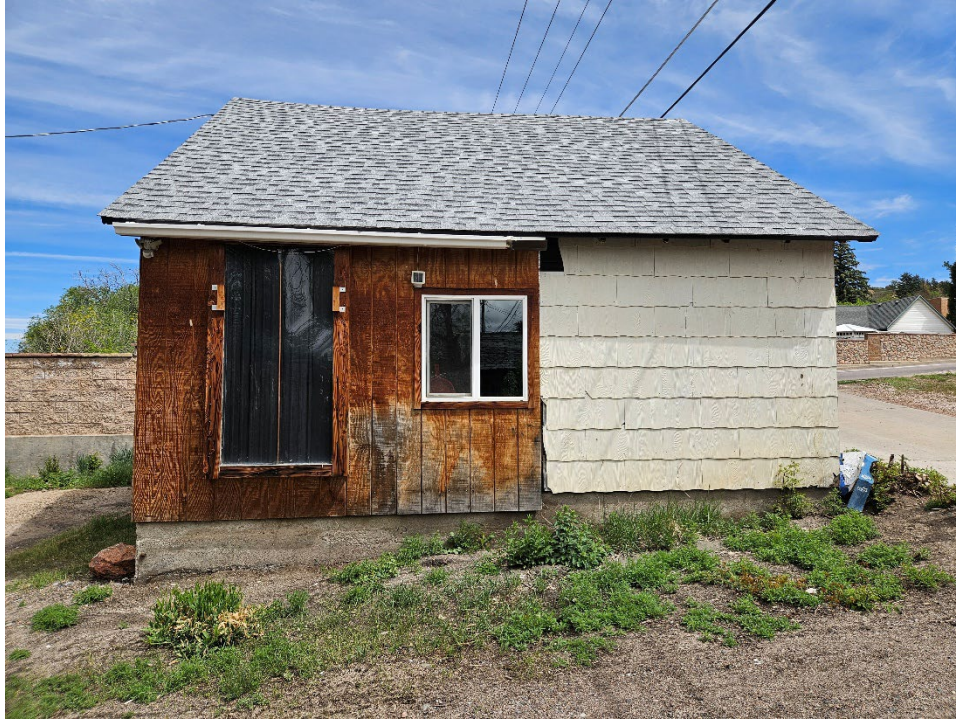
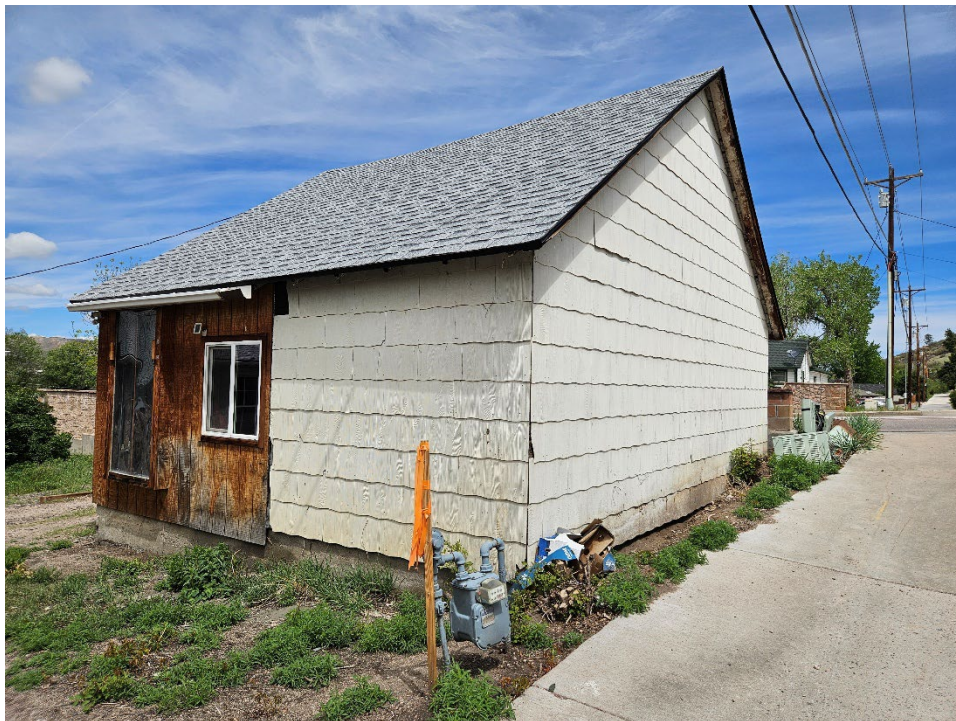
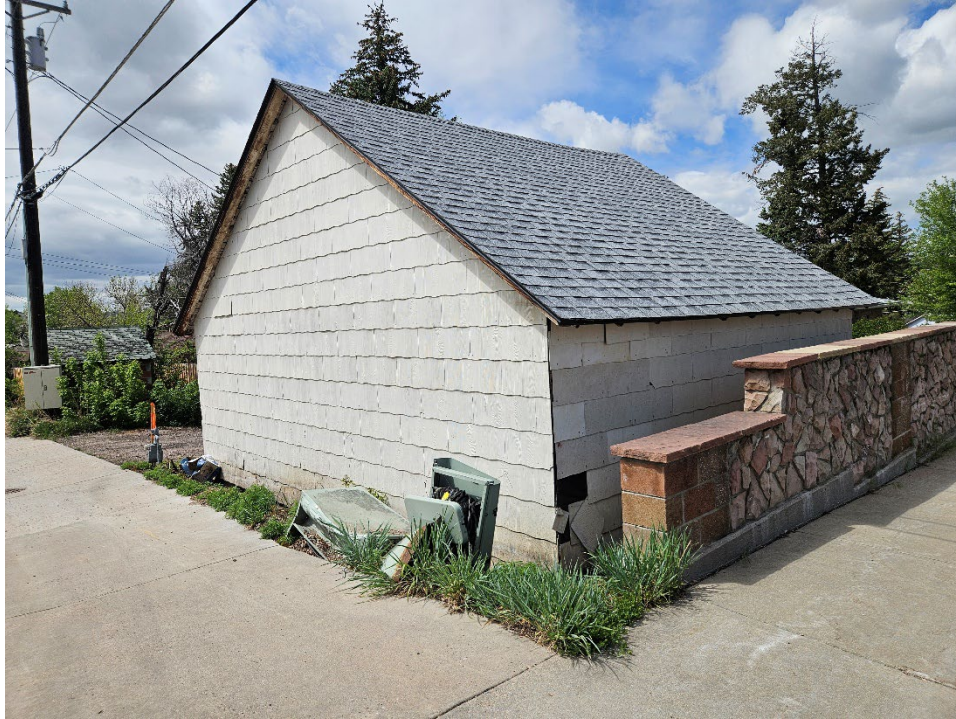
**West and south elevations of F2 (garage), view northeast**  
(Roll 26-450, image 105859; Emily Wren; 5/22/2026)

**South elevation of F2 (garage), view north**  
(Roll 26-450, image 105910; Emily Wren; 5/22/2026)

**South and east elevations of F2 (garage), view northwest**  
(Roll 26-450, image 105917; Emily Wren; 5/22/2026)

**East and north elevations of F2 (garage), view southwest**  
(Roll 26-450, image 105939; Emily Wren; 5/22/2026)

24. Associated buildings, features, or objects:  
**Feature 2** is a one-story, two-stall, rectangular plan garage that is located to the east (rear) of the residence. The garage rests on a concrete foundation and features a wood frame structural system clad in asbestos siding. It is topped by a front gable roof clad in asphalt shingles with exposed rafter ends. The garage features two sliding, wood, garage doors on its west elevation. Half of the south elevation is clad in vertically oriented wood siding. A tall, wood framed, rectangular window and a vinyl, one-by-one, horizontal sliding unit are present on the south elevation. The east and north elevations are devoid of fenestration.

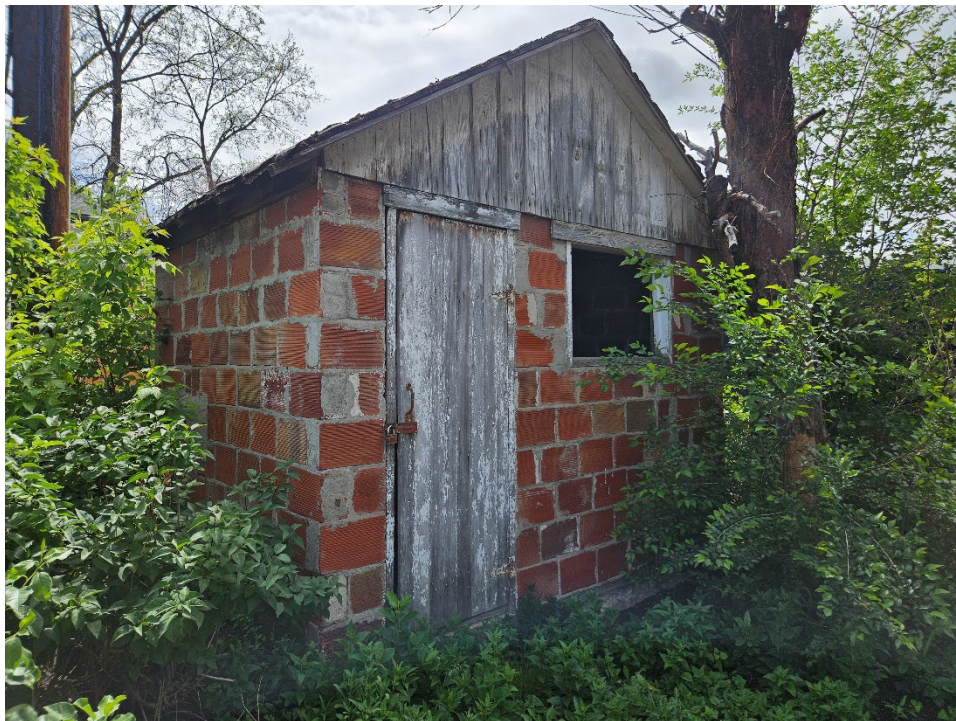
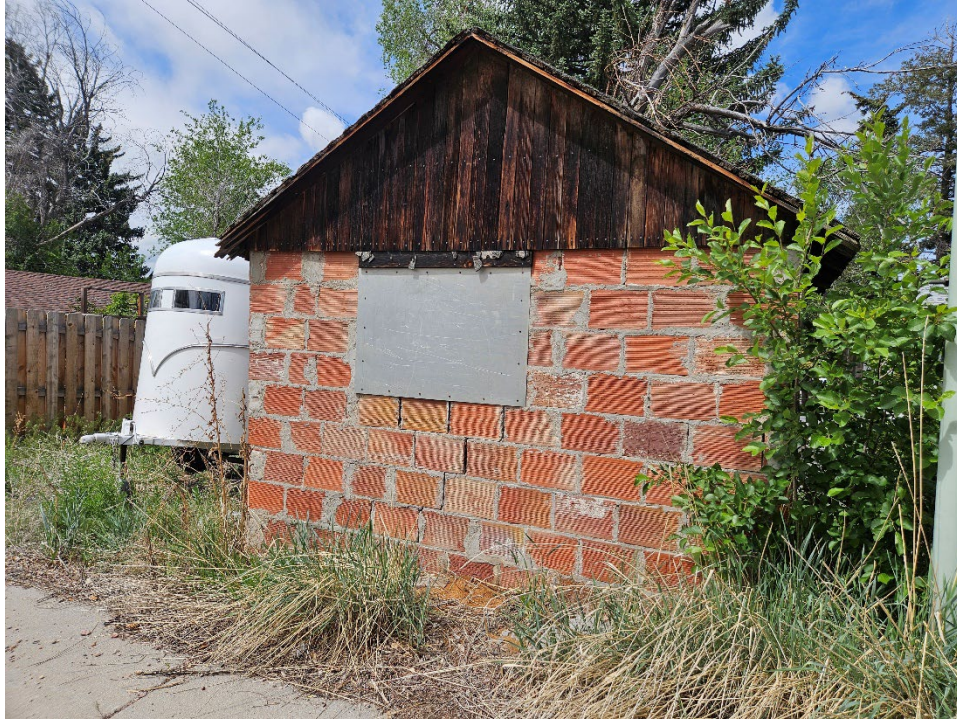
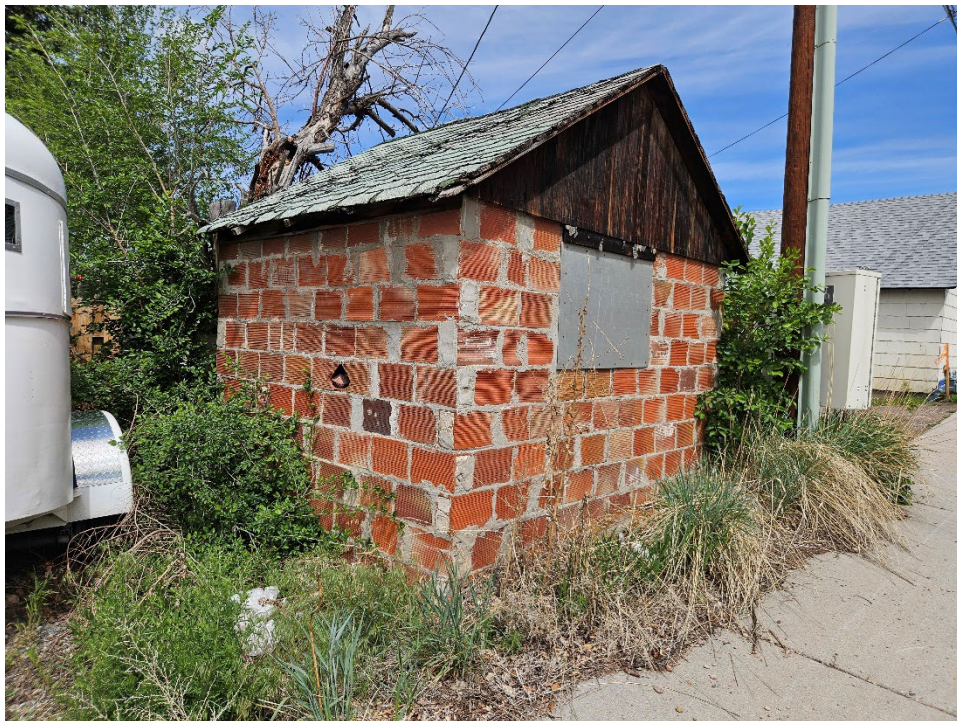
**West and north elevations of F3 (shed), view southeast**  
(Roll 26-450, image 105805; Emily Wren; 5/22/2026)

**East elevation of F3 (shed), view west**  
(Roll 26-450, image 105819; Emily Wren; 5/22/2026)

**South and east elevations of F3 (shed), view northwest**  
(Roll 26-450, image 105826; Emily Wren; 5/22/2026)

**Feature 3** is a one-story, rectangular plan outbuilding located to the east (rear) of the residence. It is constructed of large, red brick. It is topped by a front gable roof clad in asphalt shingles. The gable ends are clad in vertically oriented wood. It is accessible on its west elevation through a vertical wood plank pedestrian door with carriage door hinges. The west elevation features one window opening, while the east elevation has one window opening that was covered with sheet metal at the time of survey. The north and south elevation are devoid of fenestration.

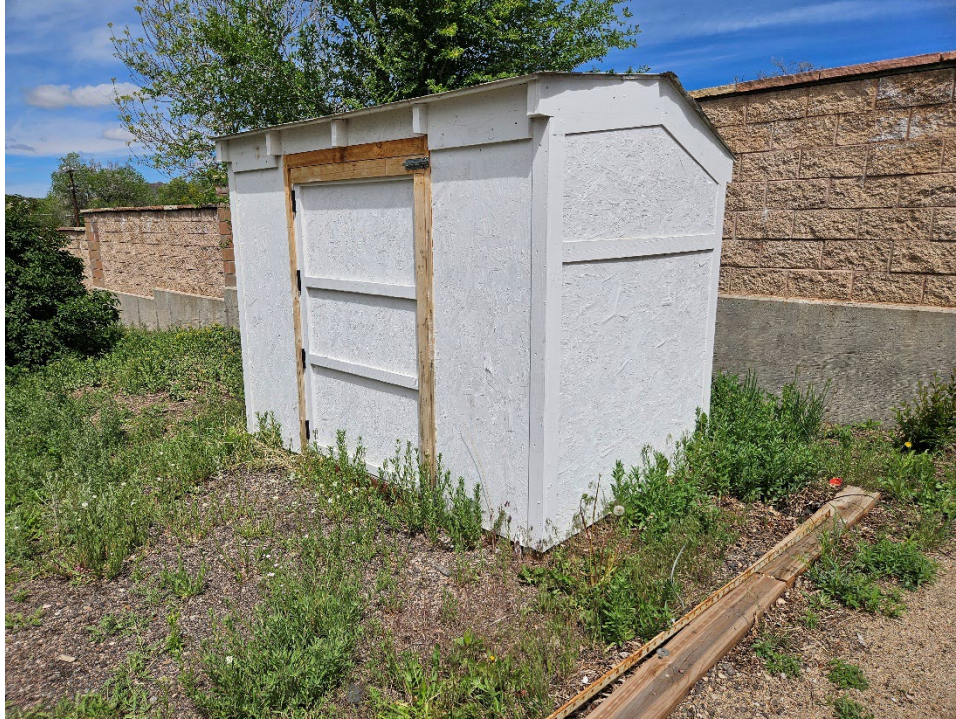
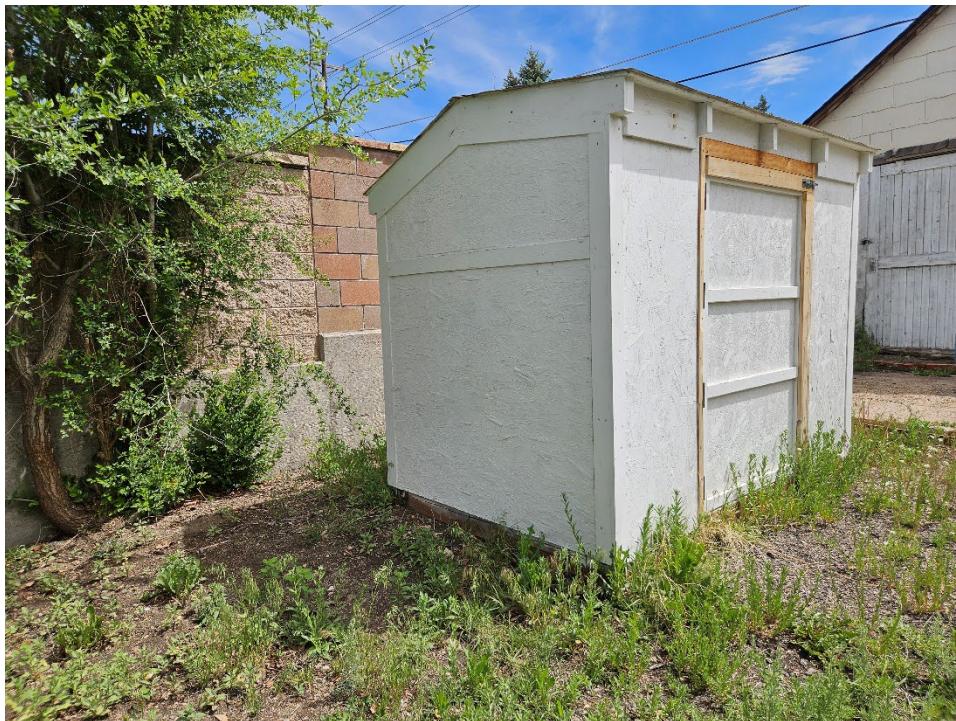
**South and east elevations of F4 (shed), view northwest**  
(Roll 26-450, image 110027; Emily Wren; 5/22/2026)

**West and south elevations of F4 (shed), view southeast**  
(Roll 26-450, image 110100; Emily Wren; 5/22/2026)

**Feature 4** is a small shed located west of F2. It is a rectangular shed clad in painted plywood. It is topped by an asymmetrical side gable roof clad in tar paper. There is one plywood, pedestrian entrance on the south elevation.

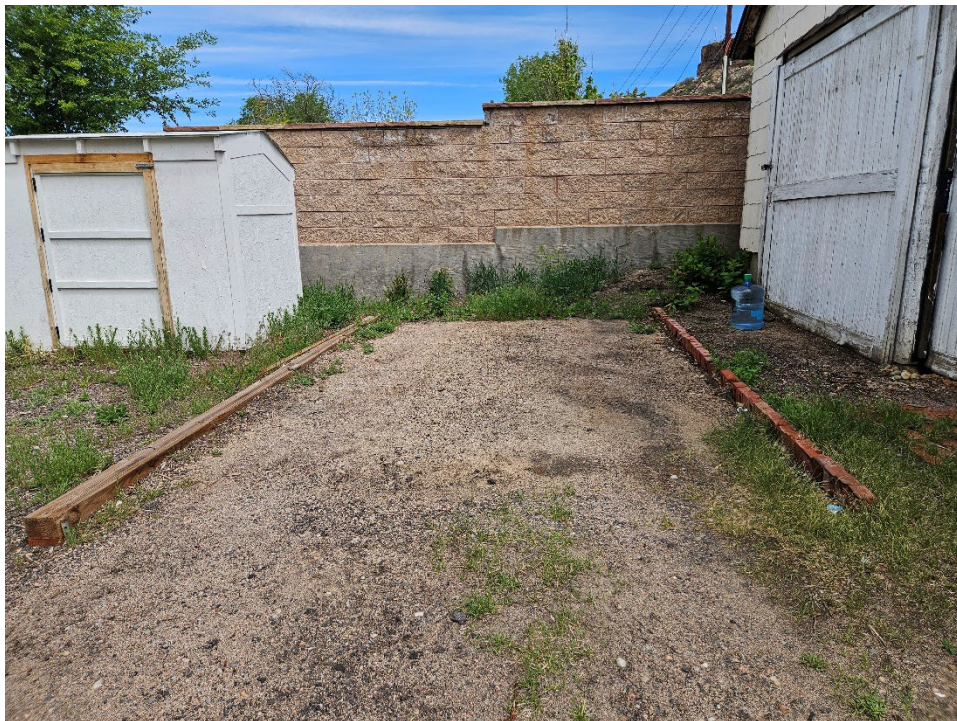
**View of gravel parking space, view north**  
(Roll 26-450, image 110245; Emily Wren; 5/22/2026)

22. Architectural style/building type: Late 19<sup>th</sup> and Early 20<sup>th</sup> Century American Movements/Classic Cottage
23. Landscaping or special setting features: The residence is located within a residential area, on the edge of the commercial area of the Town of Castle Rock. The west side of the parcel is bordered by a chain link fence. A concrete walkway extends from the fence to the front porch. The north side of the property is lined by a stepped, stone wall to block the residence from the adjacent street. The front yard features patches of sod grass and natural grasses, shrubs, and two large fir trees at the entrance of the chain link fence. The east side of the property is bordered by a concrete alleyway. The yard east side of the residence is filled in largely with gravel and features sparse patches of grass and several shrubs. There are two gravel parking spaces.
