Land Suitability Analysis Report

Canyons Far South
August 2022

This Land Suitability Analysis Report (LSAR) has been prepared for The Canyons Far South Planned Development Plan (PDP). The property comprises 409 acres and is planned for 474 residential units and a neighborhood retail center. This analysis explores the property's opportunities and constraints for development by identifying surrounding land uses and environmental context, such as the site's existing vegetation, existing man-made improvements, geology, wildlife habitat, soils, wildfire mitigation, and rock outcroppings found on the site. The overall design intent for Canyons Far South is to develop an environmentally sensitive residential community that will protect the visual character of the site, maintain wildlife corridors, and preserve steep slopes, rock outcroppings and drainageways and provide trail access to passive recreational areas, community parks and cultural resources that total approximately 57% of the total project area.

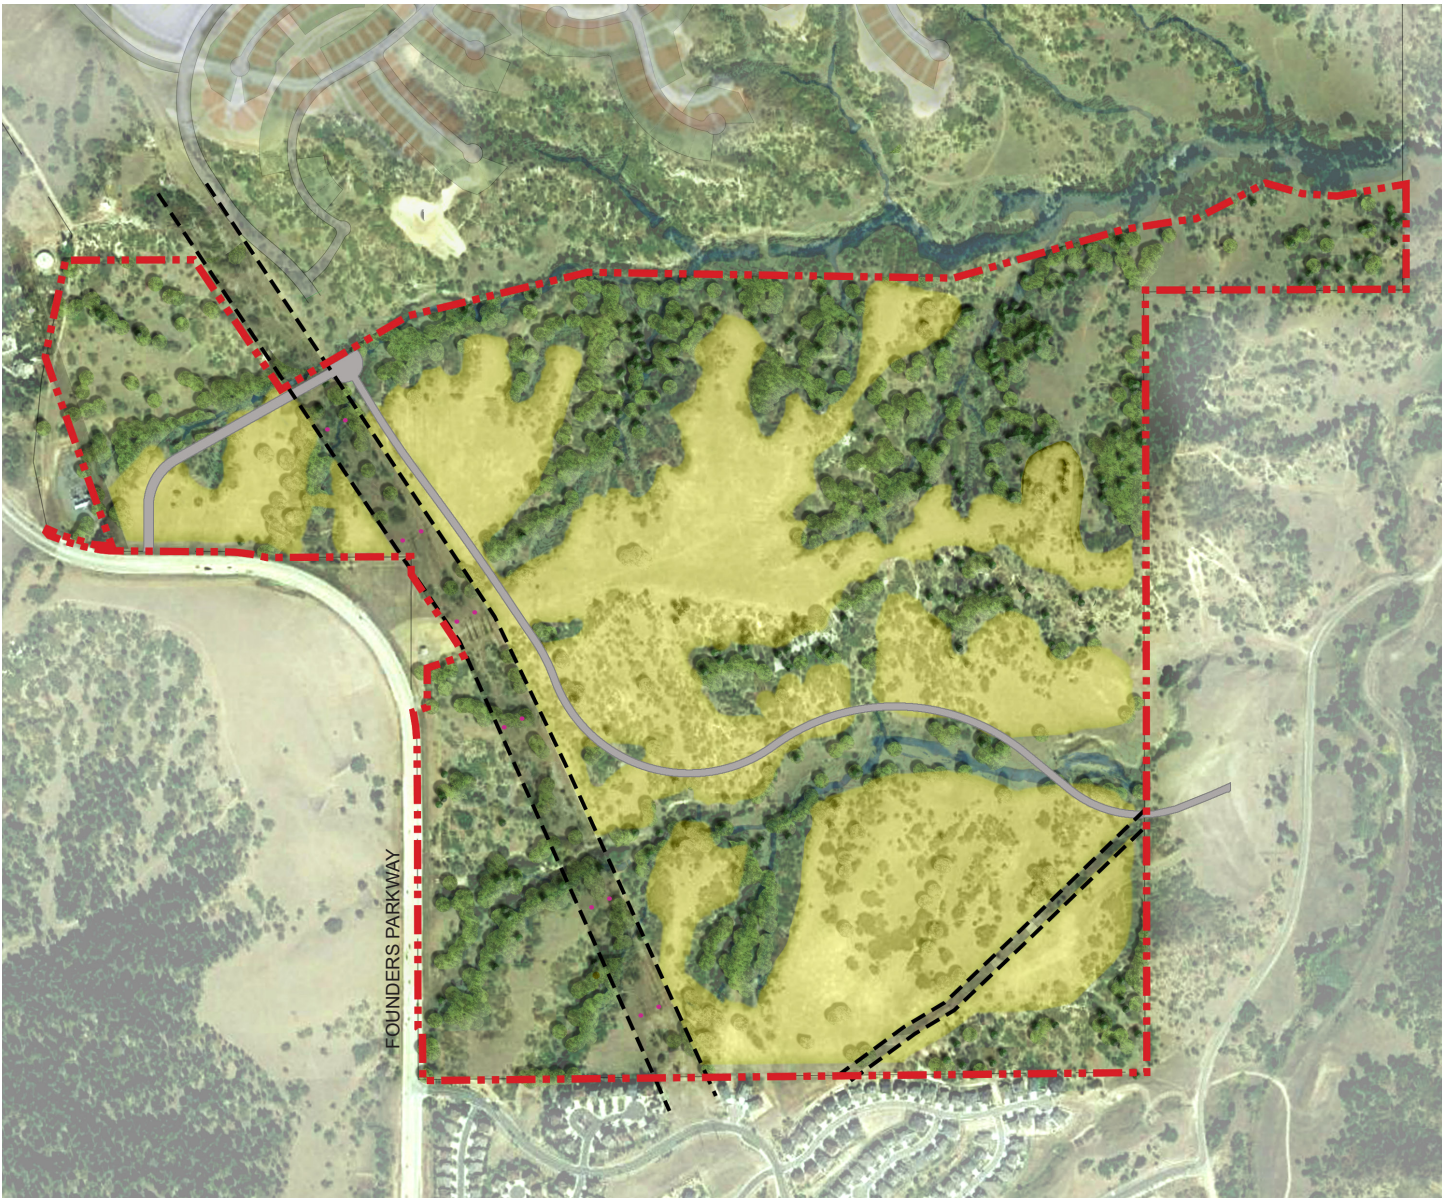
EXHIBIT D

- Developable Area
- Power Line Poles
- Main Road
- Easement
- Site Boundary

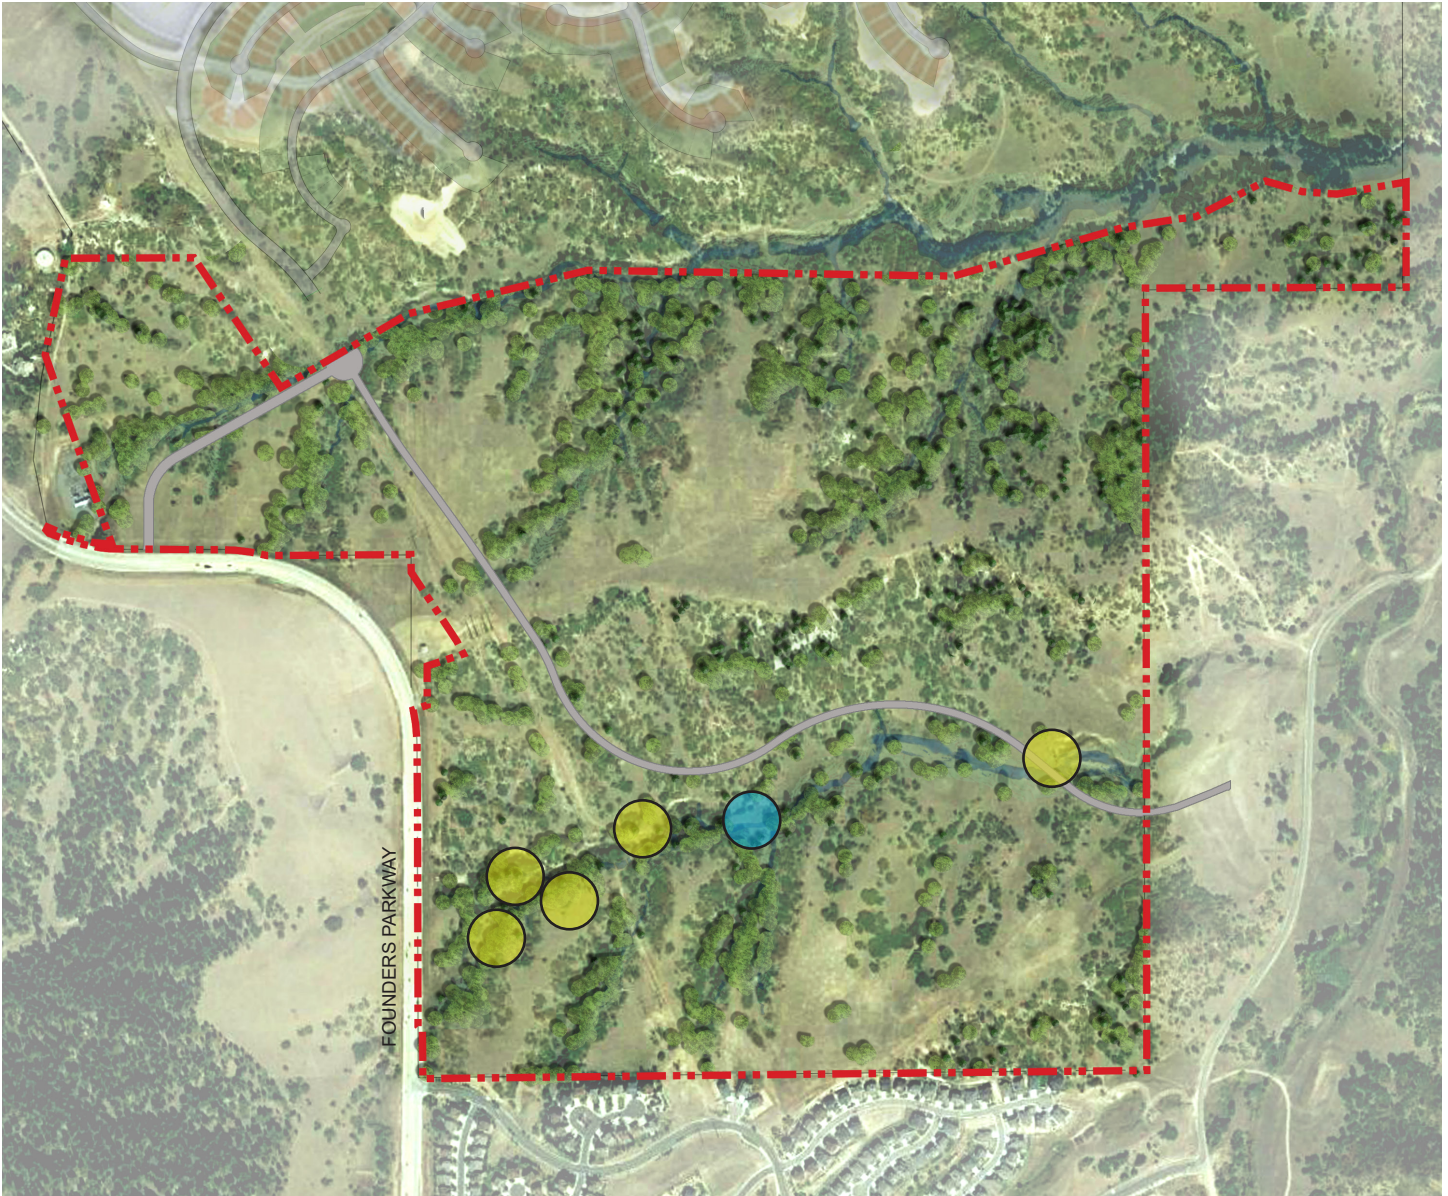
EXHIBIT E

Check Dam Structures
-

Windmill
-

Cultural resources are relatively abundant in the Castle Rock area attesting to the region's long use by different people for various purposes. Due to this, both a Class I overview and Class II Cultural Resource Inventory have been previously conducted for the Canyons Far South property. These reports identified that the property (indicated as Canyons South in the documents) includes several cultural resources, see Exhibit E.

Structures include a windmill and multiple check dams. All of these structures are located within the central drainage corridor and have been identified as open space areas outside of future developable areas. The CCC check dam structures are located in the central drainage corridor as identified in Exhibit E. If possible, some CCC check dams will be utilized as part of the drainage management plan to the extent they are structurally sound and fit. The windmill is also located in the central drainage corridor. It will be retained as a site element if it can be secured for safety purposes. No historical or Native American artifacts have been found on property.
