## BIOLOGICAL ASSESSMENT AND CULTURAL RESOURCES RECORDS REVIEW

PLUM CREEK SUBDIVISION  
WEST OF CROSSHAVEN PLACE  
AND PLUM CREEK BOULEVARD  
CASTLE ROCK, COLORADO

Project No. DN51,549.000-240-R1

May 2, 2022

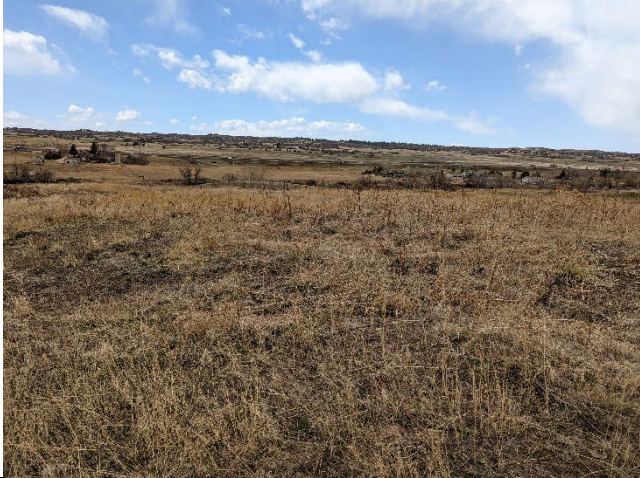
| Subject Property Photos | | | |
|---|--|---|--|
| Description: General site view<br>Direction: West | | Description: General site view<br>Direction: East | |

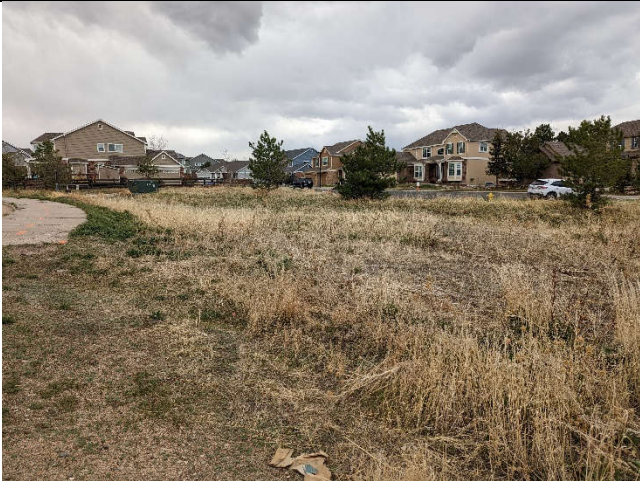
| Subject Property Photos | | | |
|---|--|---|--|
| Description: Eastern portion of the property<br>Direction: East | | Description: Northern portion of property<br>Direction: North | |

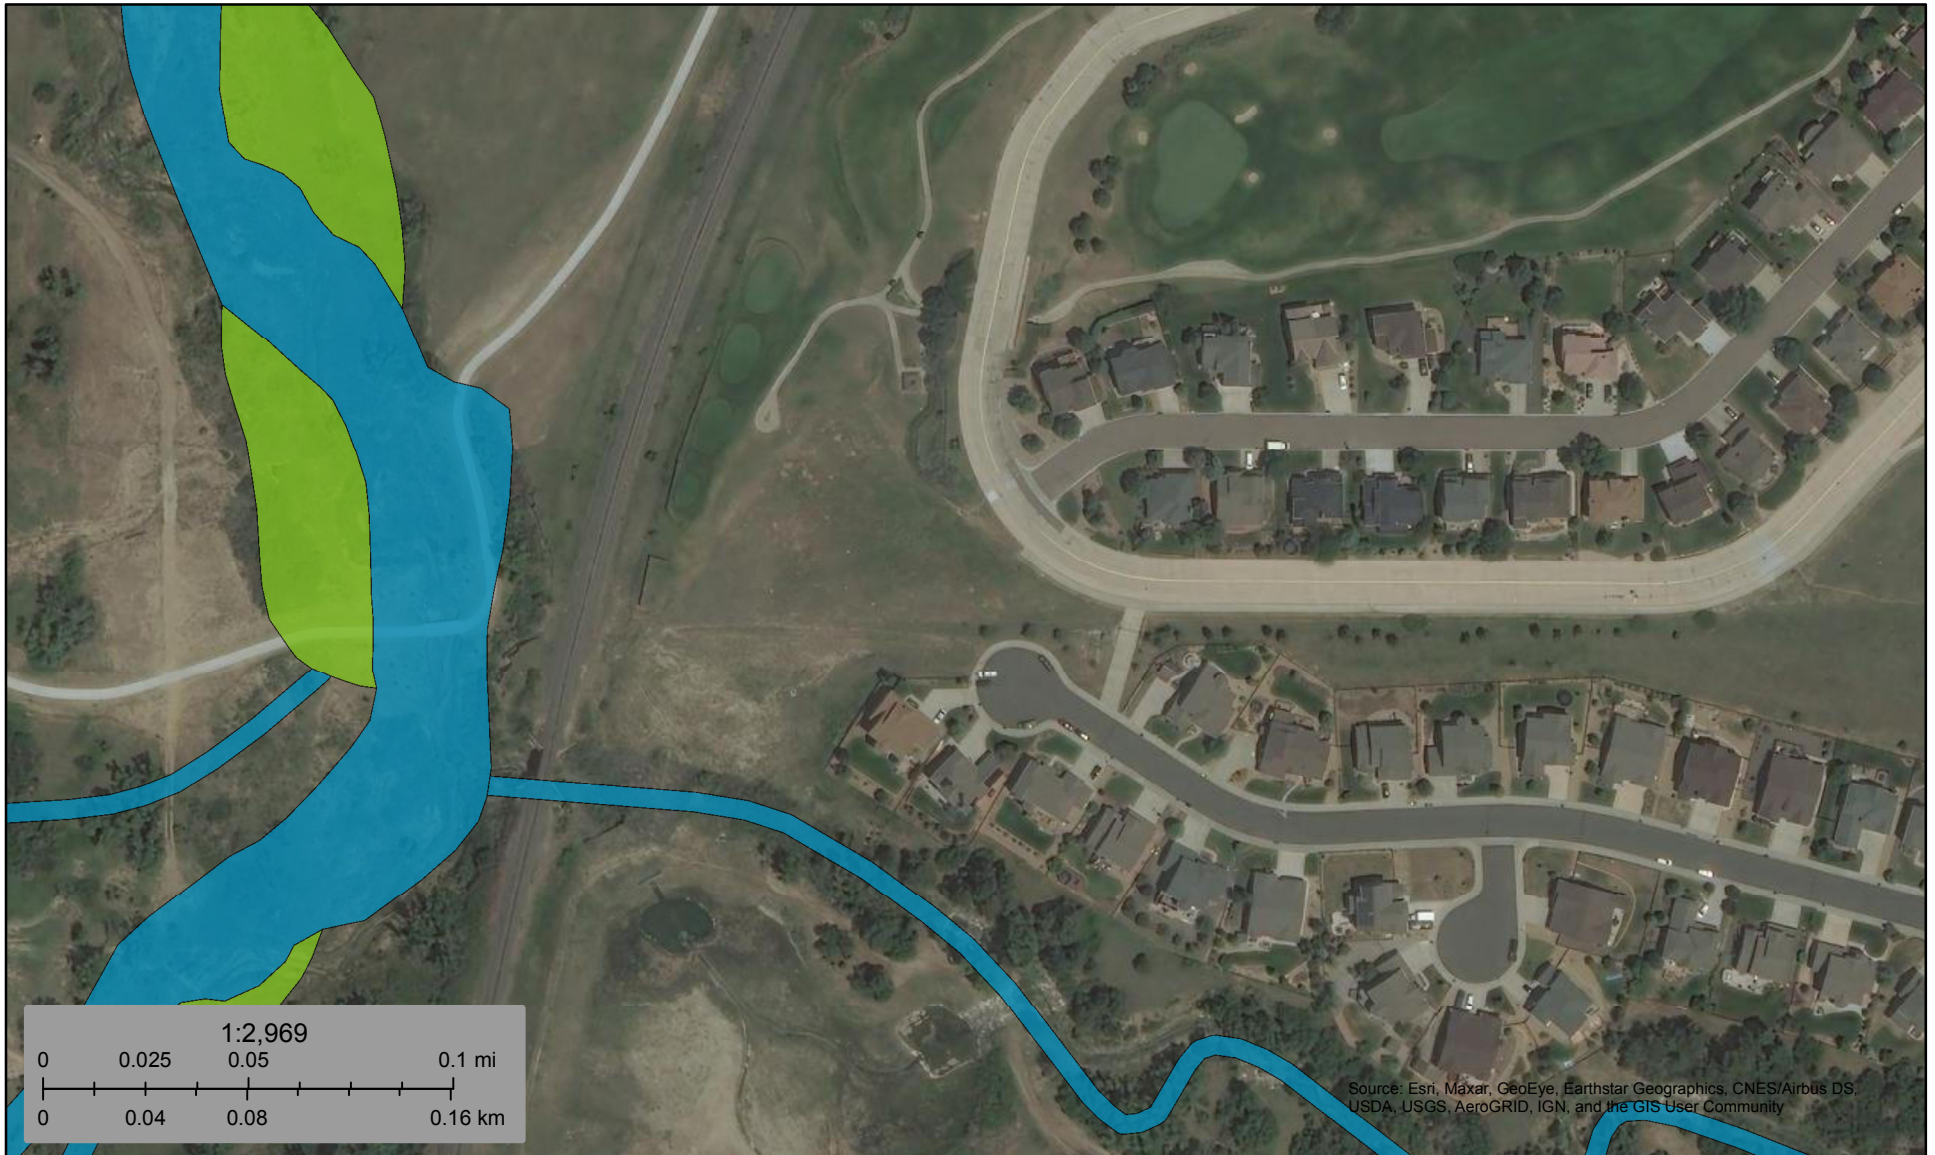
## Appendix B - Subject Property Wetlands

CTL|T used a USFWS National Wetland Inventory Map as an aid to help determine the location of wetlands that might be present at the Subject Property. The map, included in **Appendix B**, does not indicate the presence of wetlands on the Subject Property.
