# **Engineer's Opinion Report**

## **Meadows Taft House – Site Drainage**

### **The Meadows, Castle Rock, Colorado**

Project No. 111298

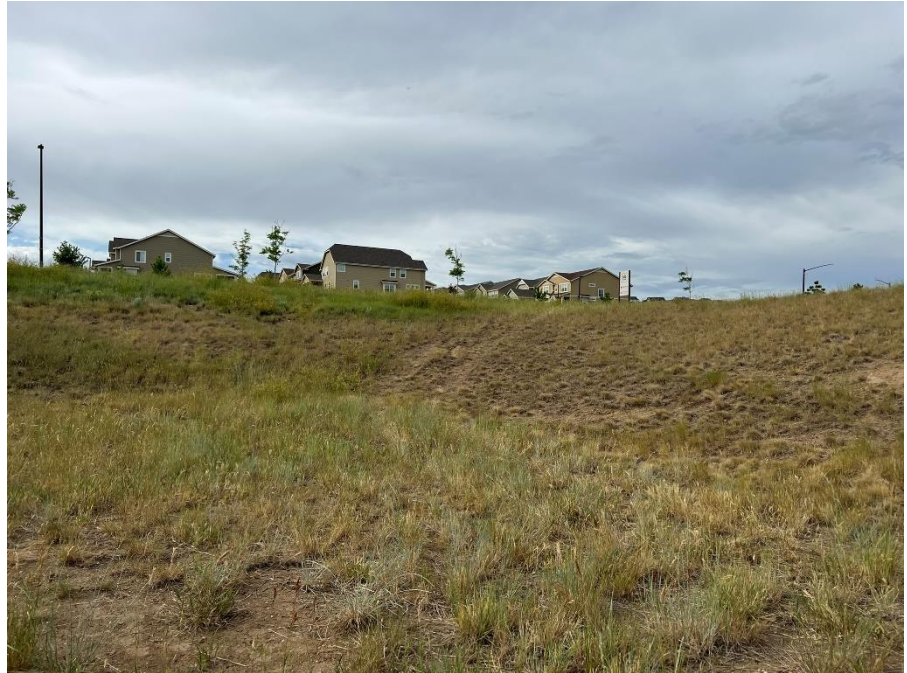
**Comments: Evidence of  
bare soil and rilling  
erosion on undeveloped  
slope west of Taft House.**

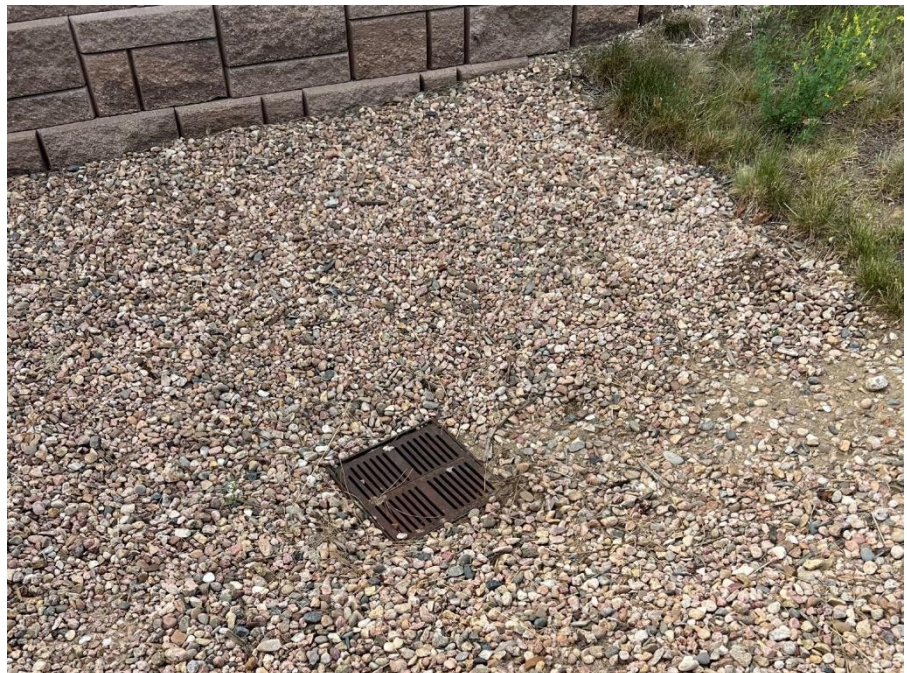
**IMG\_1146**

**Comments: Farthest west  
(First inlet grate drain).**

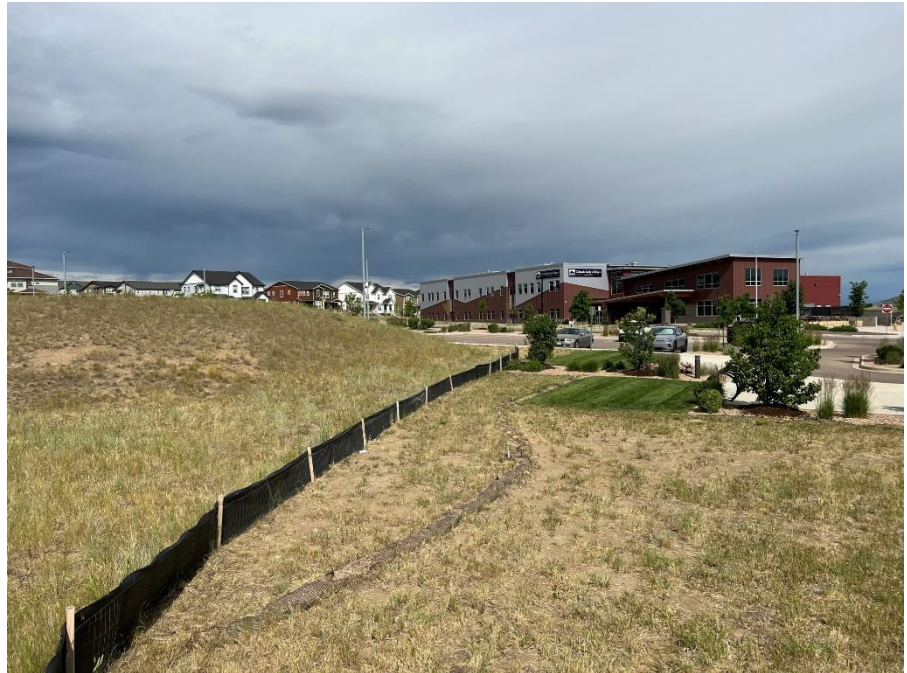
**Comments: Location of  
silt fence and straw  
wattles installed for  
erosion control.**

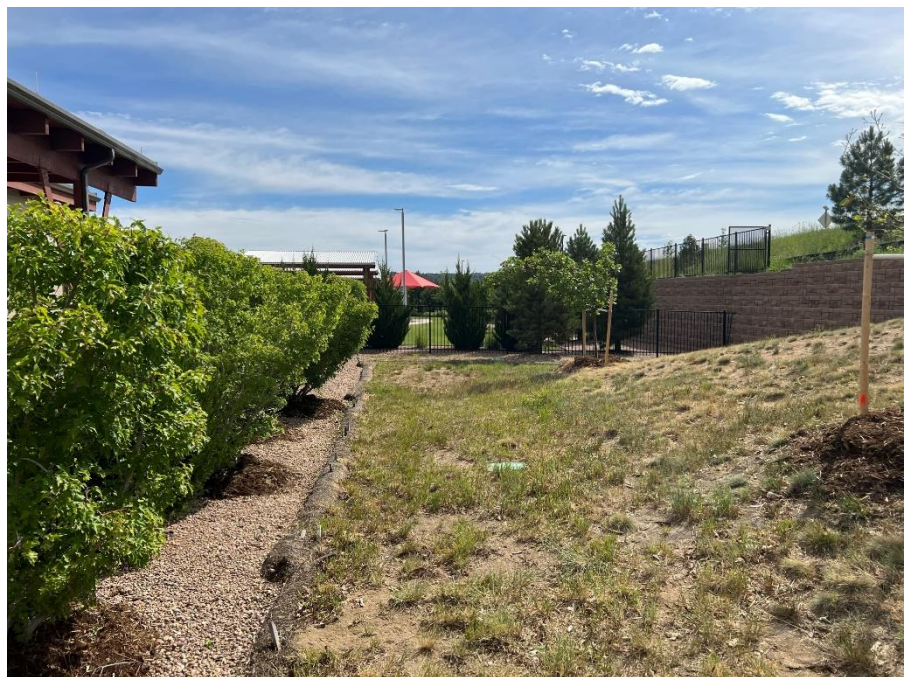
**IMG\_1159**

**Comments: Connection  
between west slope and  
taft house property.**

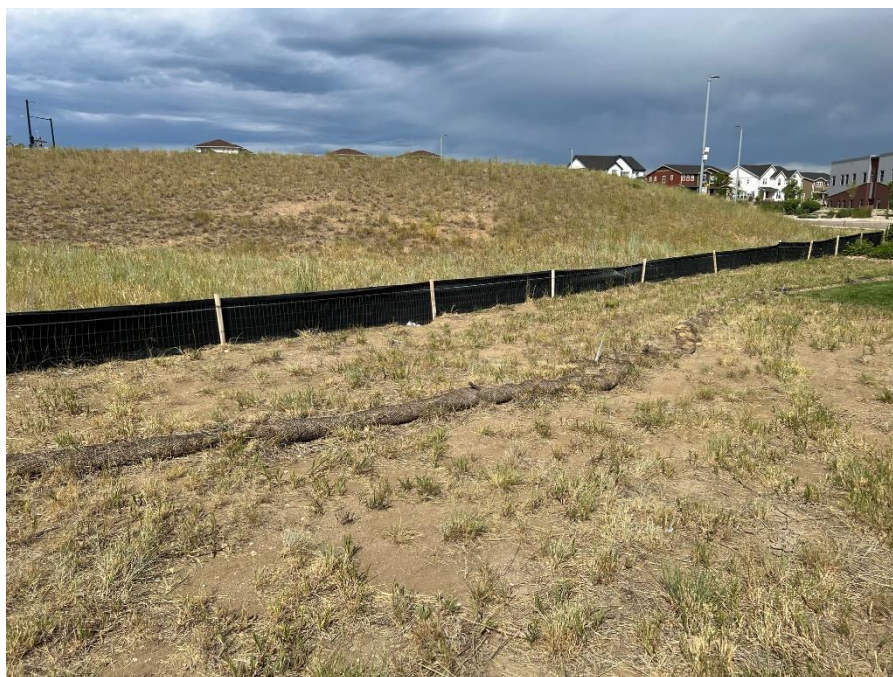
**Comments: Silt fence and erosion on the slope west of the Taft House.**

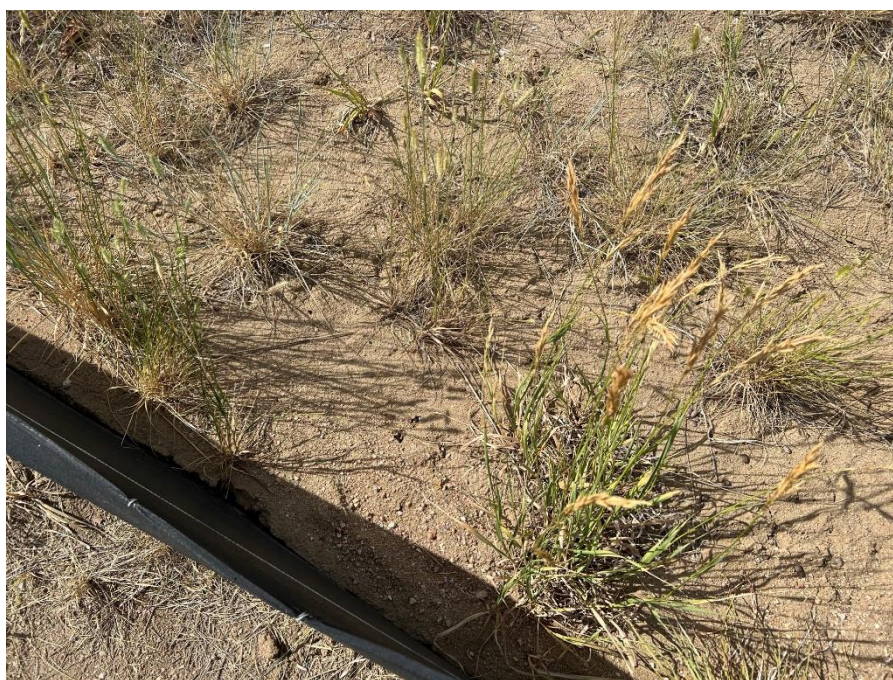
**IMG\_1162**

**Comments: Buildup of sediment behind silt fence.**

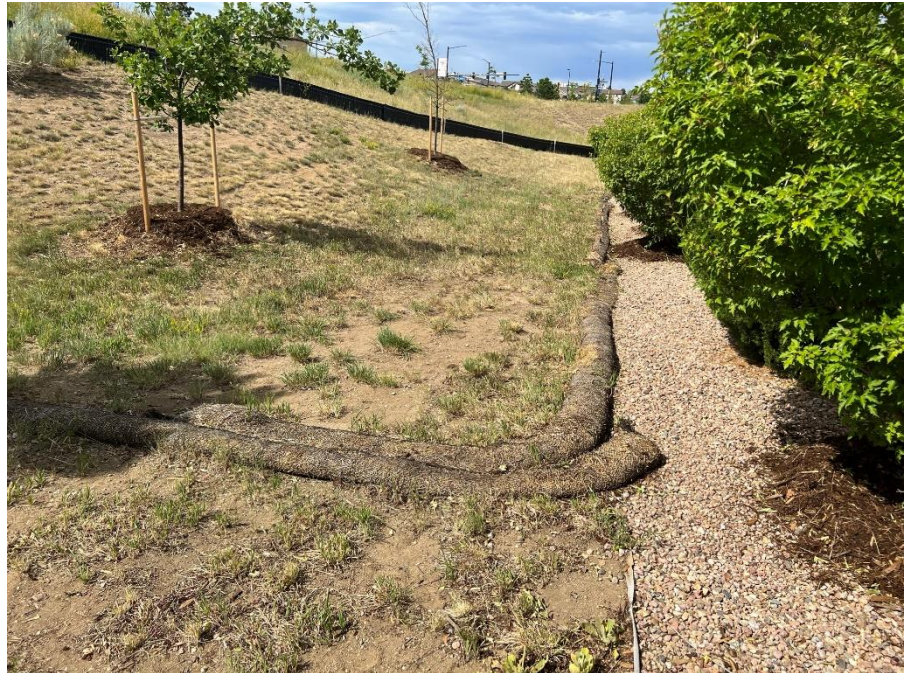
**Comments: Connection  
between west slope and  
taft house property.**

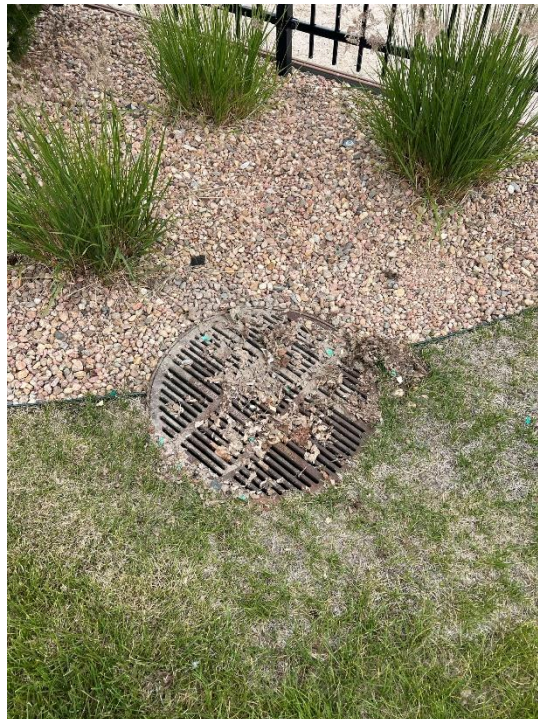
**IMG\_1167**

**Comments: Buildup of  
debris at inlet grate east  
of the pool adjacent to the  
volleyball courts.**

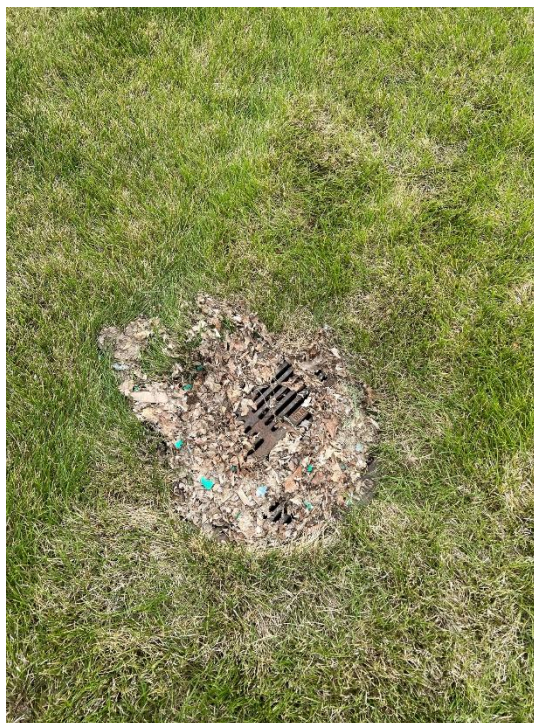
**Comments: Buildup of debris at inlet grate east of the pool.**

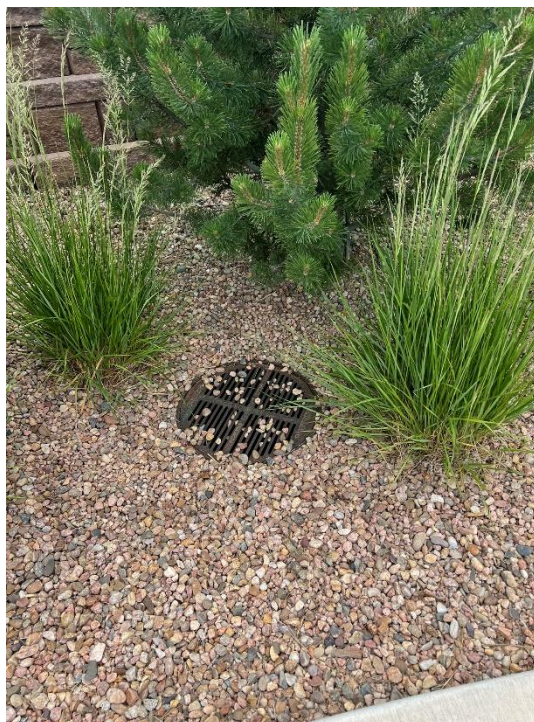
**IMG\_1169**

**Comments: Landscaping rock partially blocking inlet grate south of pool adjacent to retaining wall.**

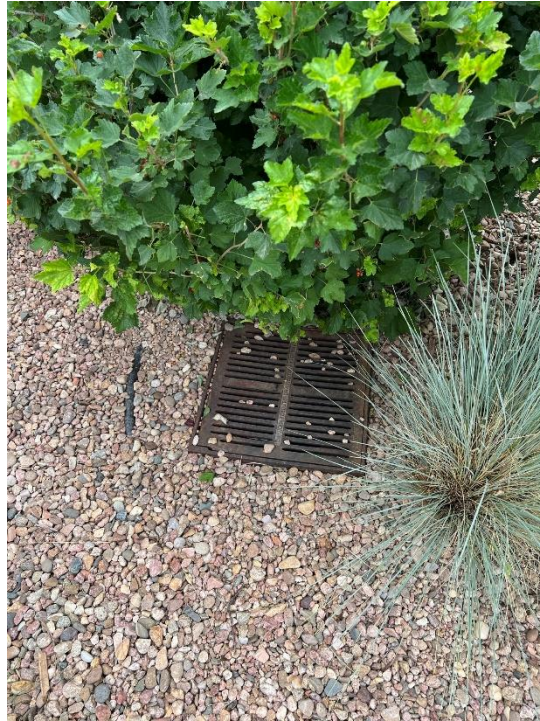
**Comments:** Landscaping rock partially blocking inlet grate south of pool adjacent to retaining wall.

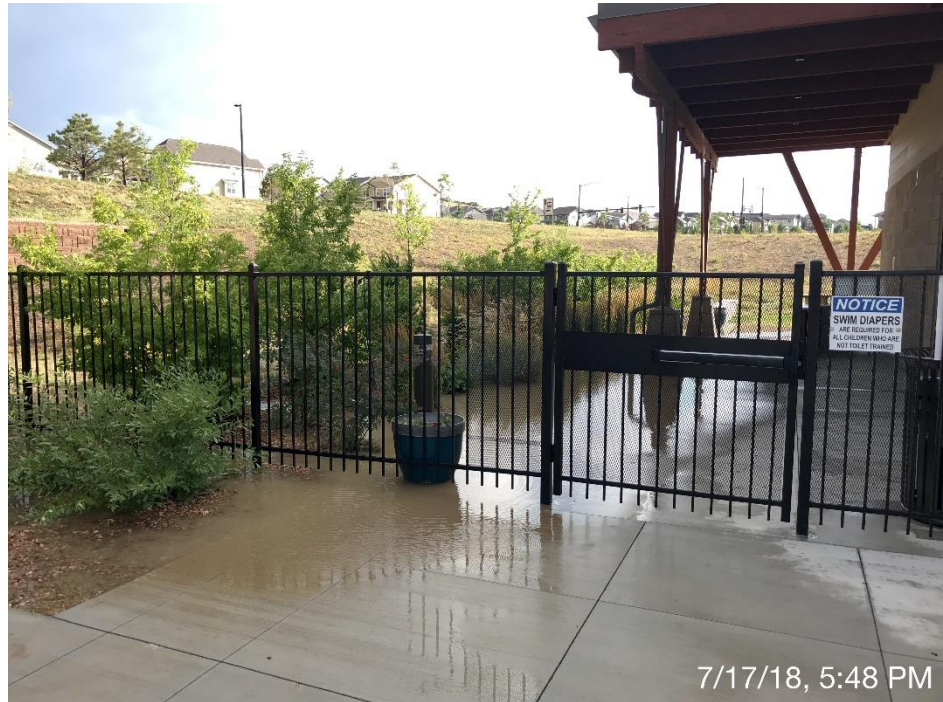
**Comments: Ponding of  
water around the first  
drain inlet.**

- It is our opinion that the Builder did not provide sufficient hydraulic capacity to handle the major storm runoff. Drain Inlet 1, which is the only inlet for the drainage west of the Taft House (Subbasin EA-1), is inadequate to drain the 100-year recurrence rainfall event. The drain pipe which runs along the south retaining wall downstream of the first inlet, only has a capacity of 3.39 cfs which cannot handle the peak inflow to the drains west of the pool (Hydraulic Segments 10 and 12 on Figure 4-1). The standard of care would have been to design and construct the main drain inlet to be capable of draining the 100-year recurrence rainfall event.

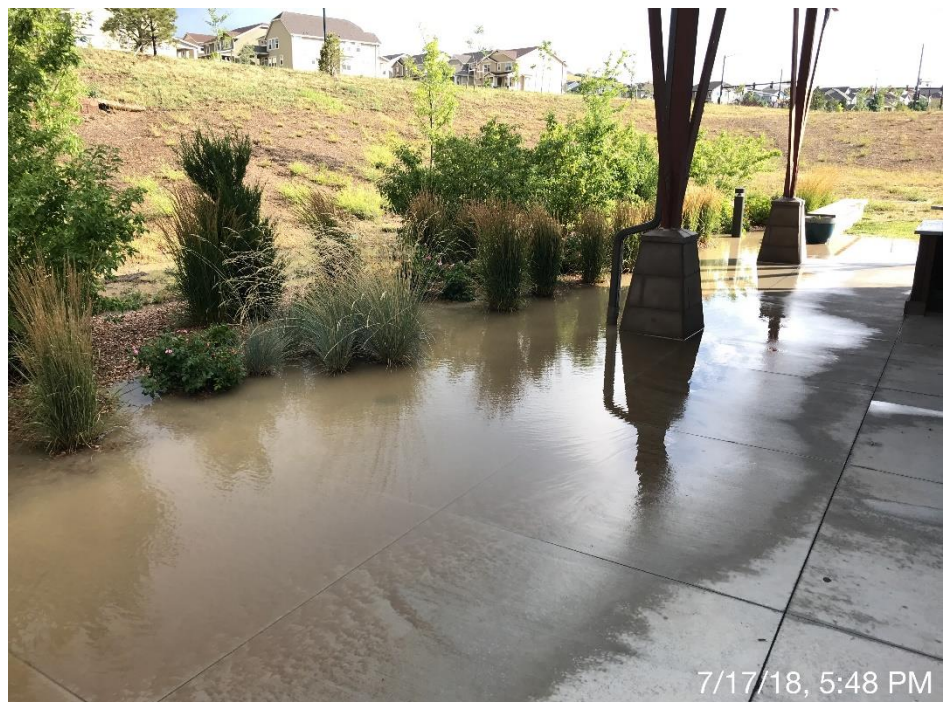
**MNC\_000942**

**Comments: Ponding of  
water around the first  
drain inlet.**

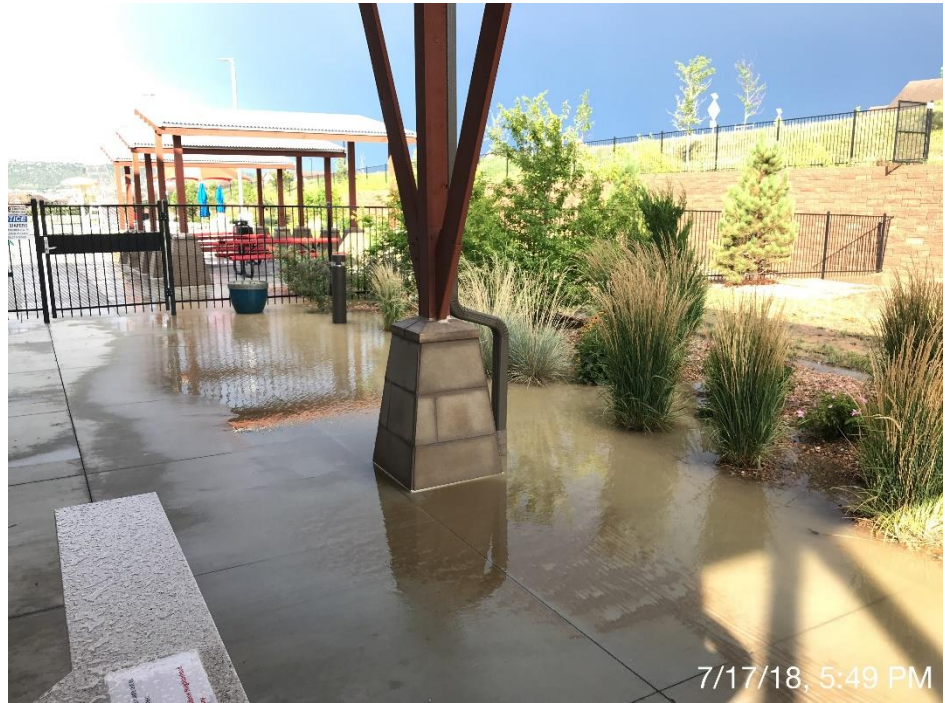
**Comments: Ponding of  
water around the first  
drain inlet.**

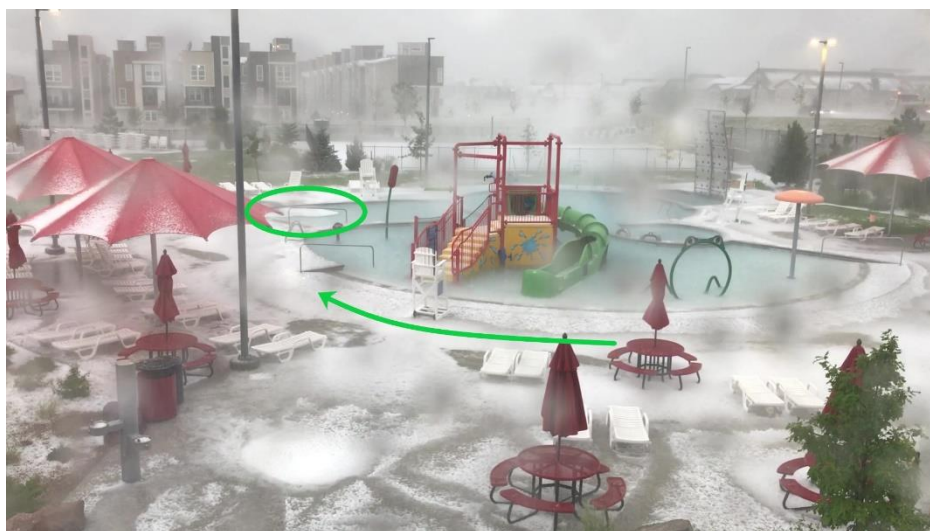
**Comments:** Frame from  
video MNC\_000963  
showing flow of water  
from right to left and  
deposition of hail in north  
end of pool.

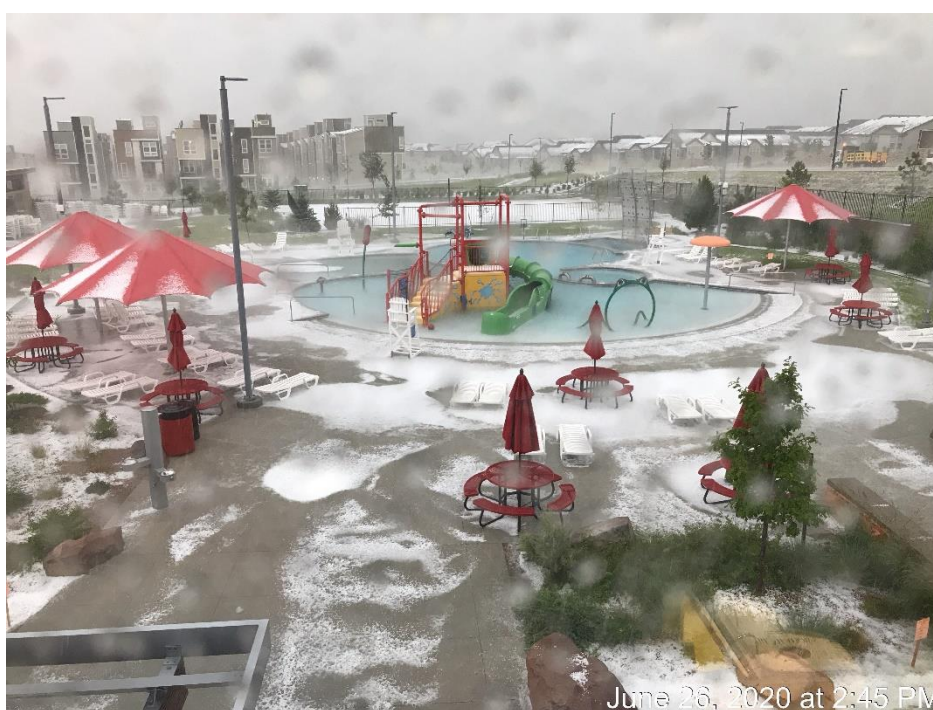
**MNC\_000964**

**Comments:**  
Accumulation of hail on  
pool deck showing water  
flow paths.

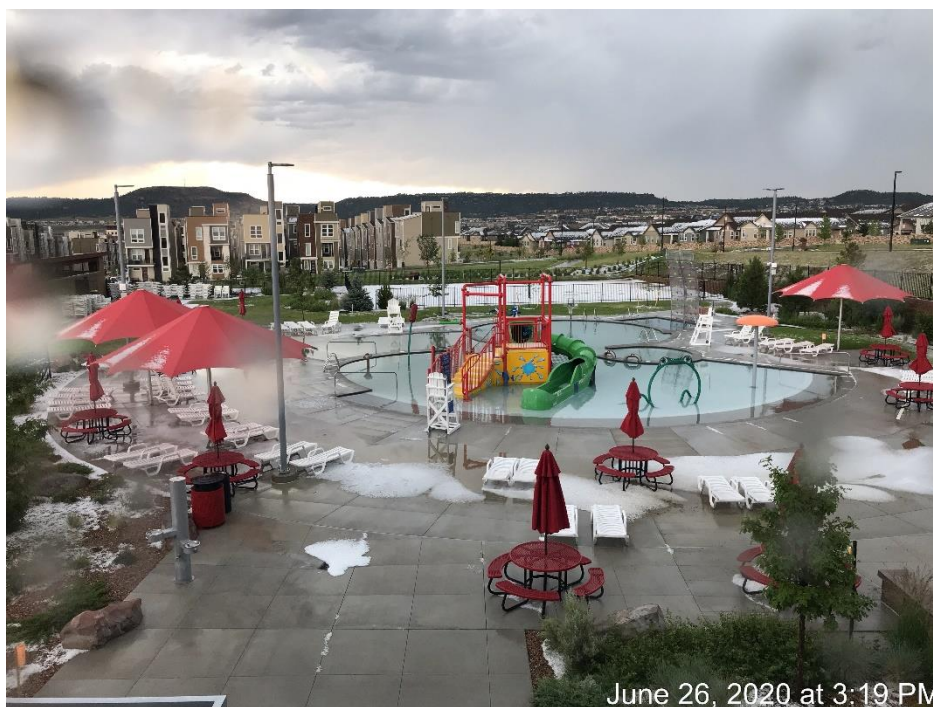
**Comments: Post-storm  
on 6/26/2020.**

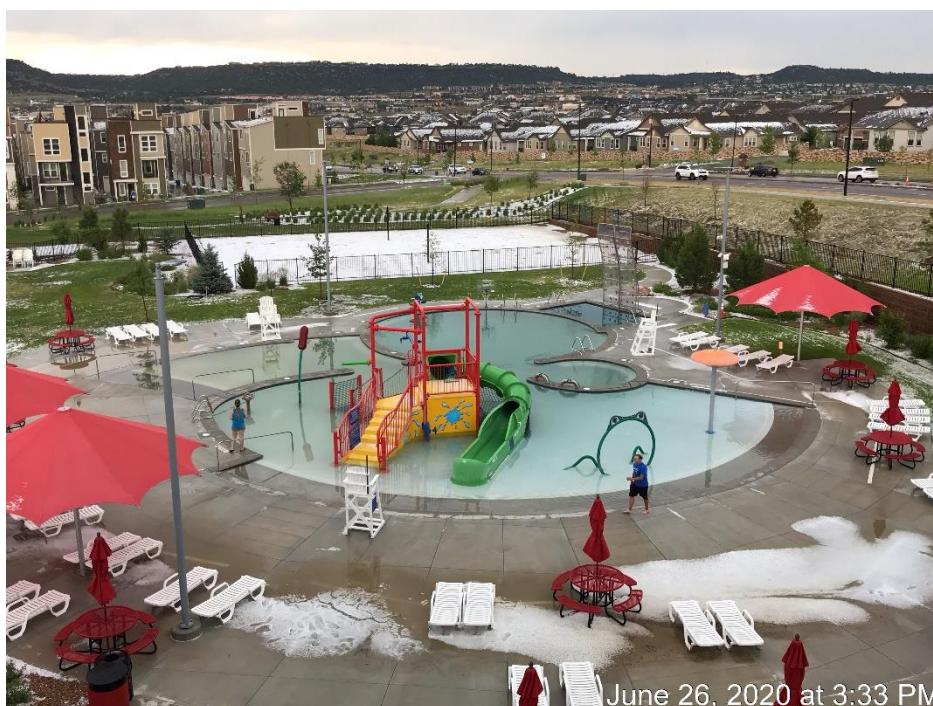
**MNC\_000971**

**Comments: Sediment in  
pool area after a storm.**
