## **Land Suitability Analysis Report**

**3161 North Castleton Court  
3161 North Castleton Court  
Castle Rock, Colorado 80104**

**Project Number:  
E513T2848**

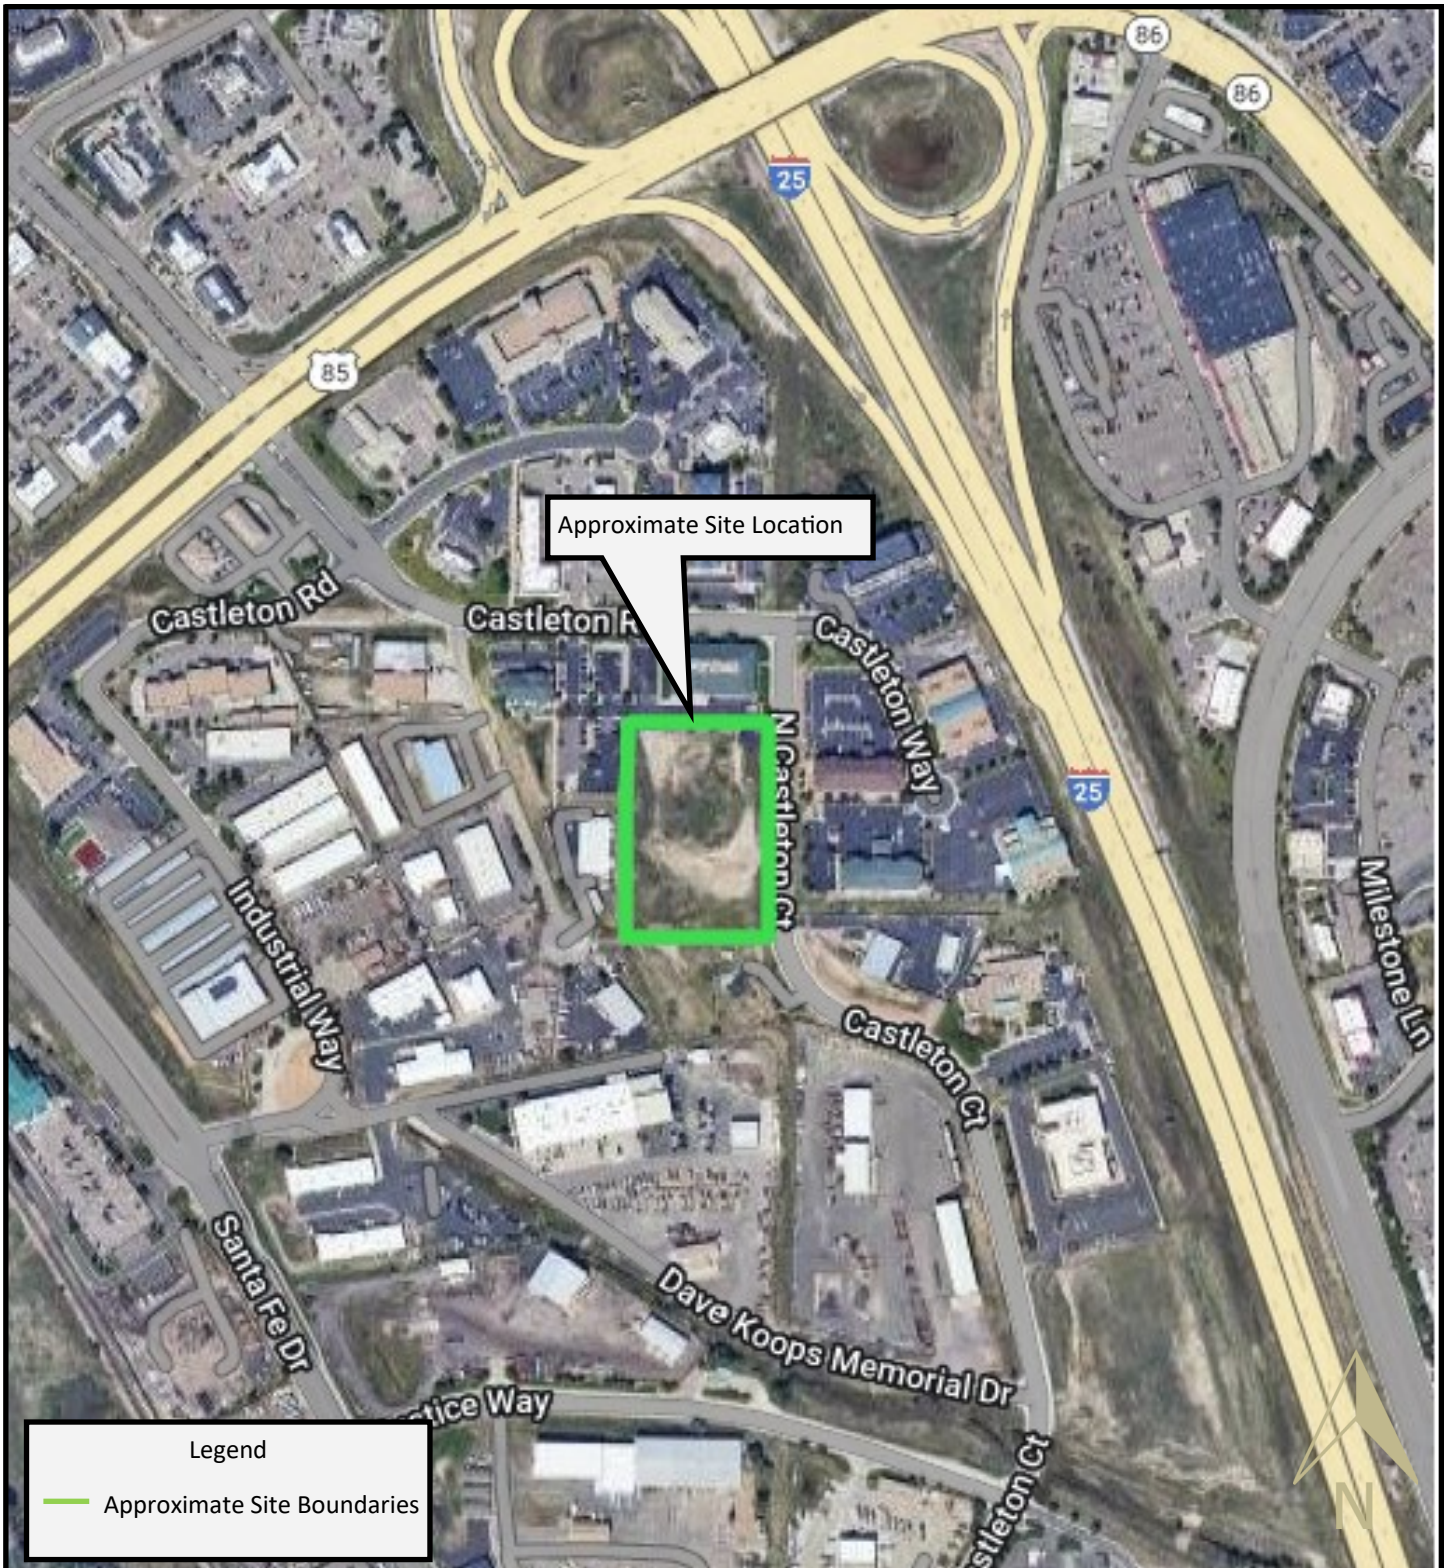
| <p>Figure 1– Aerial Photograph</p> <p>3161 North Castleton Court</p> <p>3161 North Castleton Court</p> <p>Castle Rock, Colorado</p> | <p>Project Number: E513T2848</p> <p>Date Drawn: 12/26/24</p> <p>Drawn By: JF</p> <p>Checked By: JE</p> | <p>GILL GROUP</p> |

The subject property is located at 3161 North Castleton Court in Castle Rock Colorado and can be further described as being located at 39.4083330 and -104.8685600 Longitude. An aerial map, and topographic map are provided in Appendix A-Figures 1 and 2.

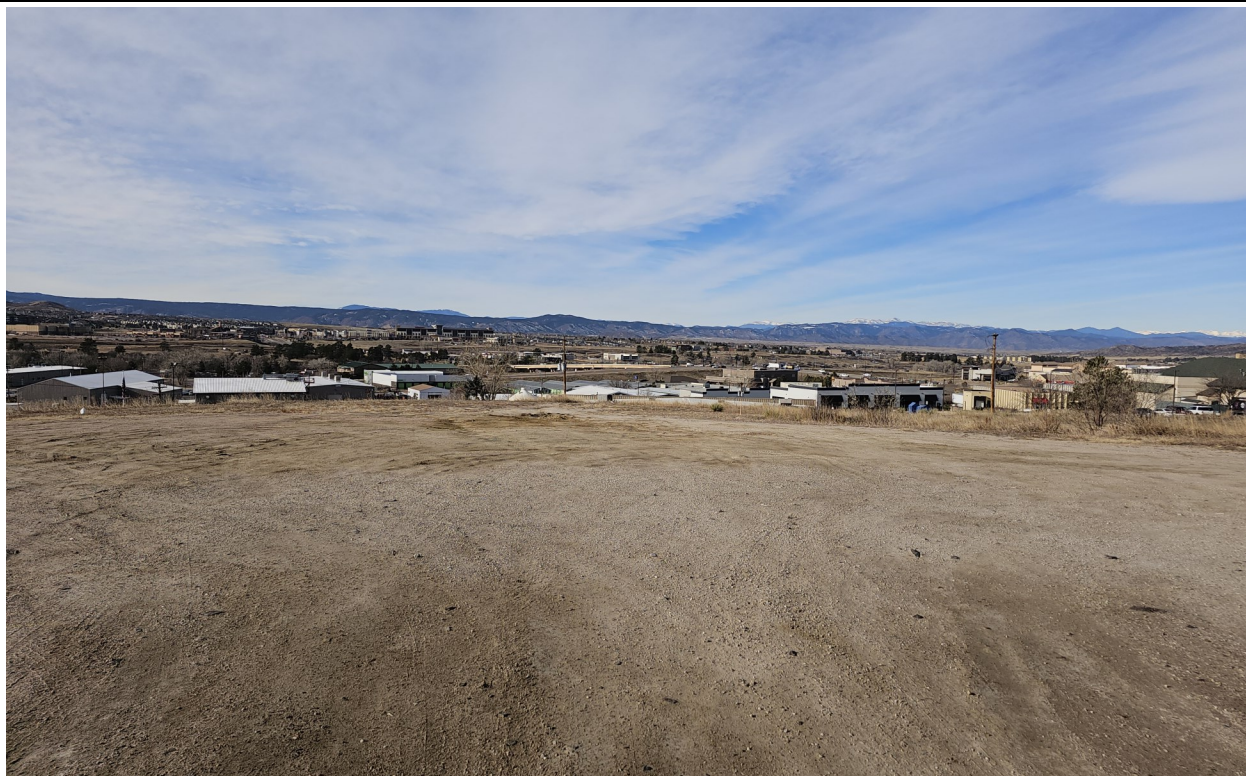
No. 1

View of the center of the subject property

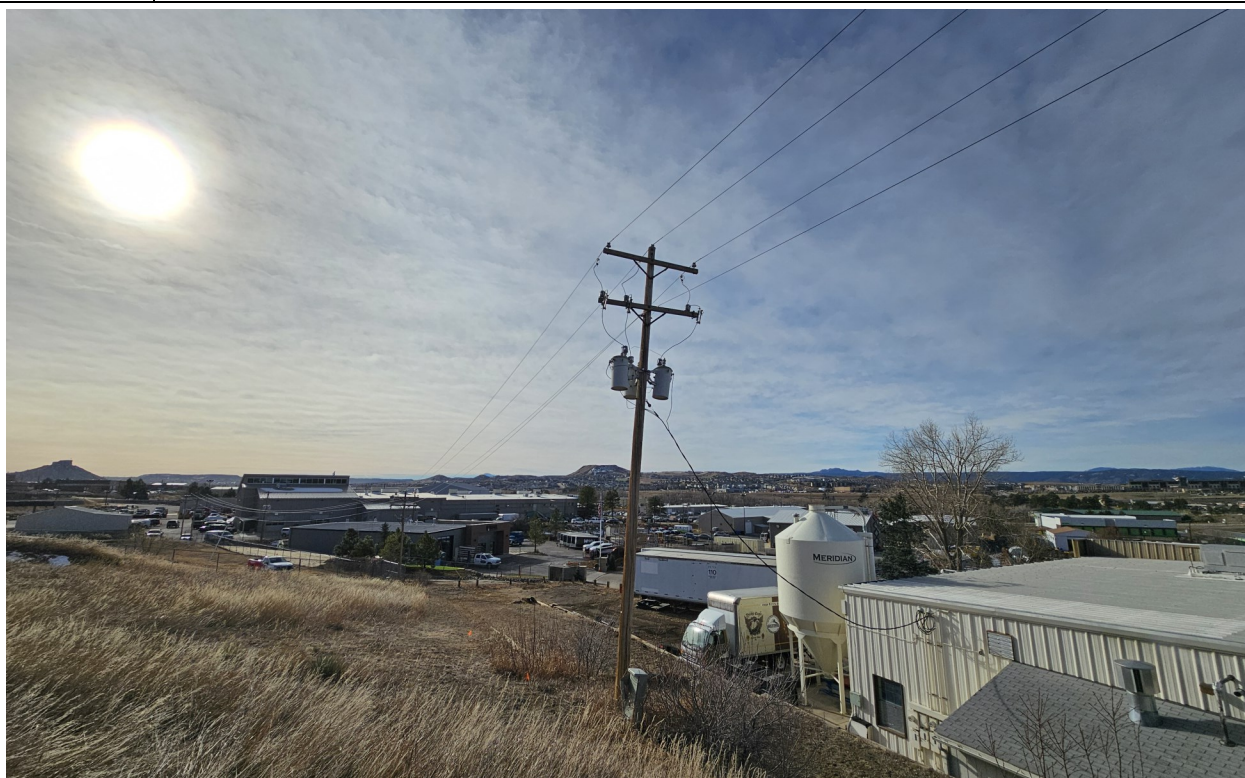
No. 2

View of the pole-mounted transformers on the western boundary

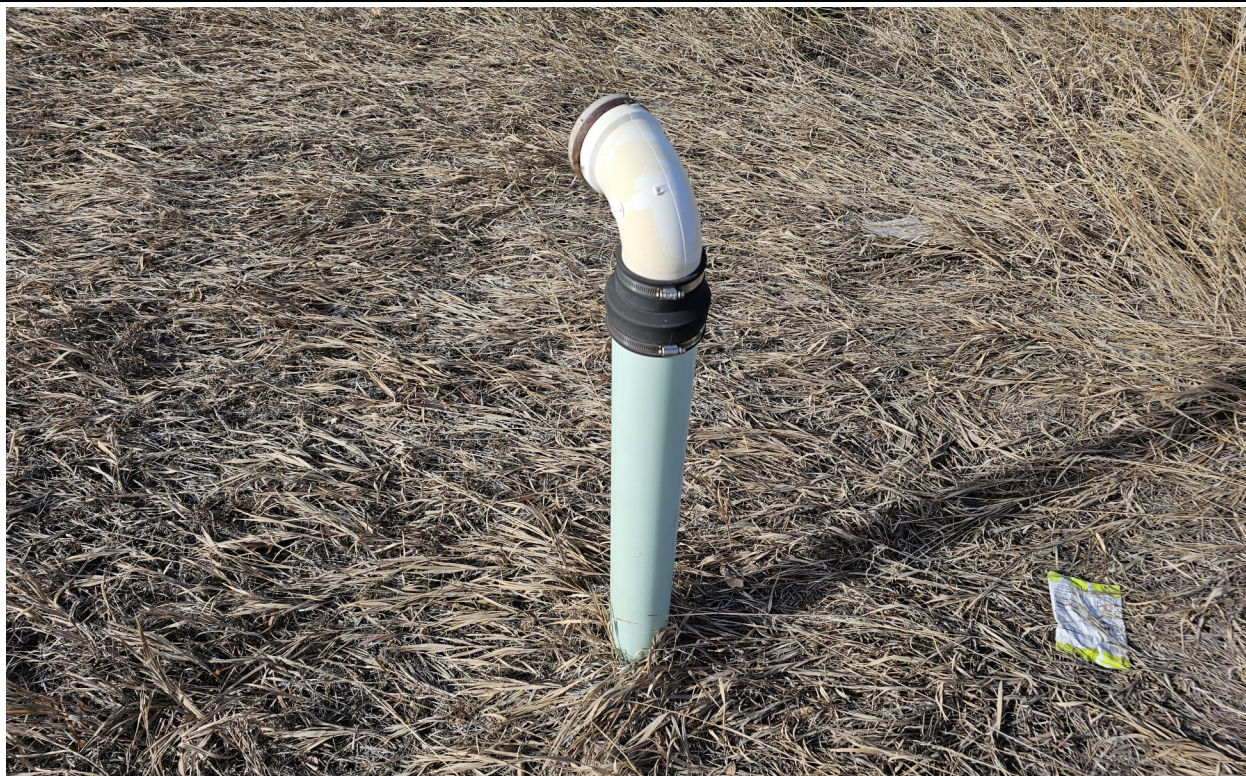
No. 3

View of a ventilation pipe near the northwest boundary

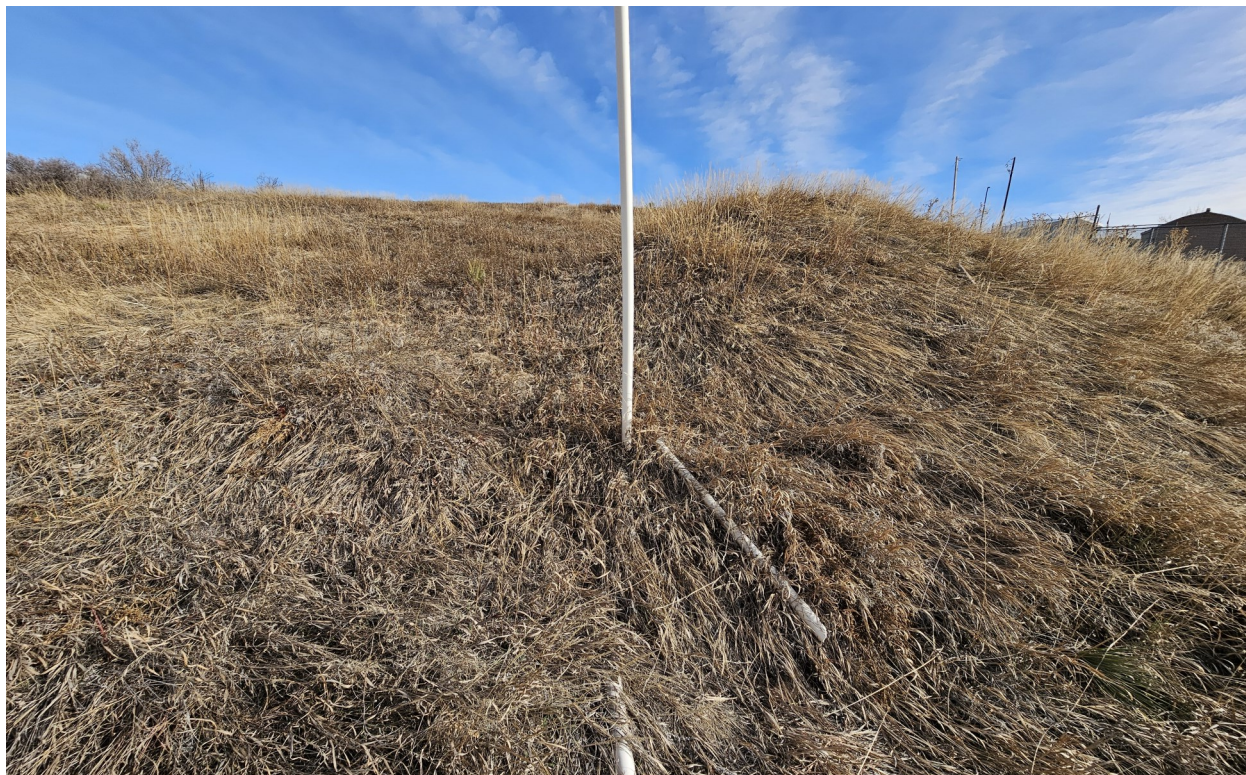
No. 4

View of PVC pole on the southwestern portion of the subject property

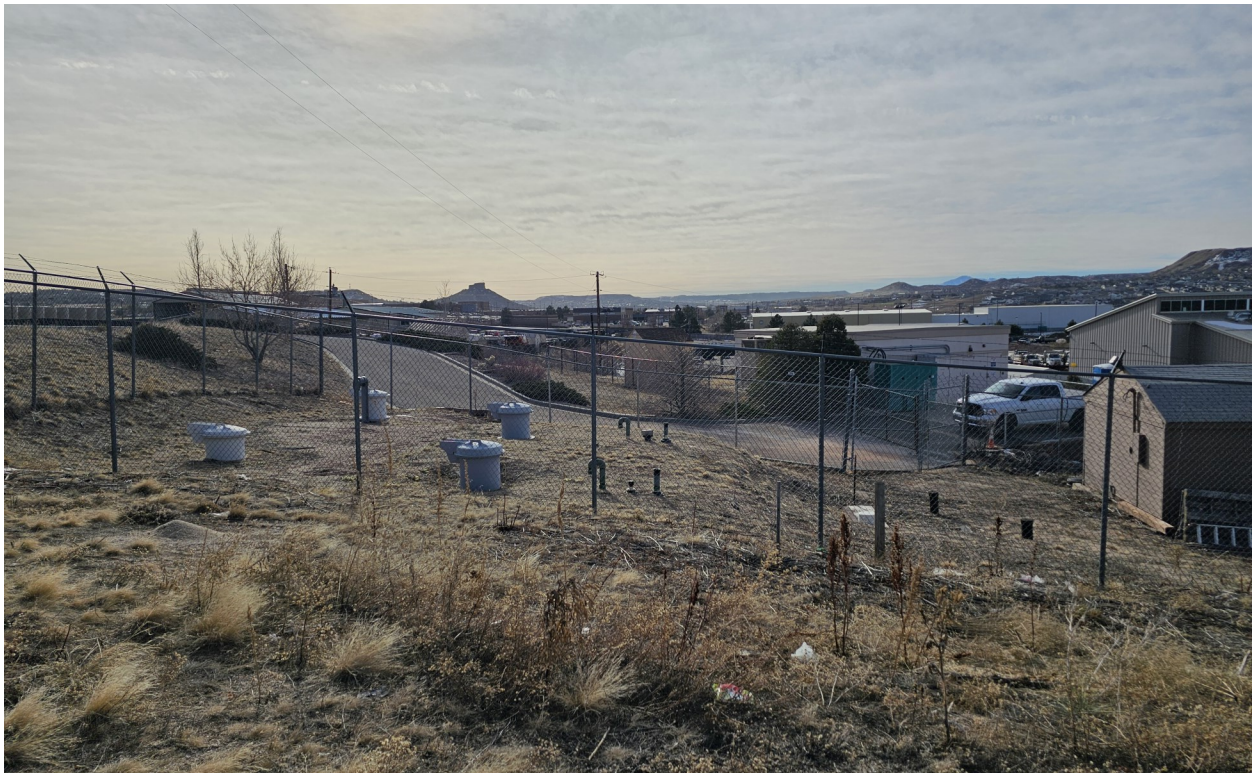
No. 14 | View of the Castleton Water and Sanitation District water taps

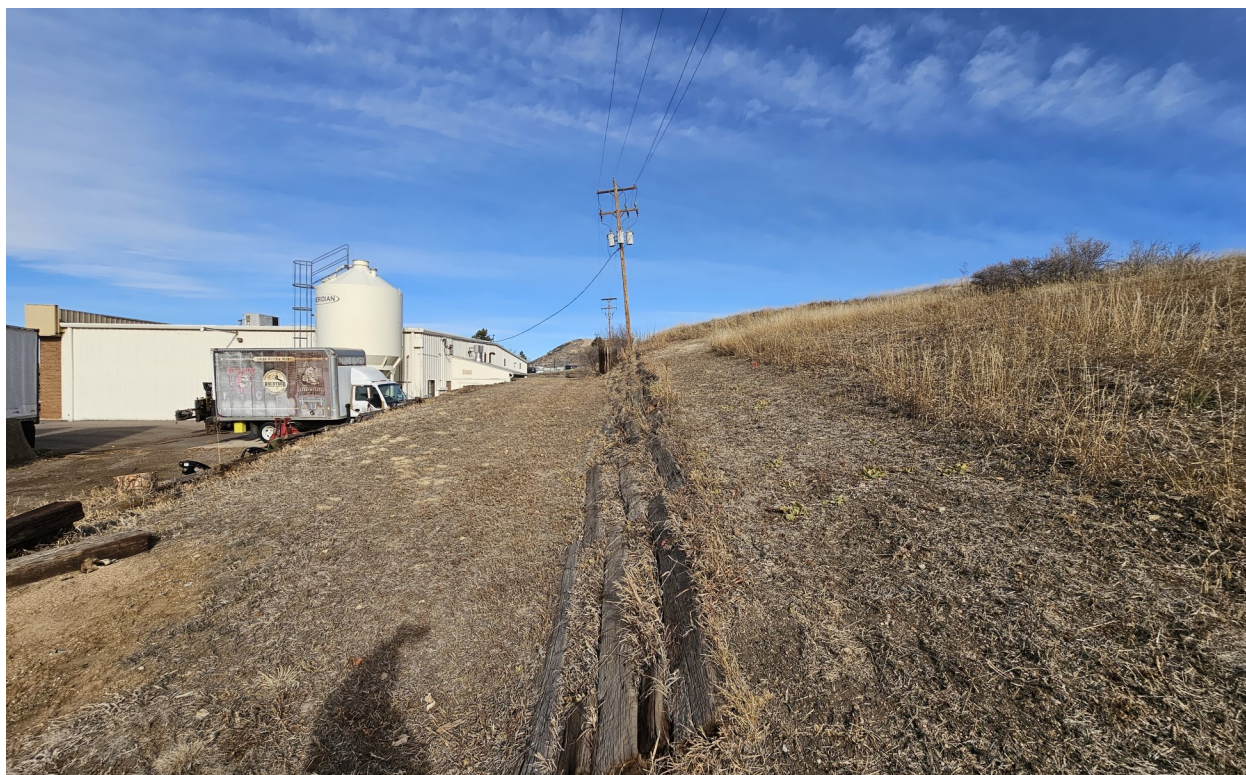
No. 18

Front view of the western property boundary slope

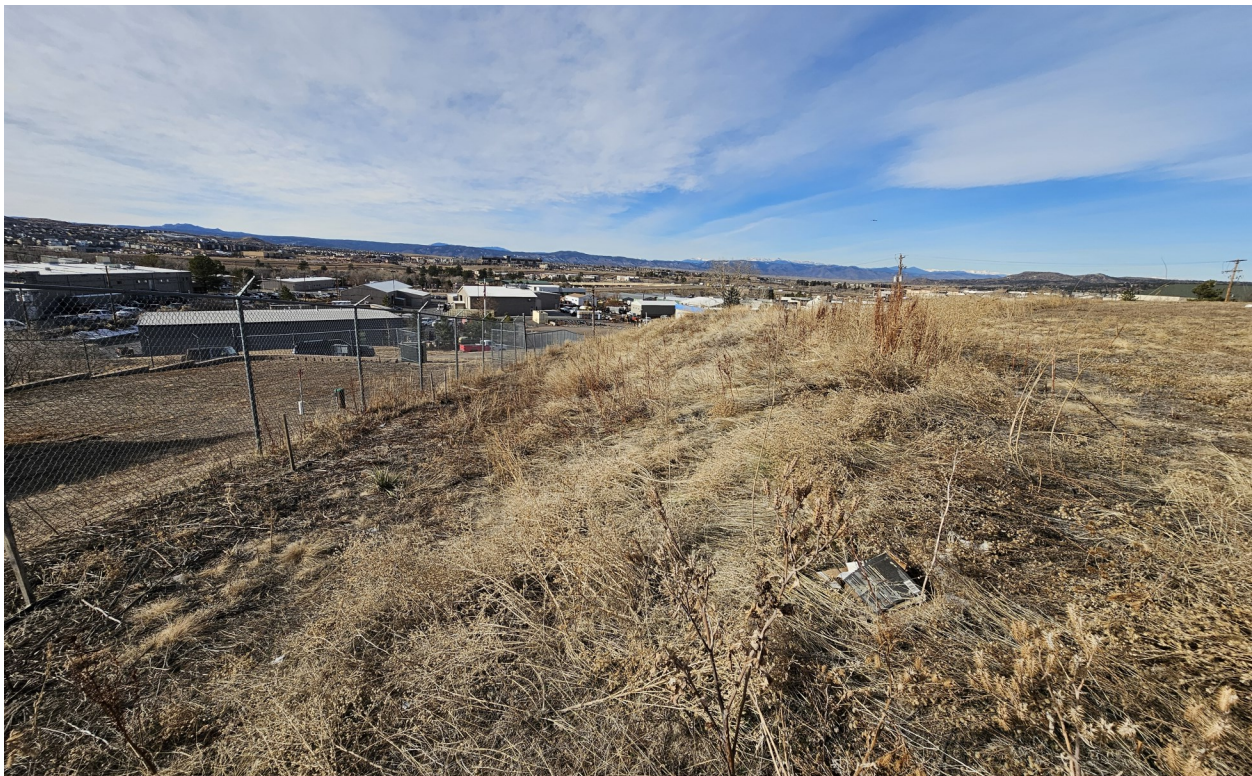
| No. 19 | View of the southern property boundary slope |
