# Land Suitability and Analysis Report

## Bella Mesa South

May 21, 2025  
Project No. 17026.007

# Phase I Environmental Site Assessment Founders Village Filing No. 24 Tracts M, N, O, R and a Portion of P Castle Rock, Colorado

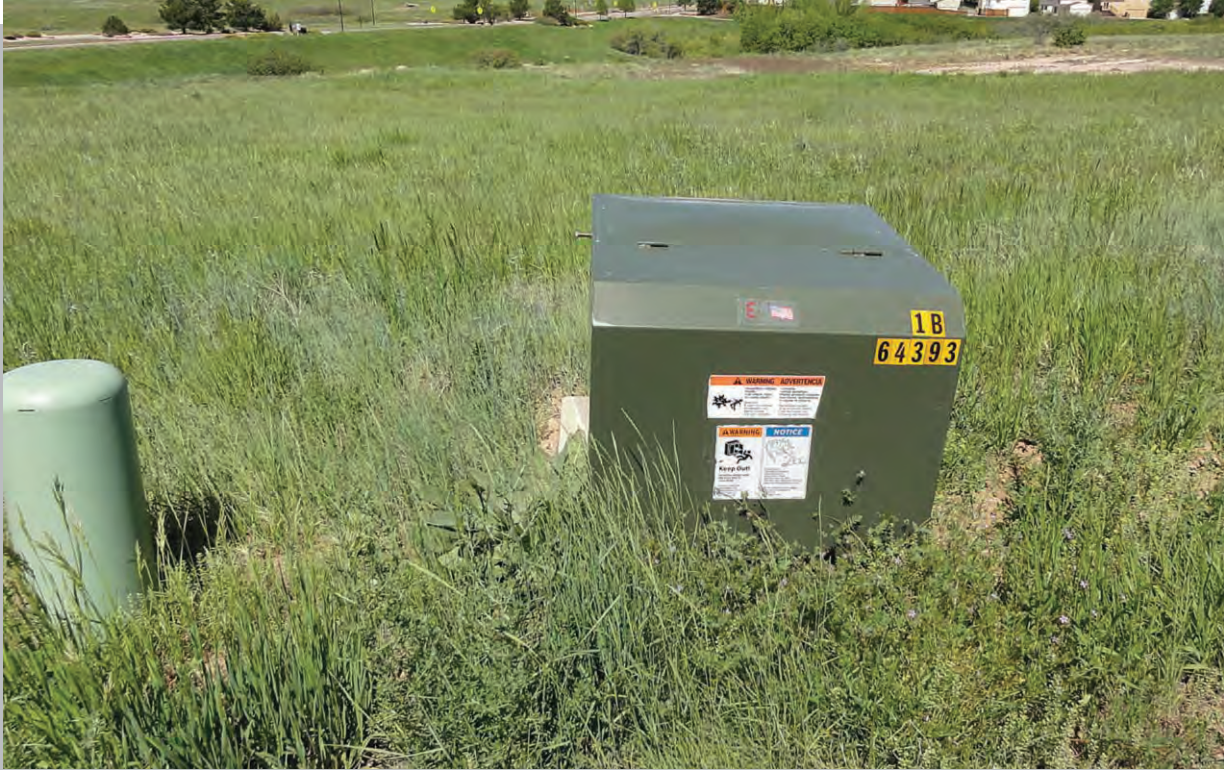
**Photo 3** - View of a pad mounted transformer near the southeast corner of the property.

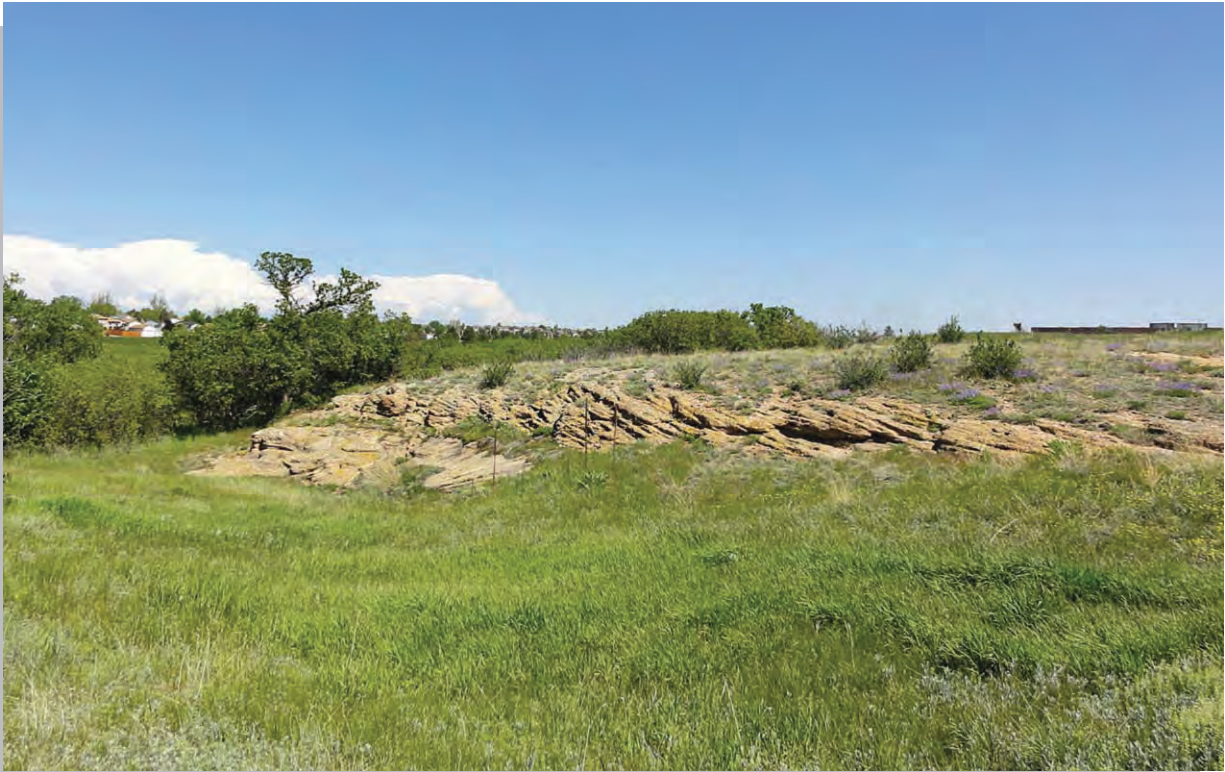
**Photo 5** - View of a typical rock outcropping at the property.

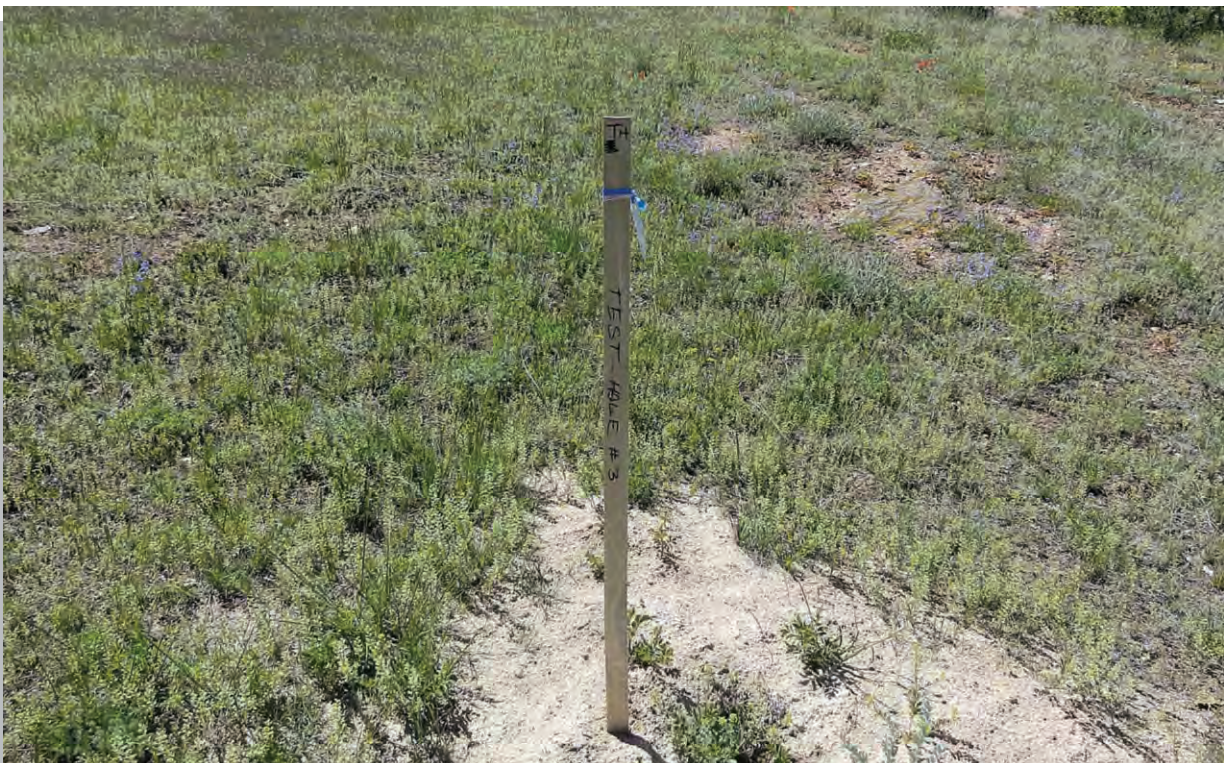
**Photo 6** - View of a "test hole" observed at the property.

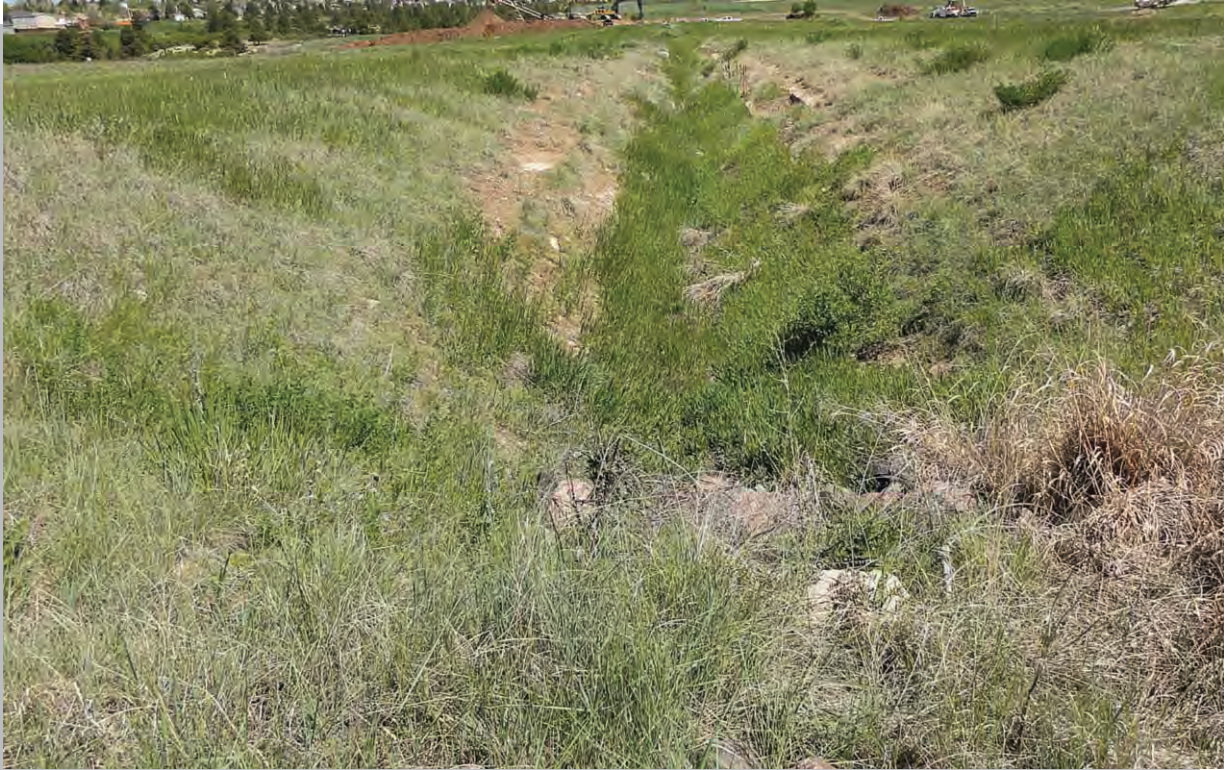
**Photo 7** - View of the shallow ditch at the northeast corner of the property.

A constructed drainage ditch dominated by smooth brome, big bluestem (*Andropogon gerardii*), switchgrass (*Panicum virgatum*), Canada thistle, and nodding plumeless thistle (*Carduus nutans*) occurs in the northeast corner of the project area. A small , dominated by cattails (*Typha* sp.), was observed along the southern edge of the project area, abutting an unnamed pond with a surface connection to Mitchell Gulch.

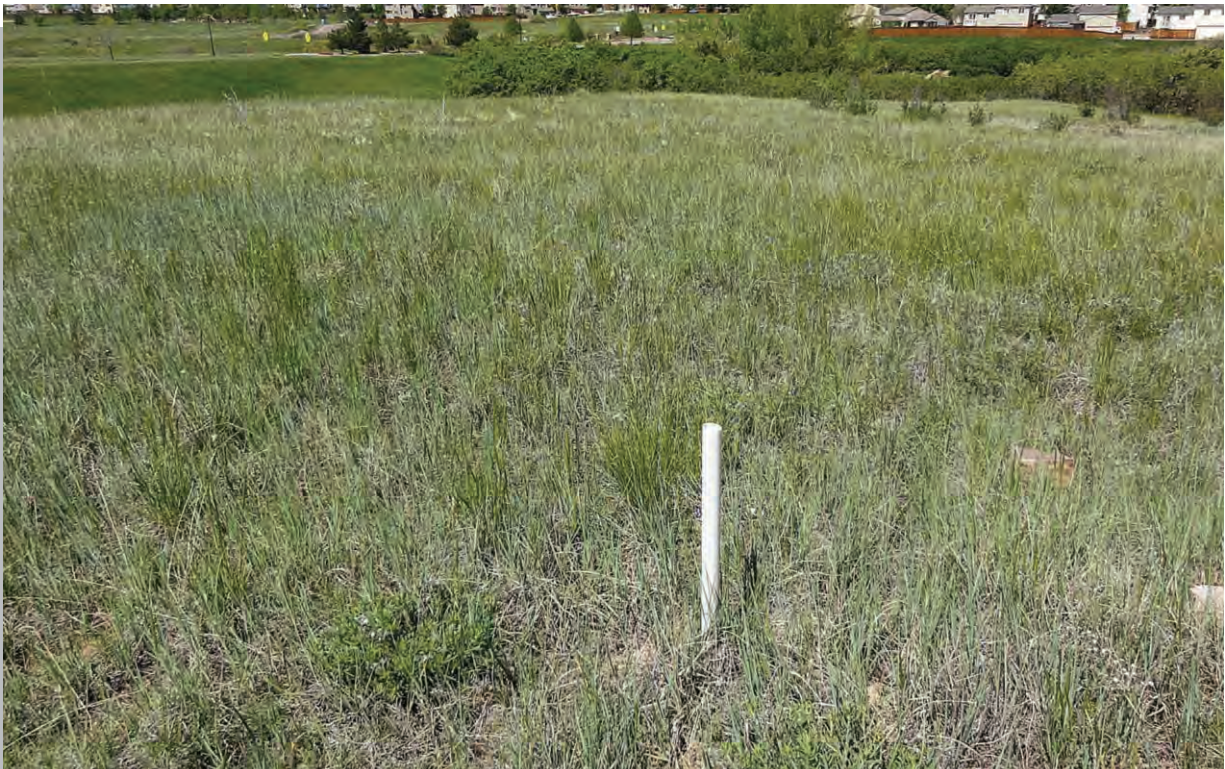
**Photo 8** - View of a PVC pipe near the center of the property.

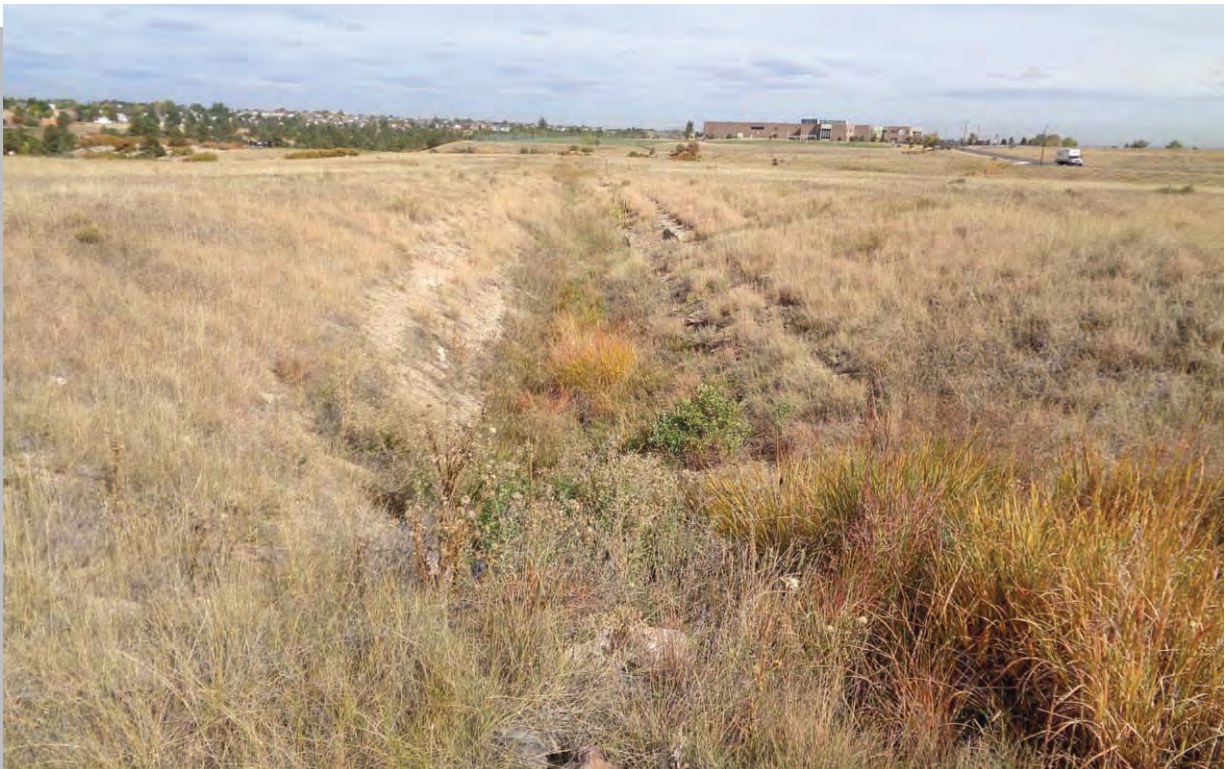
**Photo 2** - Overview of upland vegetation in a constructed drainage ditch in the northeastern corner of the project area. View is to the northwest.

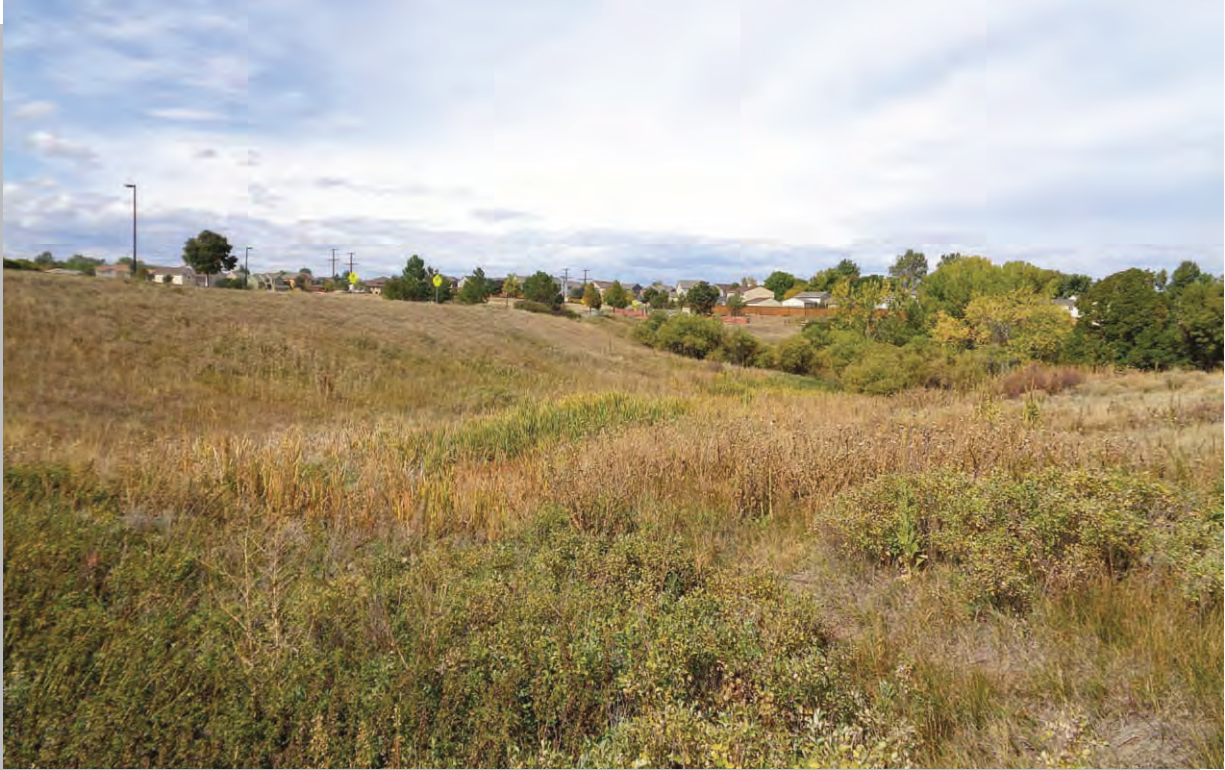
**Photo 3** - Overview of wetland on the southern edge of the project area. View is to the west.
