Land Suitability Analysis Report  
for  
**RidgeView Town Center**  
Planning Development  
December 2024

**GEOLOGIC HAZARDS STUDY  
895 NORTH RIDGE ROAD  
PROPOSED MULTI-USE DEVELOPMENT  
SOUTH OF NORTH RIDGE ROAD AND FIFTH STREET**

## Land Suitability Analysis Report

*Preliminary Geotechnical Engineering Report*  
*Proposed Mixed-Use Development – 895 N. Ridge Rd., Castle Rock, CO*  
*CGG Project No. 21.22.318*

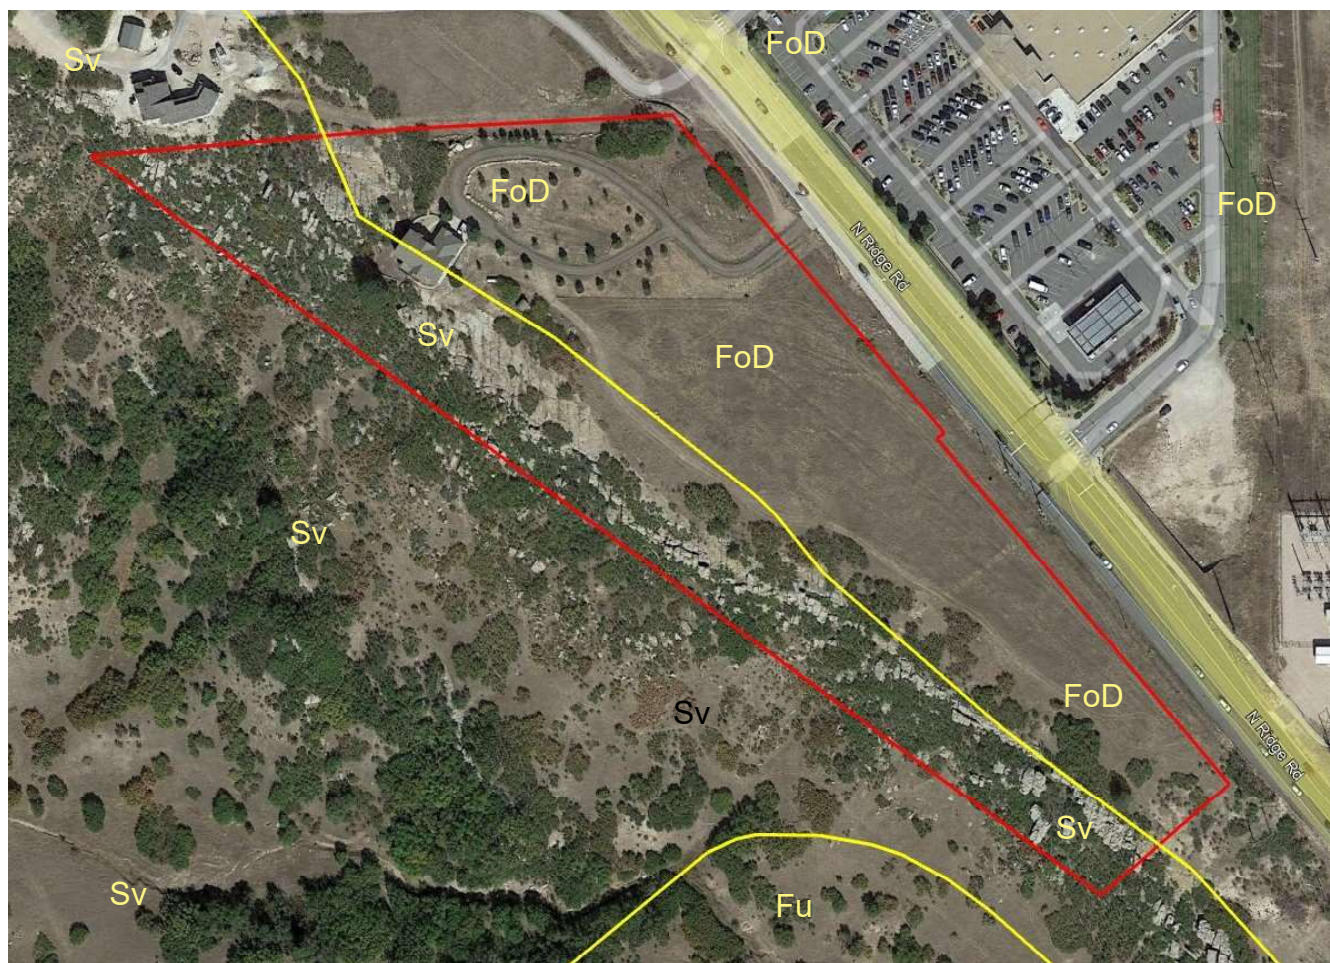
FoD: Fondis clay loam

Sv: Stony steep land

The United States Department of Agriculture Natural Resource Conservation Service (NRCS) Web Soil Survey indicates the subject site as overlain with 2 separate soil units. These units include the Fondis clay loam (FoD) and Stony steep land (Sv). A map of the soil units is presented on Figure 3. Both soil units are well drained, and have a high runoff potential. The Fondis clay loam is found within hydrologic group C, while Stony steep land is classified within hydrologic group D. The Fondis clay loam has a parent material of eolian deposits over coarse-silty outwash derived from arkose, while Stony steep land does not have parent materials listed on the Soil Survey, although its location generally correlates with the location of the Castle Rock Conglomerate. These soils are found within geomorphic positions that range from mesas, buttes, and ridges.

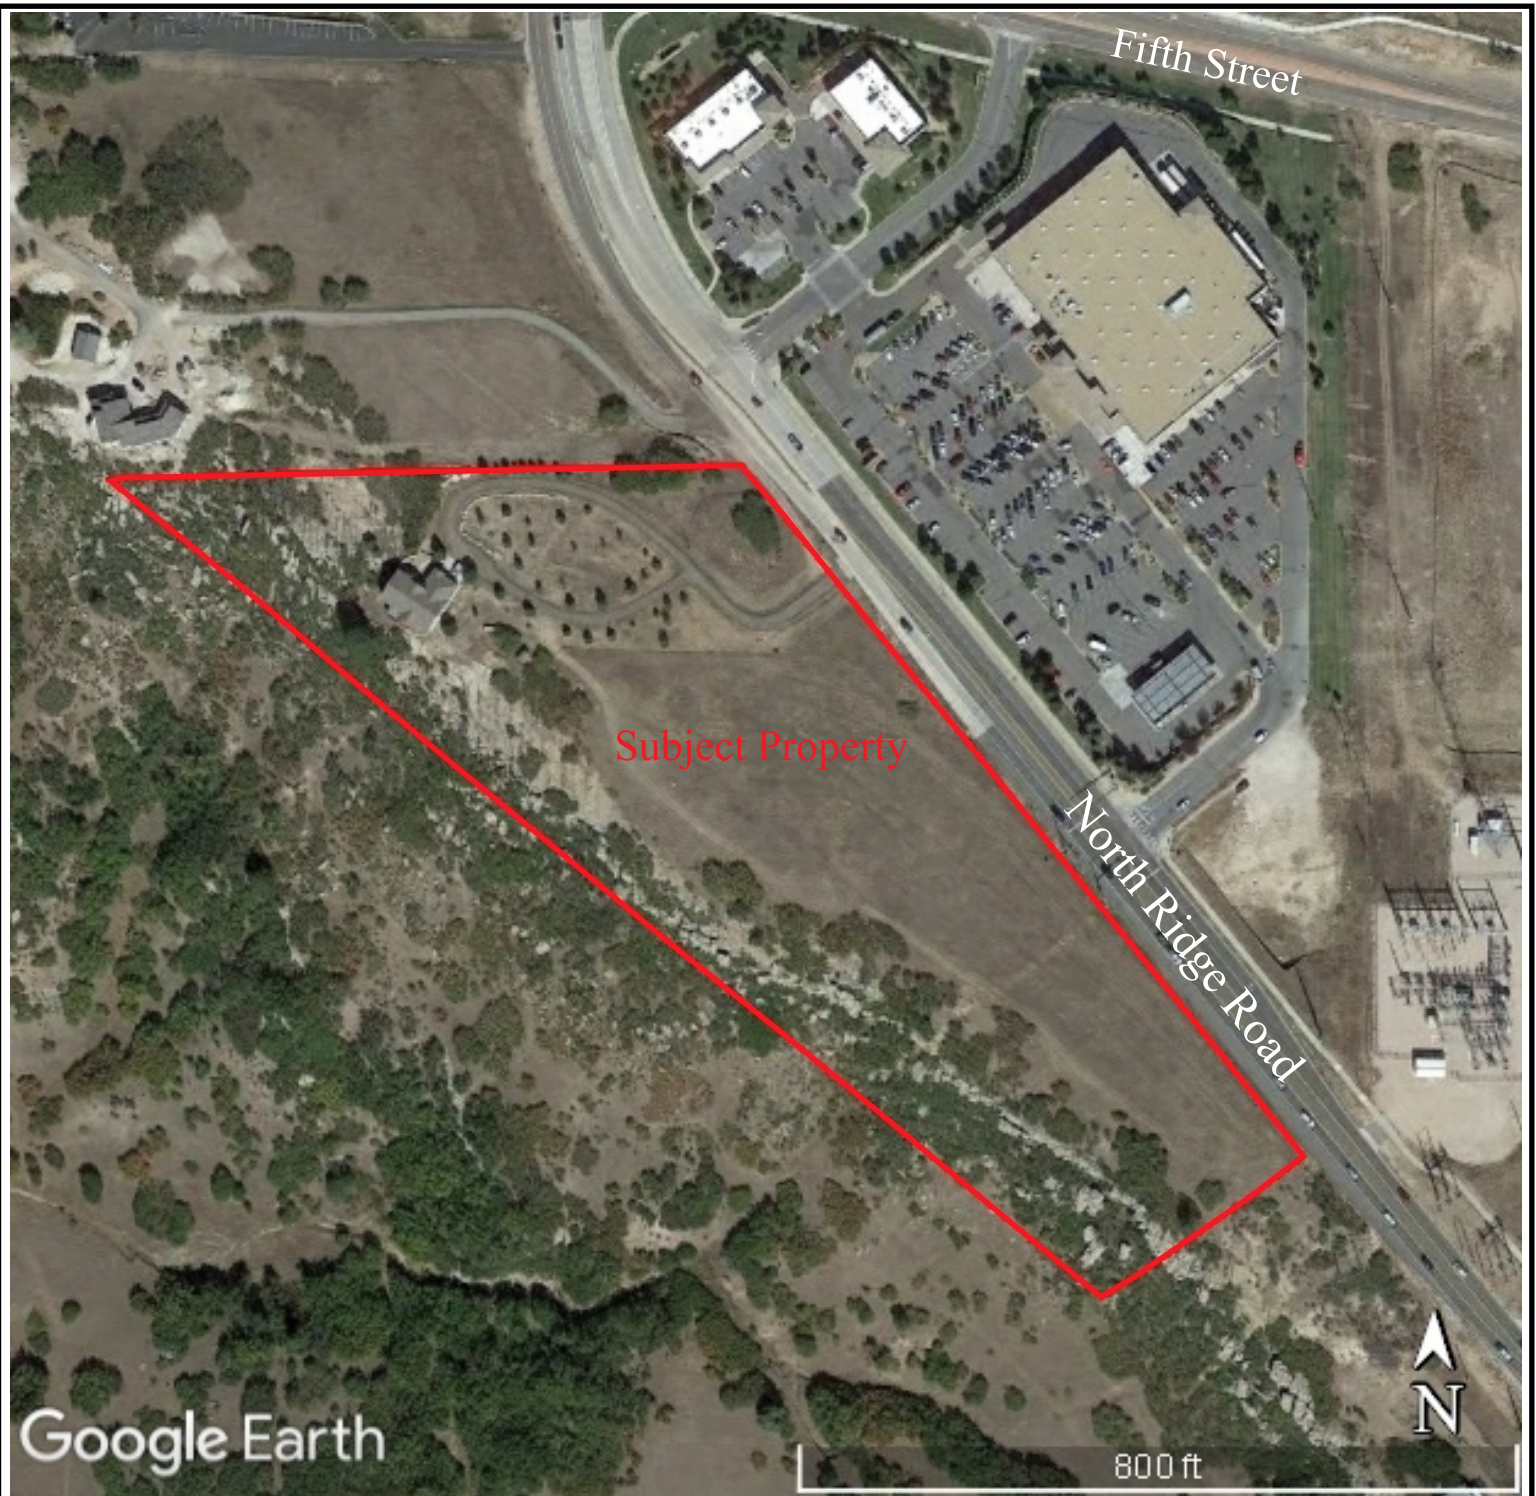
Figure 2: Site Map  
895 North Ridge Road  
Douglas County, Colorado 80104

Google Earth Image

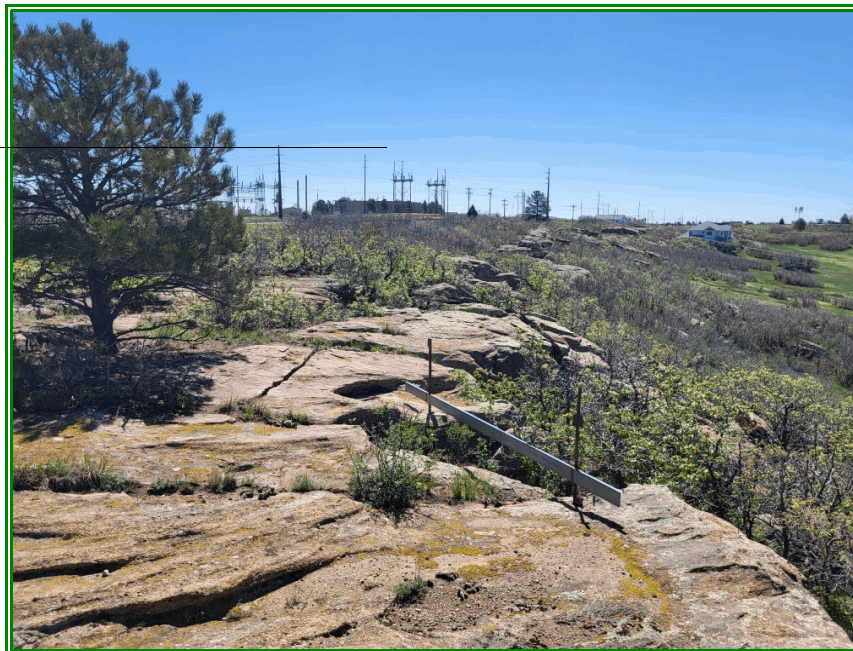
View of southwest border of the site

The site occurs at an approximate elevation range of 6,610 to 6,660 feet above sea level (USGS Castle Rock North and Castle Rock South 7.5 Minute Quadrangles, 2019). The majority of the property slopes to the southwest; however, the southwest border of the property consists of a steep rocky slope to the southwest. The US Natural Resource Conservation Service (NCRS) classifies the site soils as a majority Fondis clay loam on 3 to 9 percent slopes. Fondis clay loam is described as highly expansive, deep, well drained soils with slow to medium runoff, slow to moderately slow permeability, and moderate erosion. The soils are classified by the NCRS as Hydrologic Group C, as "soils that have low infiltration rates when thoroughly wetted and consist chiefly of soils with a layer that impedes downward movement of water and soils with moderately fine to fine structure." The southwest border of the site consists of steep stony land, with slopes between 9 and 65 percent. Steep stony land is described as well drained soils with high runoff, shallow restrictive layer, and high erosion. The soils are classified by the NCRS as Hydrologic Group D as "soils that have very low infiltration rates when thoroughly wetted and consist chiefly of clay soils with high swelling potential, soils with a permanent high water table, soils with a claypan or clay layer at or near the surface and shallow soils over nearly impervious material."

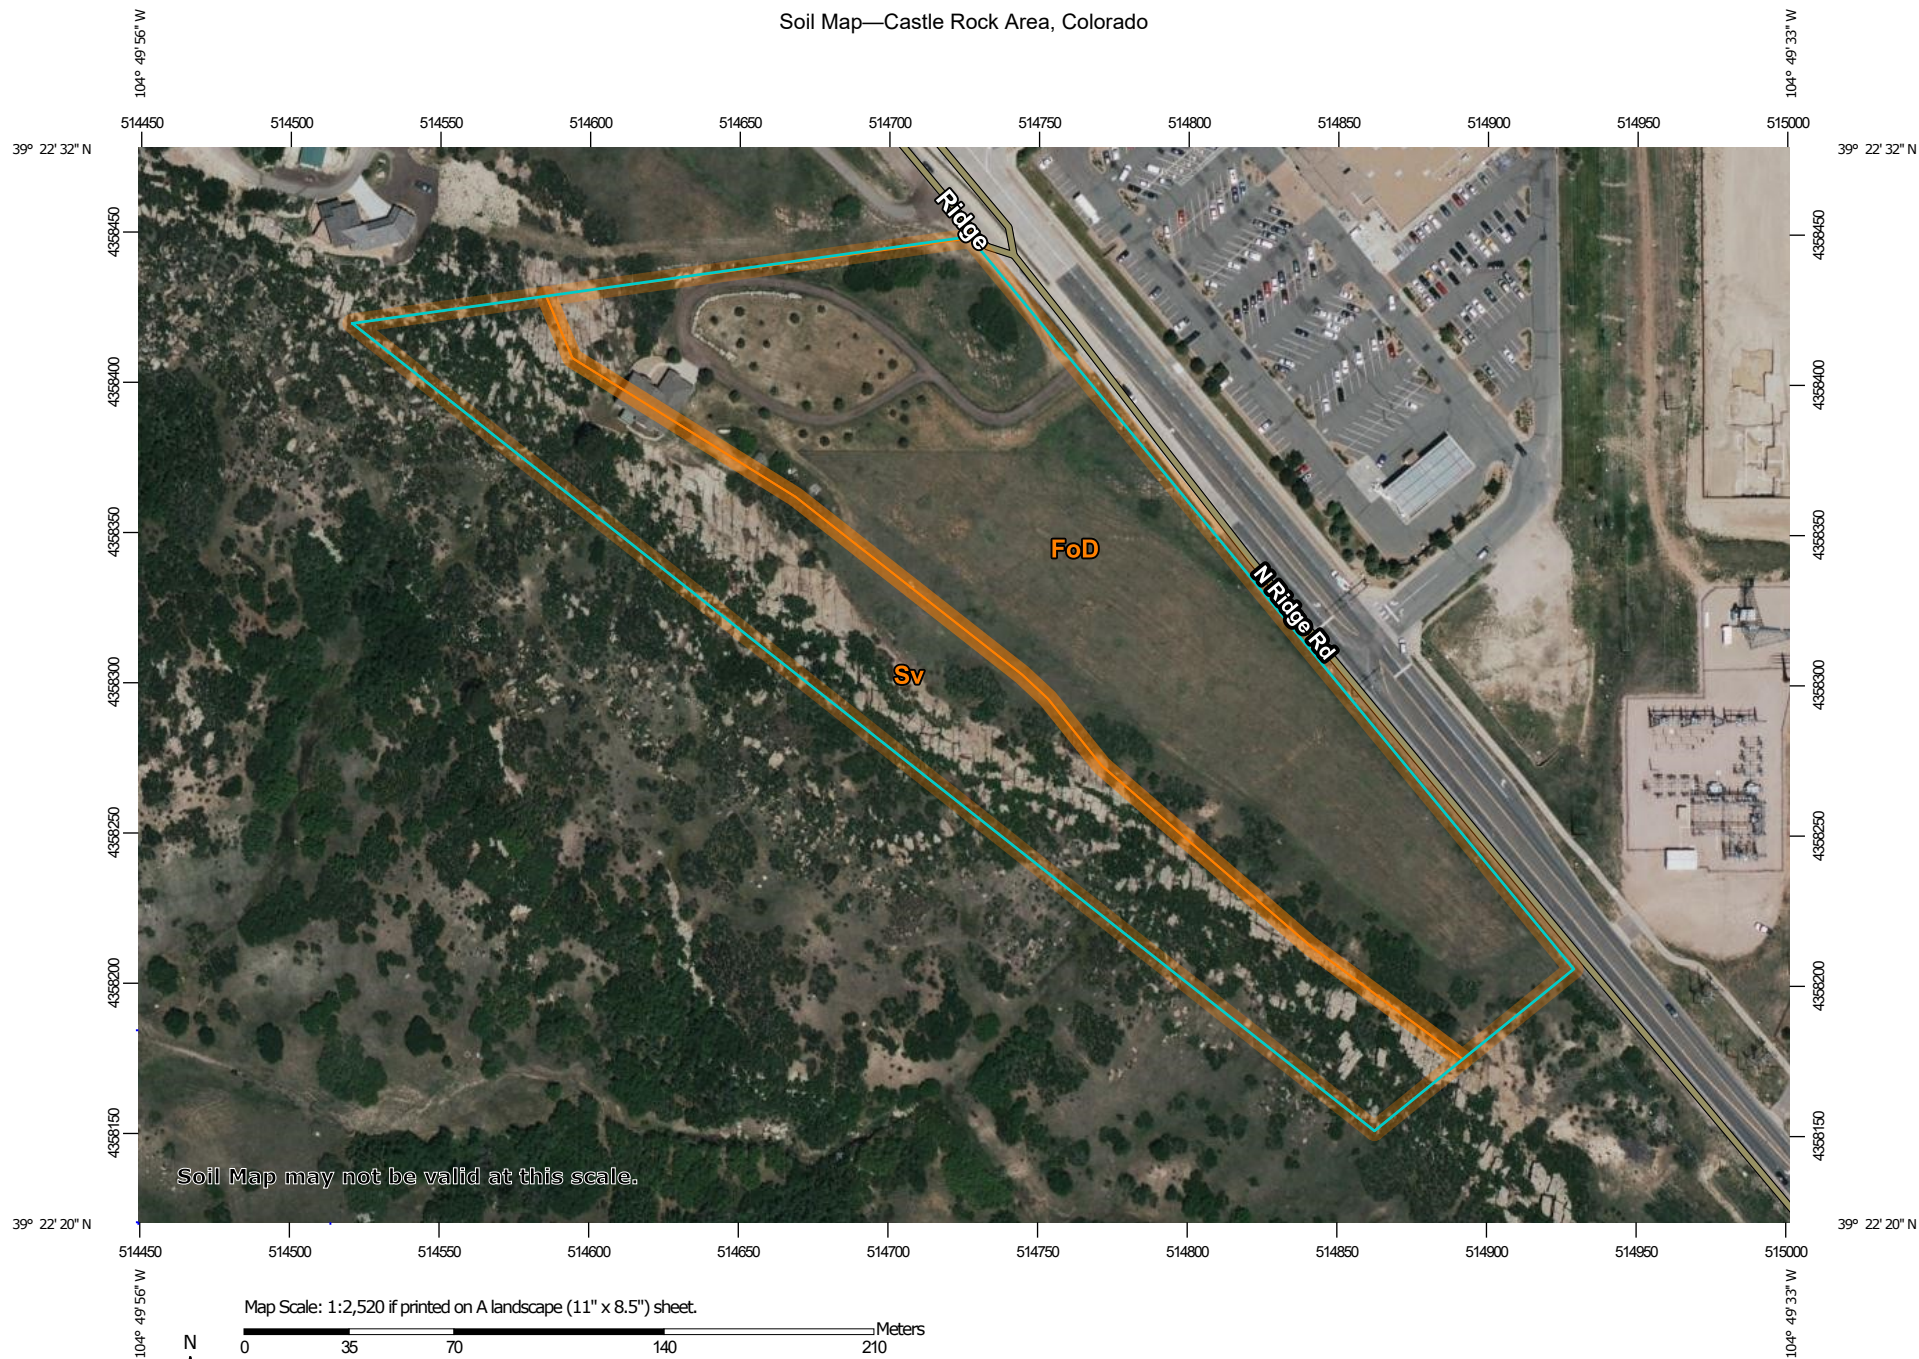
# Soil Map—Castle Rock Area, Colorado

Map Scale: 1:2,520 if printed on A landscape (11" x 8.5") sheet.

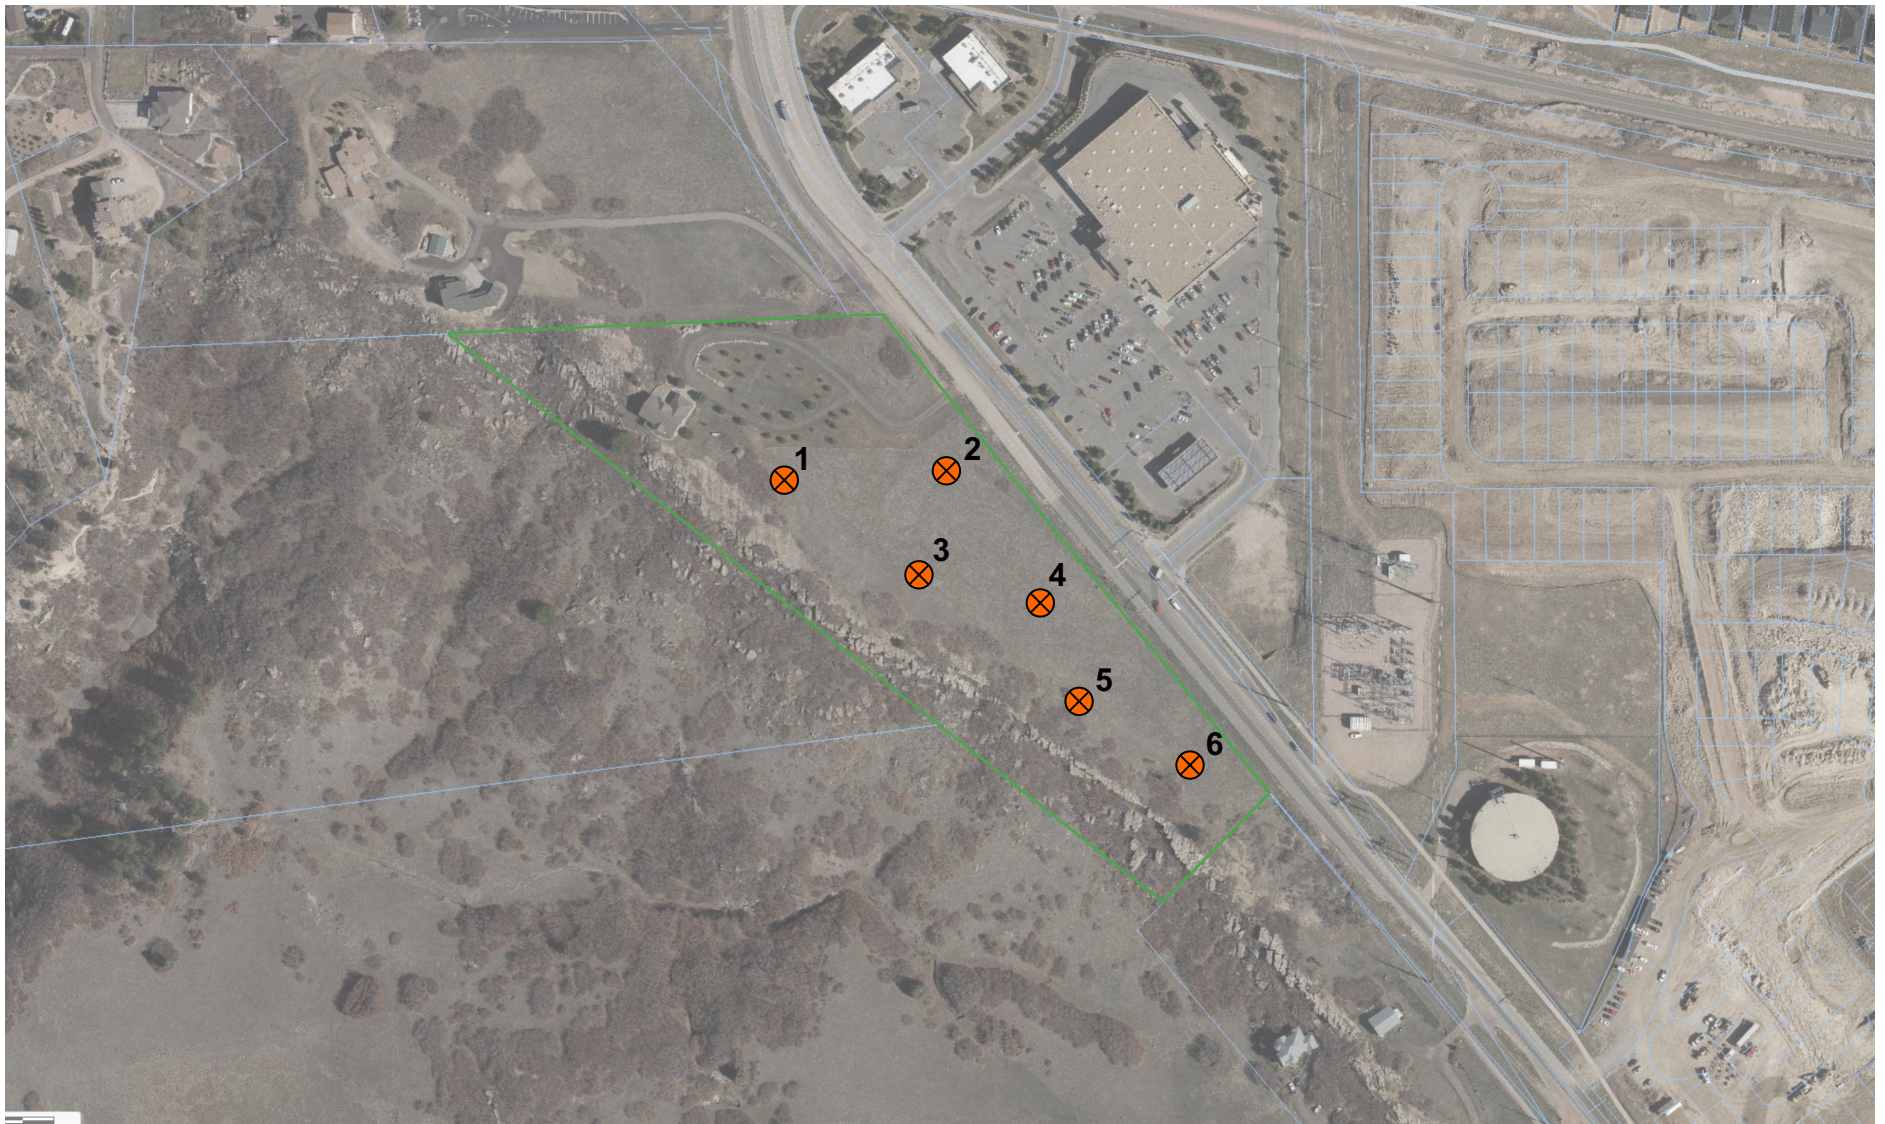
### **BORING LOCATION DIAGRAM BORING LOGS**

**1** APPROXIMATE BORING LOCATIONS
