# **Land Suitability Analysis Report:**

## **Pine Canyon Planned Development**

February 19, 2025  
Rev 1 – April 9, 2025

**GEOLOGIC AND PRELIMINARY  
GEOTECHNICAL INVESTIGATION  
PINE CANYON DEVELOPMENT  
WEST OF FOUNDERS PARKWAY,  
EAST OF PRAIRIE HAWK DRIVE,  
SOUTH OF METZLER'S RANCH SUBDIVISION,  
AND NORTH OF THE WOODLANDS SUBDIVISION  
DOUGLAS COUNTY, COLORADO**

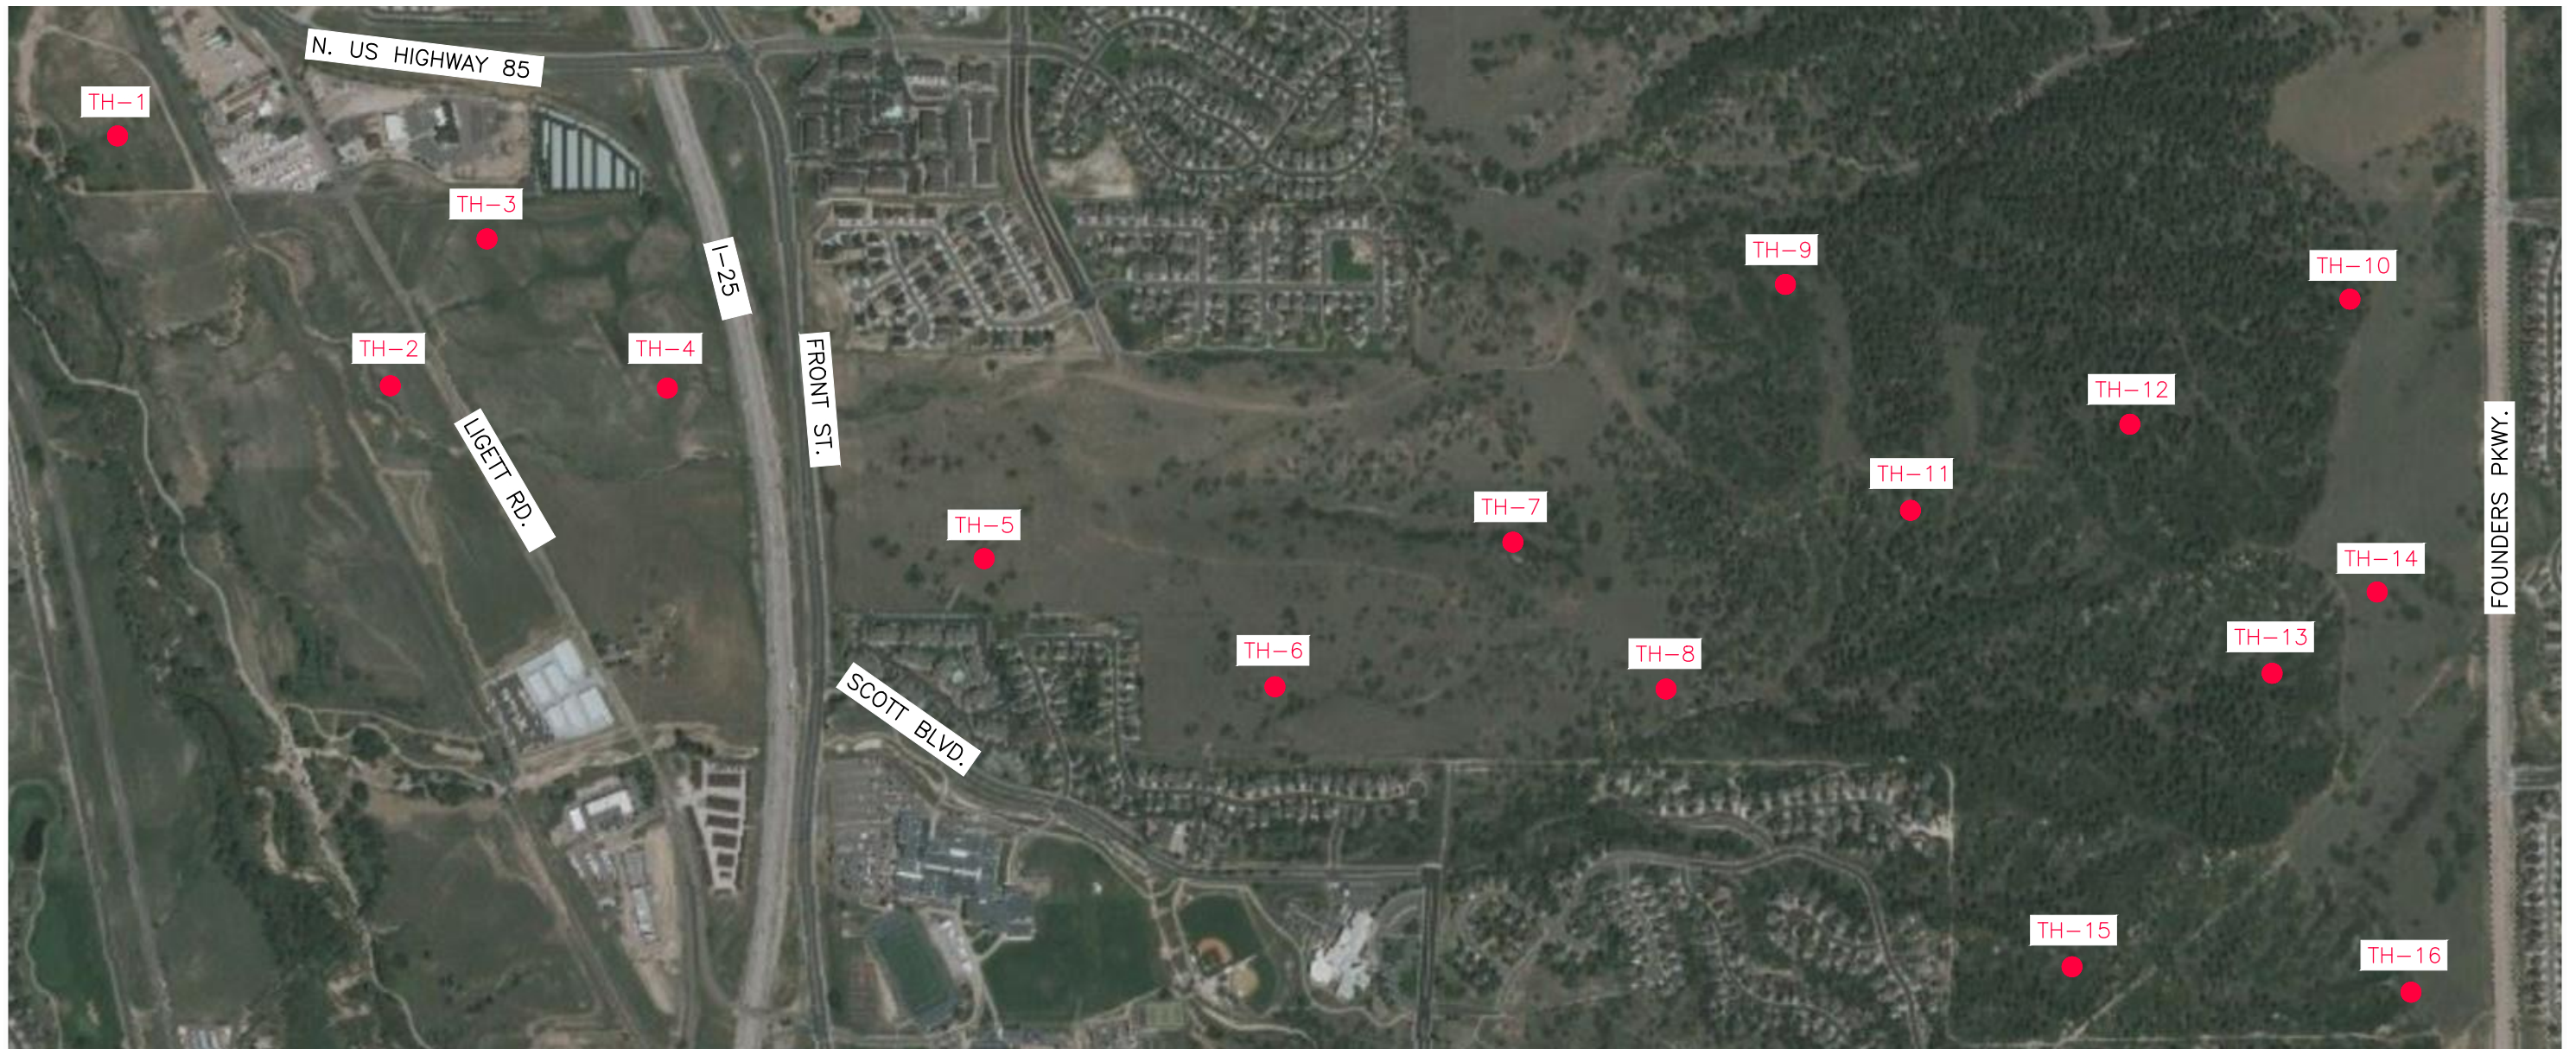
- TH-1  
● APPROXIMATE LOCATION OF EXPLORATORY BORING
- (22)  
INDICATES APPROXIMATE DEPTH TO BEDROCK (FEET)
- [6186]  
INDICATES APPROXIMATE BEDROCK ELEVATION (FEET)
- (20)  
INDICATES APPROXIMATE DEPTH TO GROUNDWATER (FEET)
- [6069]  
INDICATES APPROXIMATE GROUNDWATER ELEVATION (FEET)

NOTE: THIS ESTIMATE WAS BASED UPON A SUBJECTIVE ANALYSIS OF DRILL HOLE DATA AND MAY NOT REFLECT LOCAL VARIATIONS AND SEASONAL FLUCTUATIONS.

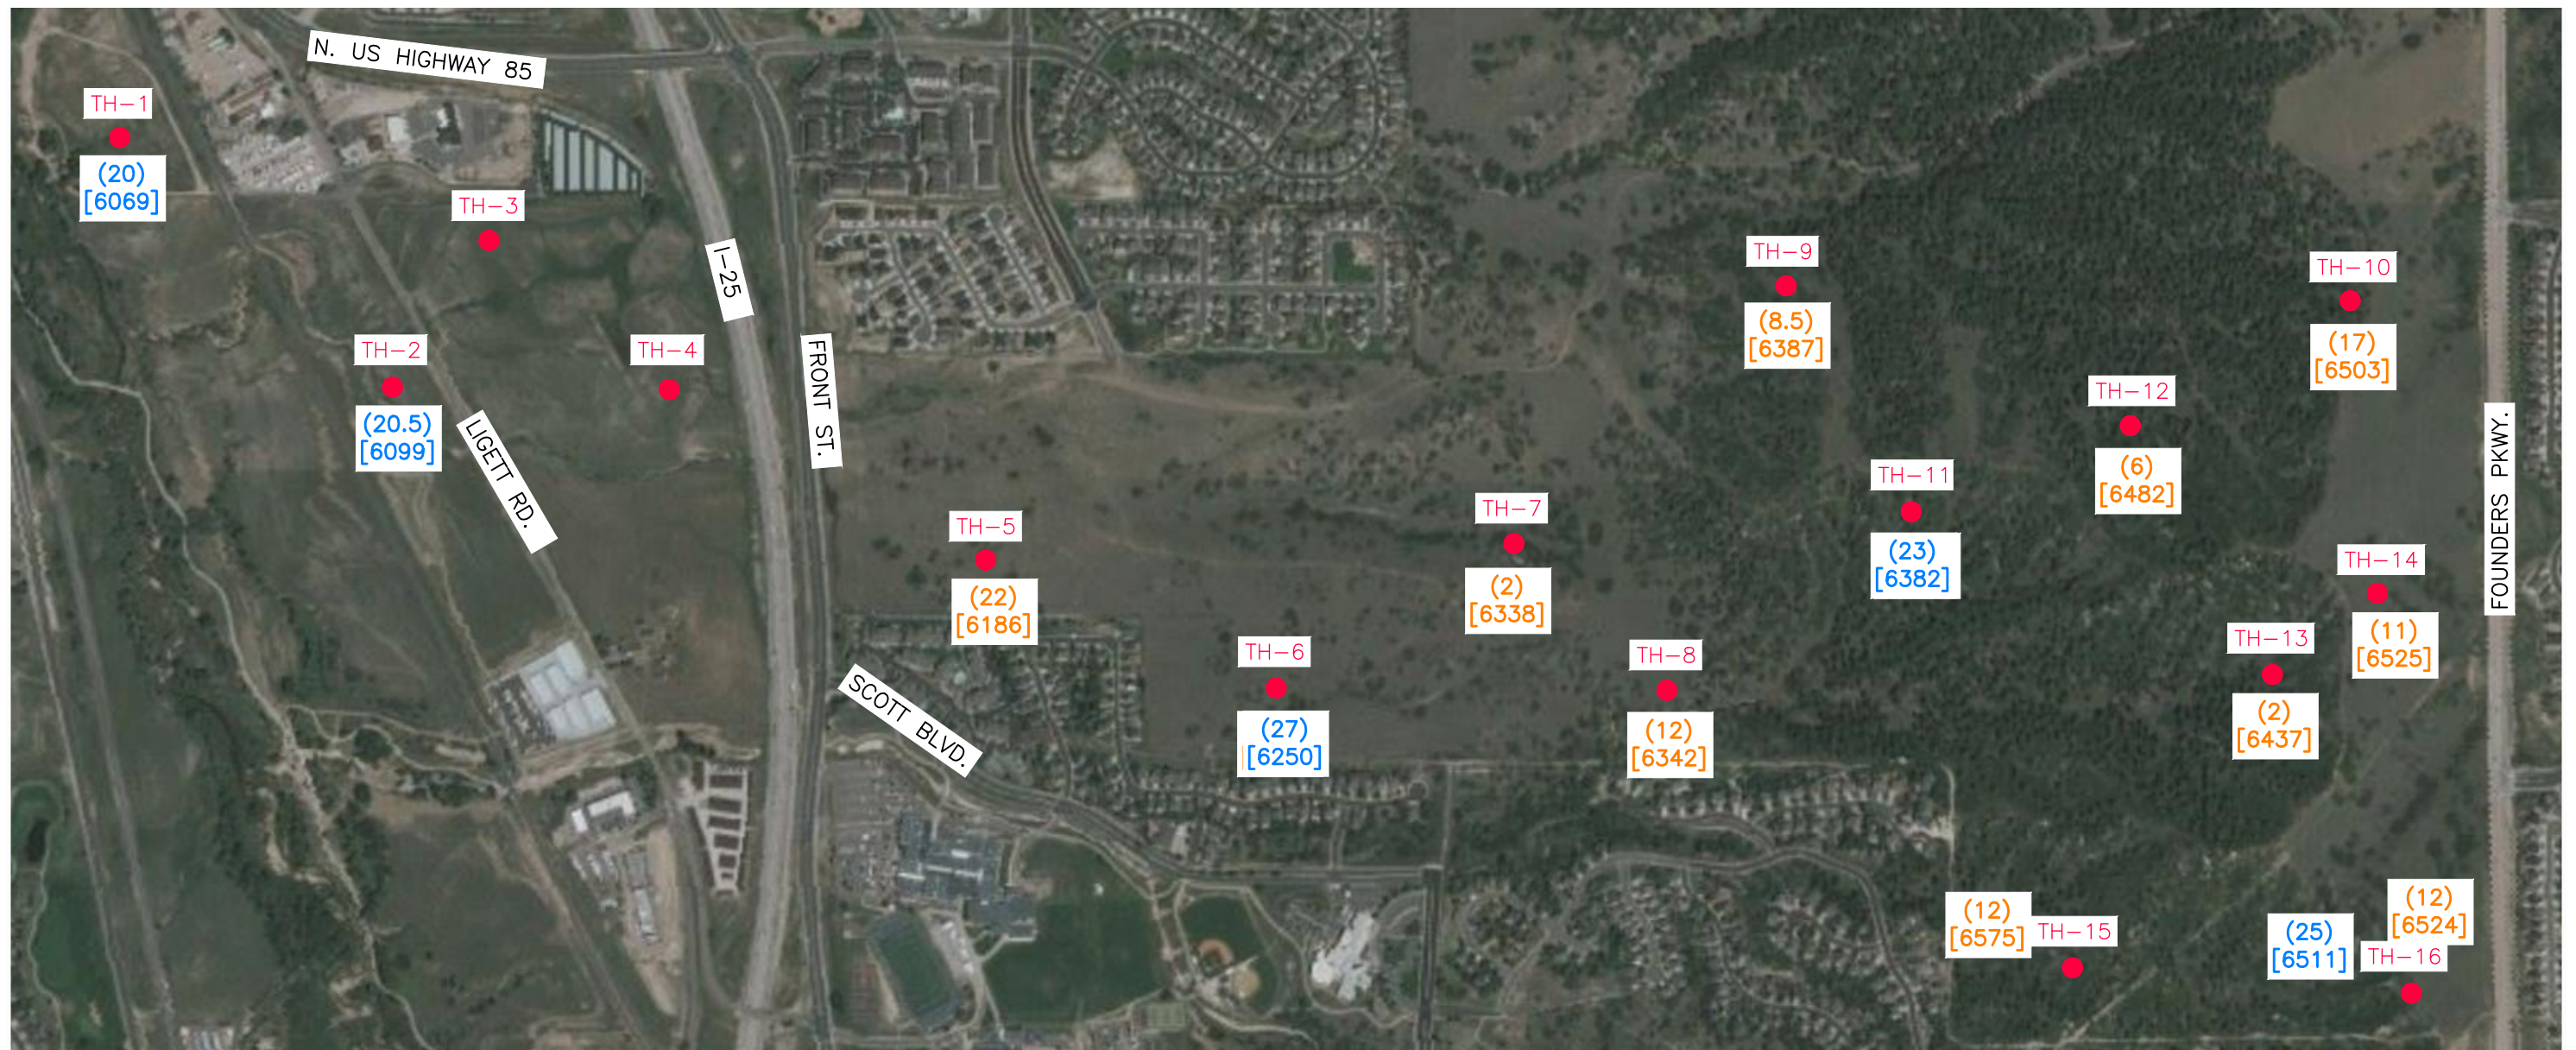
- TH-1 ● APPROXIMATE LOCATION OF EXPLORATORY BORING
- LOW RISK (0 TO 2 INCHES)
- MODERATE RISK (2 TO 4 INCHES)
- HIGH RISK (MORE THAN 4 INCHES)

to 10 feet below foundations may be merited for about 60 percent of the site (moderate to high risk areas shown on Fig. 3).

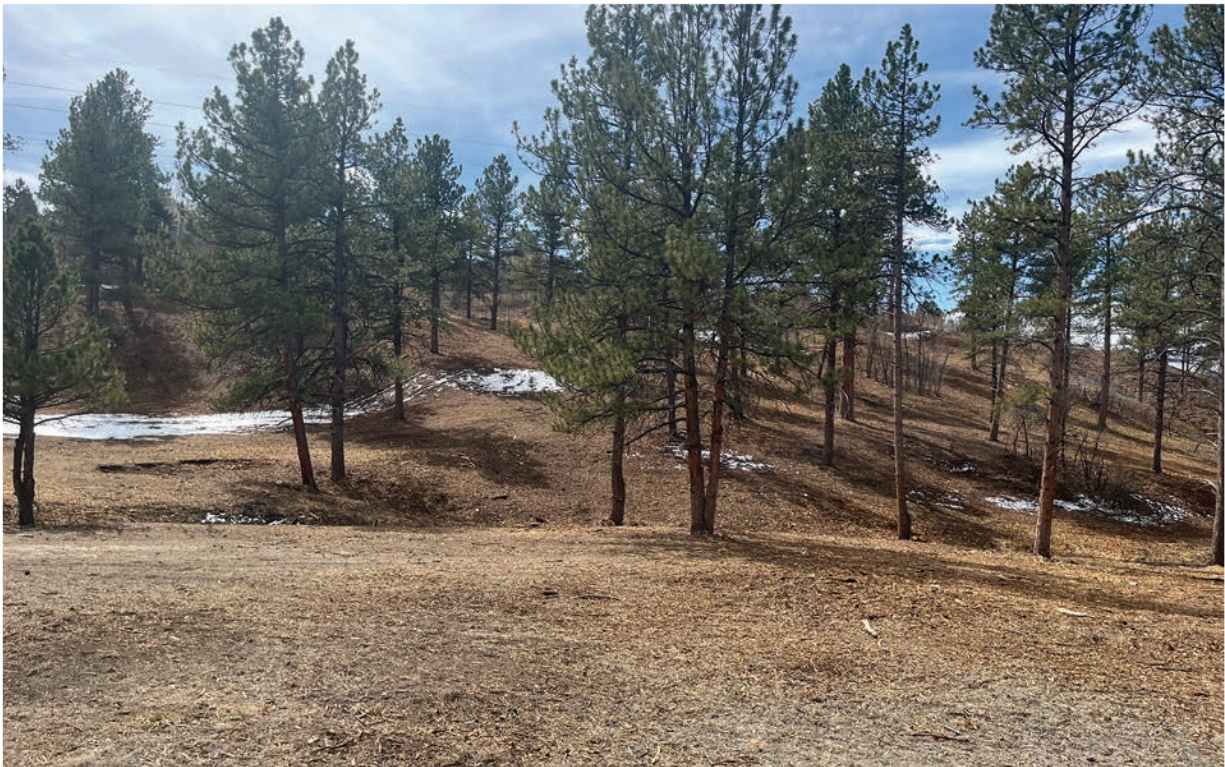
**Photo 8** - Fire mitigation in the project area including thinning and removing oak and clearing and disposing of limbs, branches, and other woody debris. View is southwest.

The Ponderosa Pine Forest vegetation community in the project area is primarily low- to mid-density and consists of an understory of shrubby species and sparse coverings of mixed-grass prairie (Photos 8 and 9). This vegetation community occurs in large contiguous areas intermixed with the Ponderosa Pine/Gambel Oak vegetation community in the eastern portion of the project area (Figure 2b).

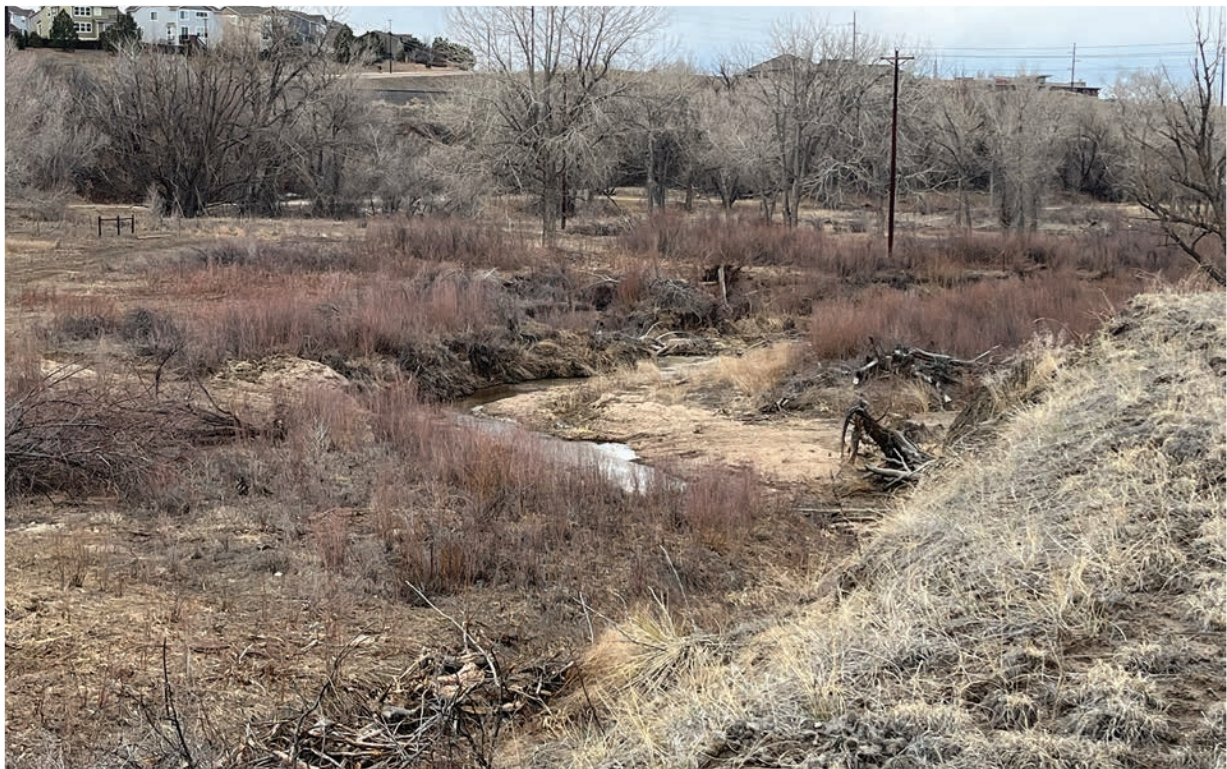
**Photo 10** - Overview of East Plum Creek in the project area and its abutting wetlands and riparian corridor.  
View is northwest.

East Plum Creek, a perennial stream, generally flows from southeast to northwest along the western boundary of the project area, and two tributaries flow into East Plum Creek in the project area (Tributary 1 and Tributary 2; Photos 10 through 14; Figure 2a and Figure 2b). East Plum Creek and the tributaries contribute to the varied topography of the project area. Potential wetlands occur along East Plum Creek on the western edge of the project area and in a few localized depressions in the project area. Potential wetland areas are described in detail under the *Wetlands and Waters of the U.S.* section below.

East Plum Creek generally flows from south to north, just inside the western boundary of the project area (Figure 2a). During the 2023 site visit, water was flowing in the creek and potential wetlands were identified in fringes and on low terraces along the channel banks (Photos 10 through 12).

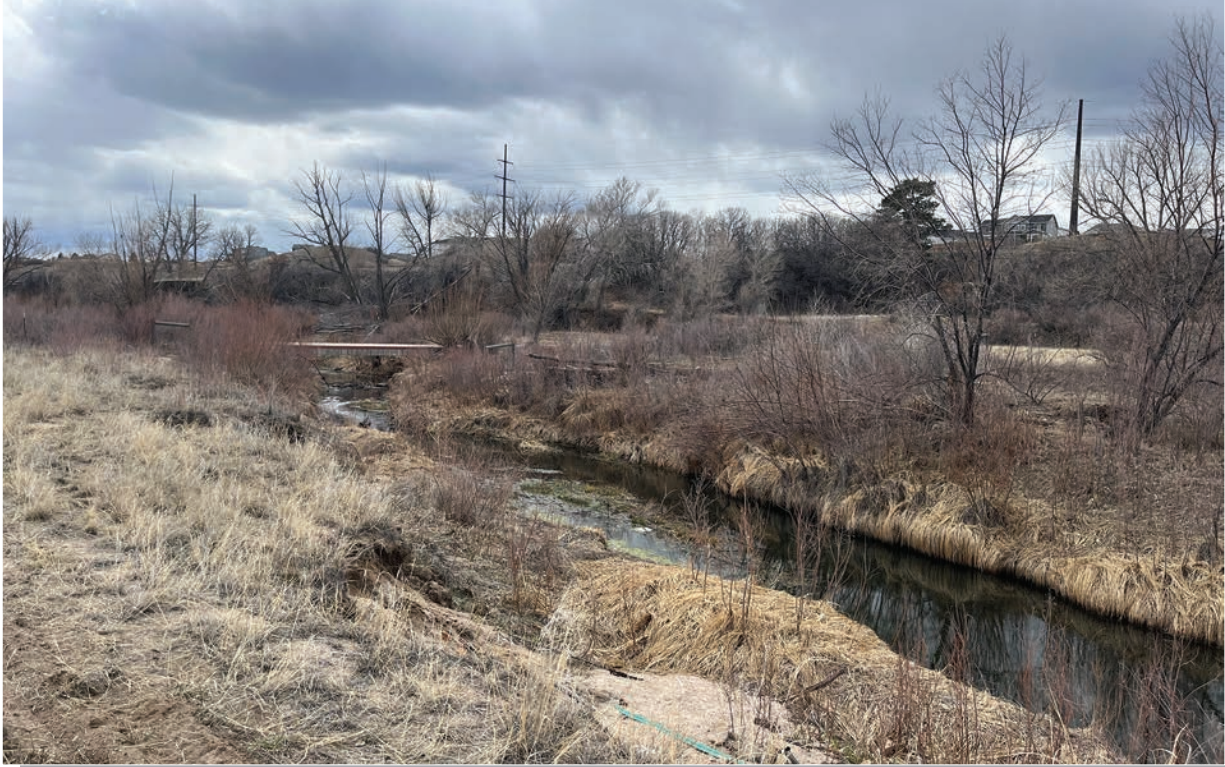
**Photo 11** - East Plum Creek in the project area and its abutting wetlands and riparian corridor in the southern portion of the project area. View is southwest.

Riparian vegetation community types occur along East Plum Creek and at the downstream end of the tributaries and include Mixed Shrubland, Plains Cottonwood/Mixed Shrubland, Plains Cottonwood/Peachleaf Willow/Sandbar Willow, and Sandbar Willow (Photos 10 through 12; Figure 2a). In the project area, most of the riparian communities are dominated by an understory of native and nonnative species including western wheatgrass (*Pascopyrum smithii*), reed canarygrass (*Phalaris arundinacea*), wild licorice (*Glycyrrhiza lepidota*), scouring horsetail (*Equisetum* sp.), sand dropseed, blue grama, Kentucky bluegrass (*Poa pratensis*), smooth brome, cheatgrass, common mullein, and diffuse knapweed. The riparian overstory along East Plum Creek is dominated by plains cottonwood (*Populus deltoides*), peachleaf willow (*Salix amygdaloides*), sandbar willow (*Salix exigua*), and western snowberry (*Symphoricarpos occidentalis*), with patches of Gambel oak and chokecherry.

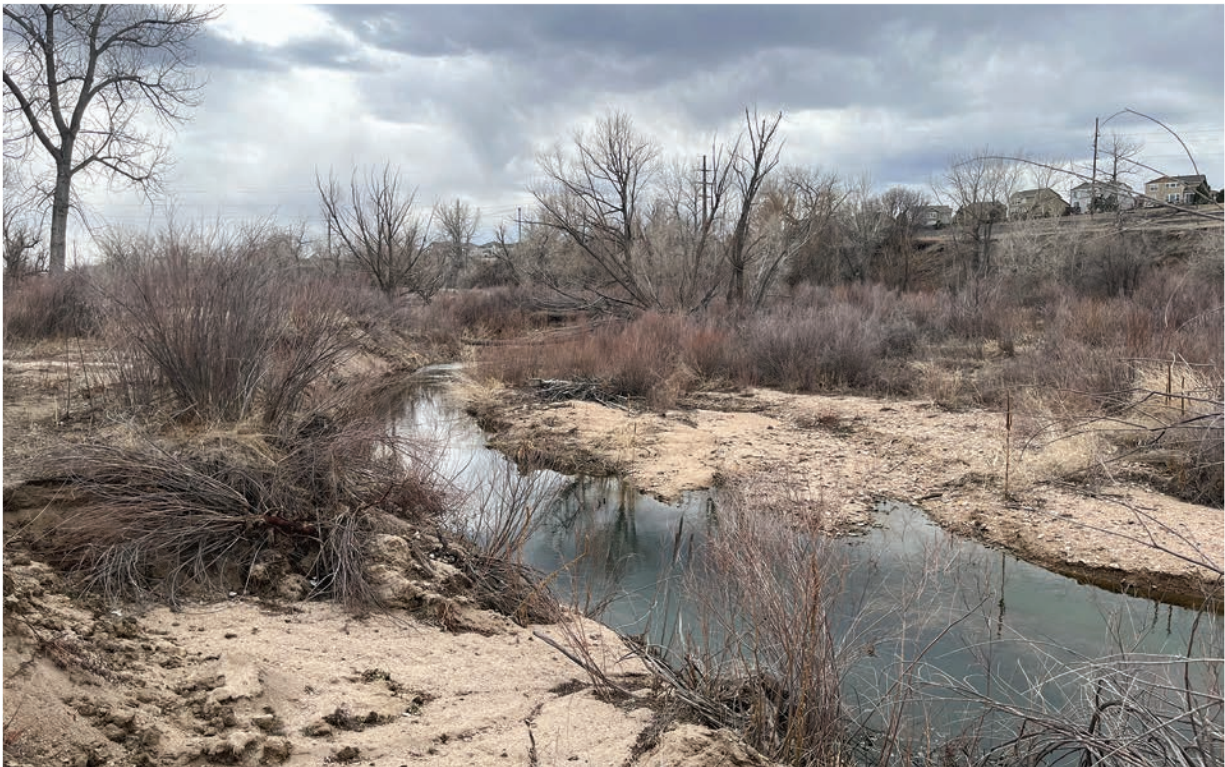
**Photo 12** - East Plum Creek in the project area and its abutting wetlands and riparian corridor with sandy terraces and eroded banks. View is southeast.

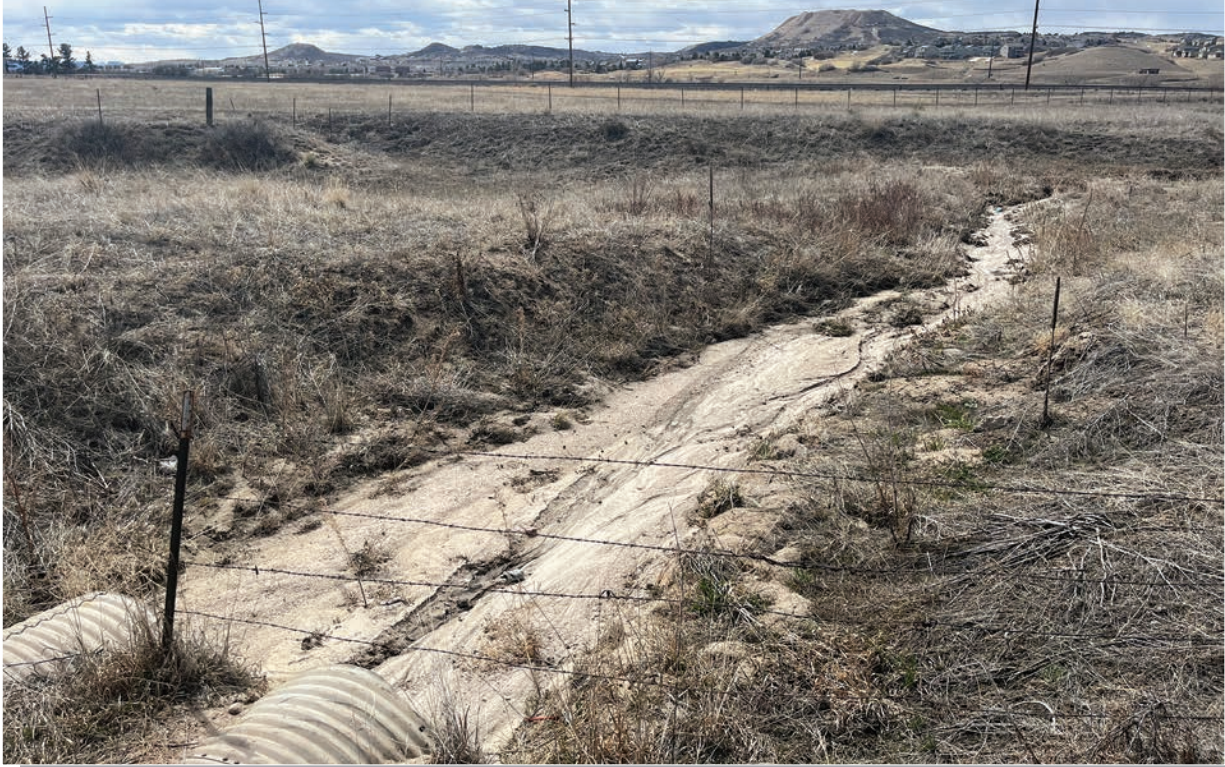
**Photo 13** - Tributary 2 east of North Liggett Road. View is east.

Two tributaries to East Plum Creek also occur in the project area (Tributary 1 and Tributary 2; Figure 2a). Both are ephemeral drainages shown on the USGS Castle Rock North topographic quadrangle. Tributary 1 occurs on the west side of East Plum Creek and flows into the creek in the southwest corner of the project area. Tributary 1 did not contain any water during the 2011 or 2023 site visit but did contain a defined channel bed and bank. The tributary is eroded with steep banks and is vegetated with Gambel oak with no wetland vegetation. Tributary 2 begins at a culvert at I-25 and heads west through the project area. The NHD shows Tributary 2 beginning east of I-25; however, in this area the tributary was identified as an upland vegetated swale that did not contain any characteristics of a WOTUS. Directly west of I-25, Tributary 2 contains a sandy wash. Surface runoff from I-25 likely contributes to flows in Tributary 2 during storm events. The banks of Tributary 2 are vegetated with smooth brome, western snowberry, Canada thistle (*Cirsium arvense*), switchgrass (*Panicum virgatum*), and kochia (*Bassia scoparia*). West of North Liggett Road, the majority of Tributary 2 contains a defined bed and bank; however, intermittent sections are vegetated with upland species. Tributary 2 connects to East Plum Creek in the southern portion of the project area (Photos 13 and 14; Figure 2a).

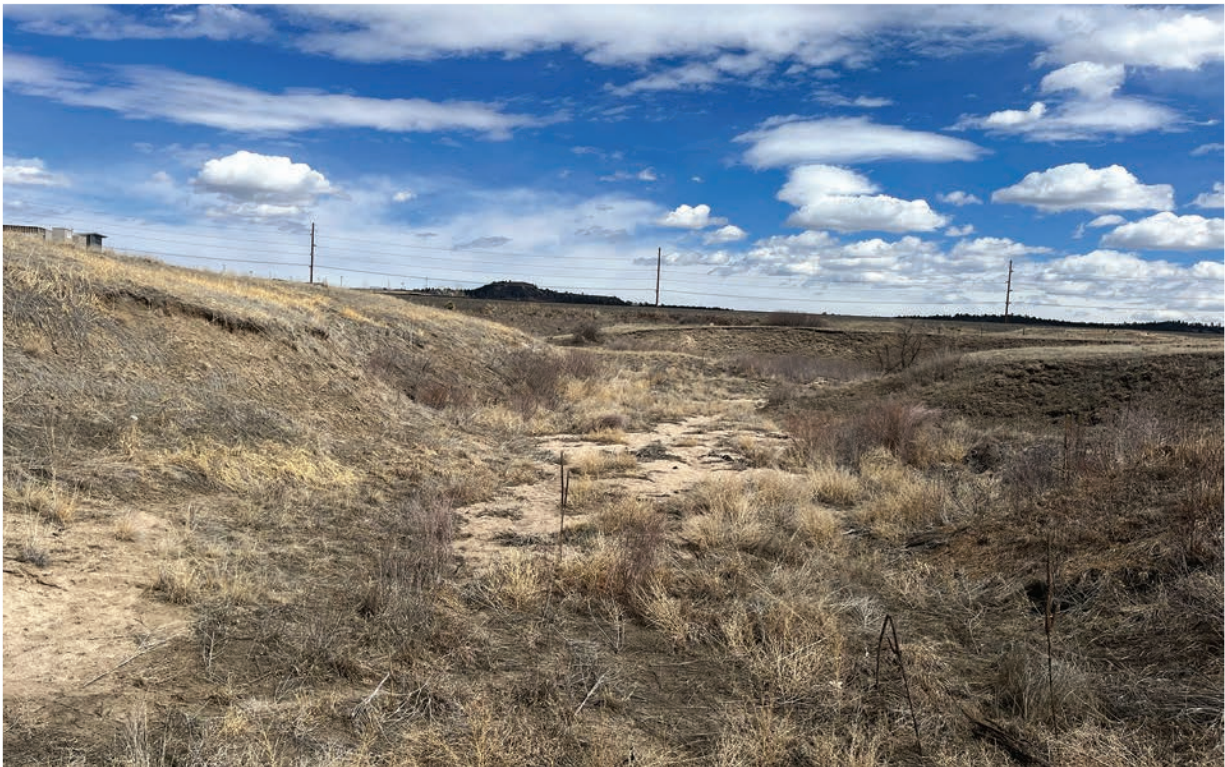
**Photo 14** - Tributary 2 near the confluence with East Plum Creek. View is east.

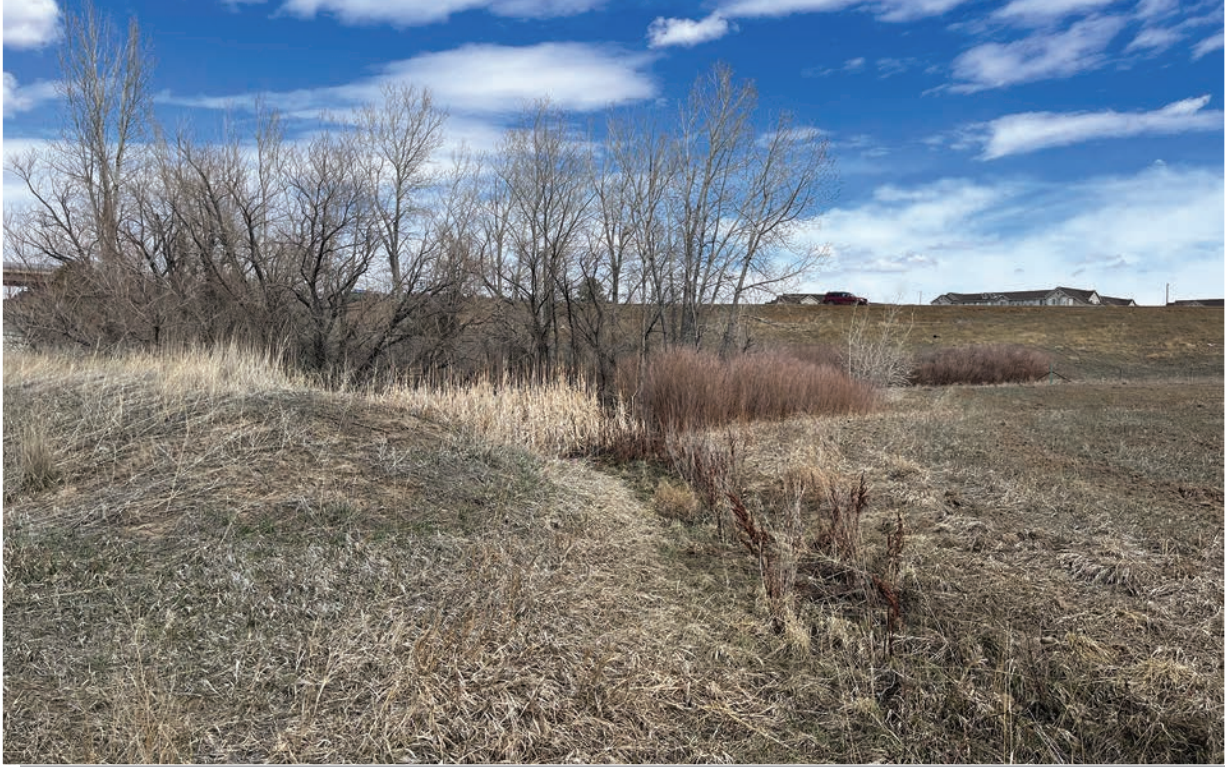
**Photo 15** - Wetland 1 south of Interstate 25. View is northeast.

A small potential wetland (Wetland 1) is located in the northern portion of the project area directly west of I-25 (Figure 2a). The wetland appears to receive water from an outfall located along the I-25 berm. The area is dominated by sandbar willow, plains cottonwood, peachleaf willow, and narrowleaf cattail (*Typha angustifolia*), with some barnyard grass (*Echinochloa crus-galli*) and curly dock (*Rumex crispus*) observed (Photo 15). Open water was observed in the area during the 2011 and 2023 site visits. Wetland 1 does not appear to have a connection to any known WOTUS and is surrounded by upland vegetation.

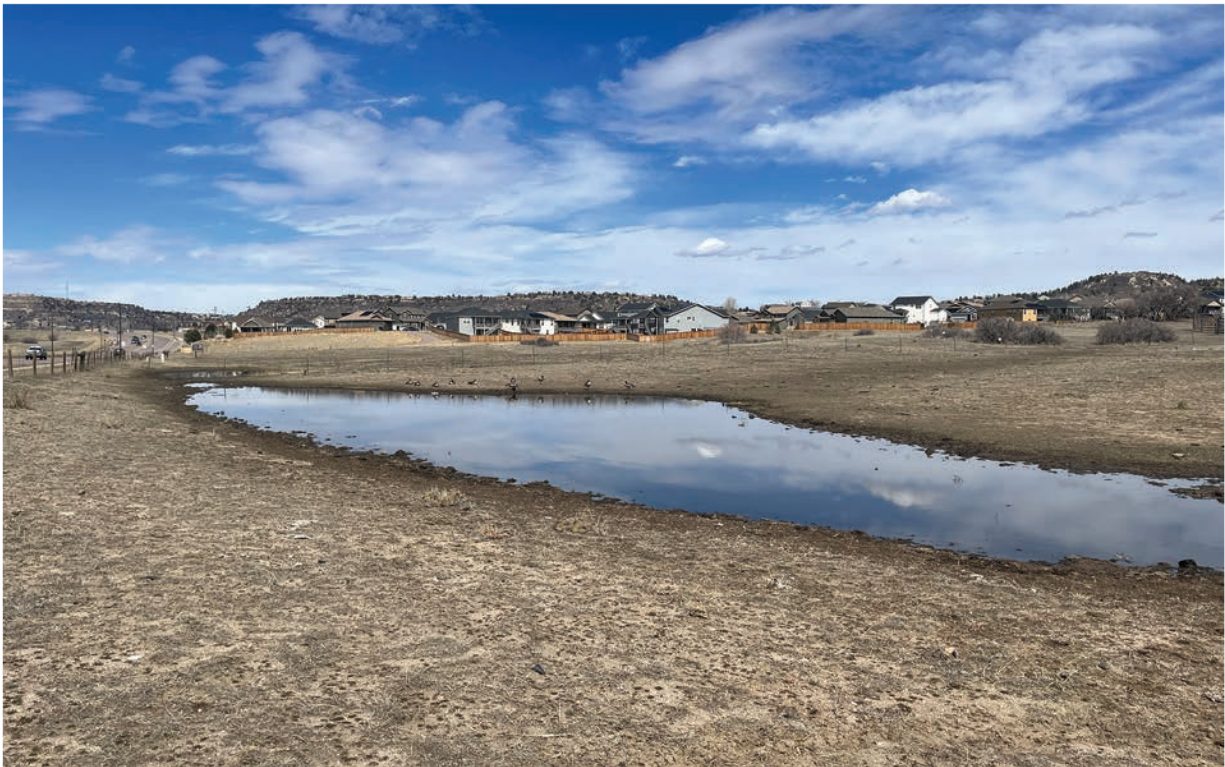
**Photo 16** - Wetland 2 east of Interstate 25, inundated at the time of the 2023 site visit. View is north.

Two potential wetlands are in the project area directly east of Front Street (Wetlands 2 and 3). Wetland 2 contained standing water at the time of the 2023 site visit and was only sparsely vegetated due to disturbance from cattle (Photo 16). This wetland extends to the culvert that runs under I-25 to Tributary

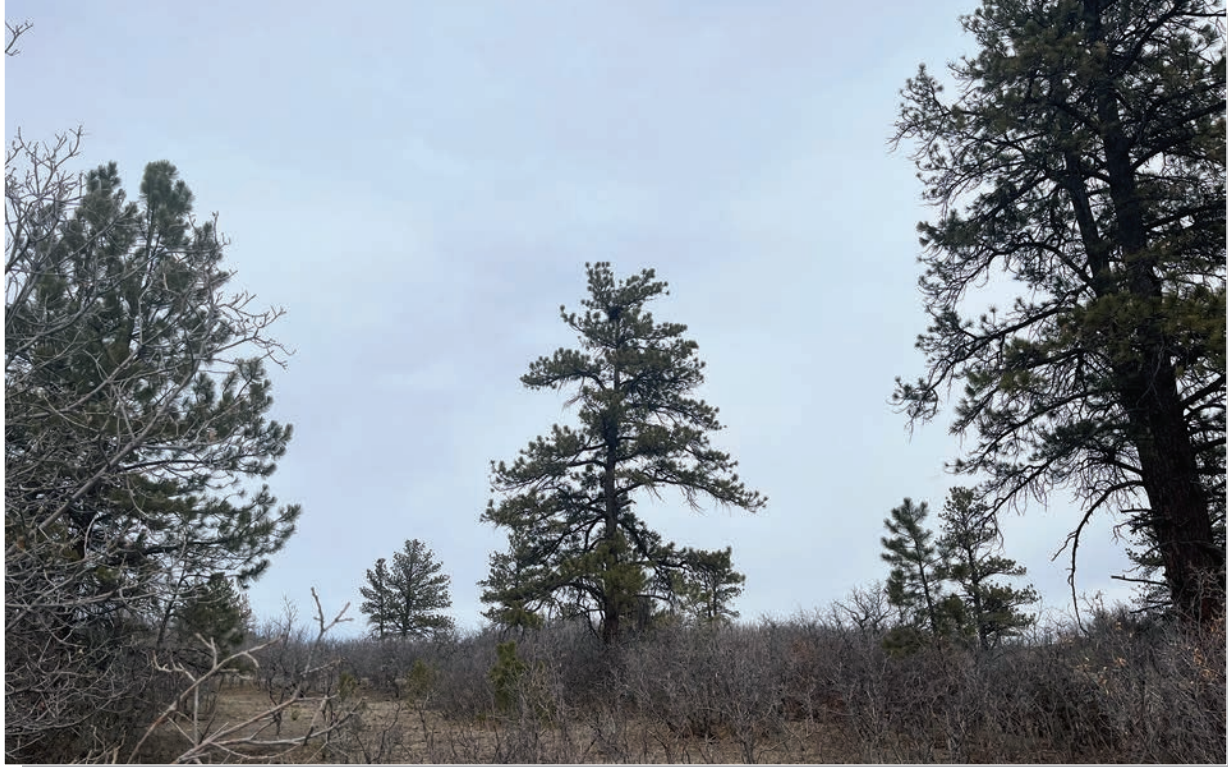
**Photo 17** - Potential raptor nest in the project area; inactive at the time of the 2023 site visit. View is east.

ERO surveyed the project area for nests during the 2023 site visit. ERO observed one unoccupied raptor nest in a pine tree near the headwaters of Lemon Gulch in the southern portion of the project area (Photo 17; Figure 3b). The size and shape of the nest suggests it is a raptor nest. A forest raptor such as Cooper's hawk (*Accipiter Cooperii*) could potentially use the observed nest. Additionally, a raptor nest was identified during the 2011 site visit near the southern border of the project area; however, this nest was not found during the 2023 site visit (Figure 3b).

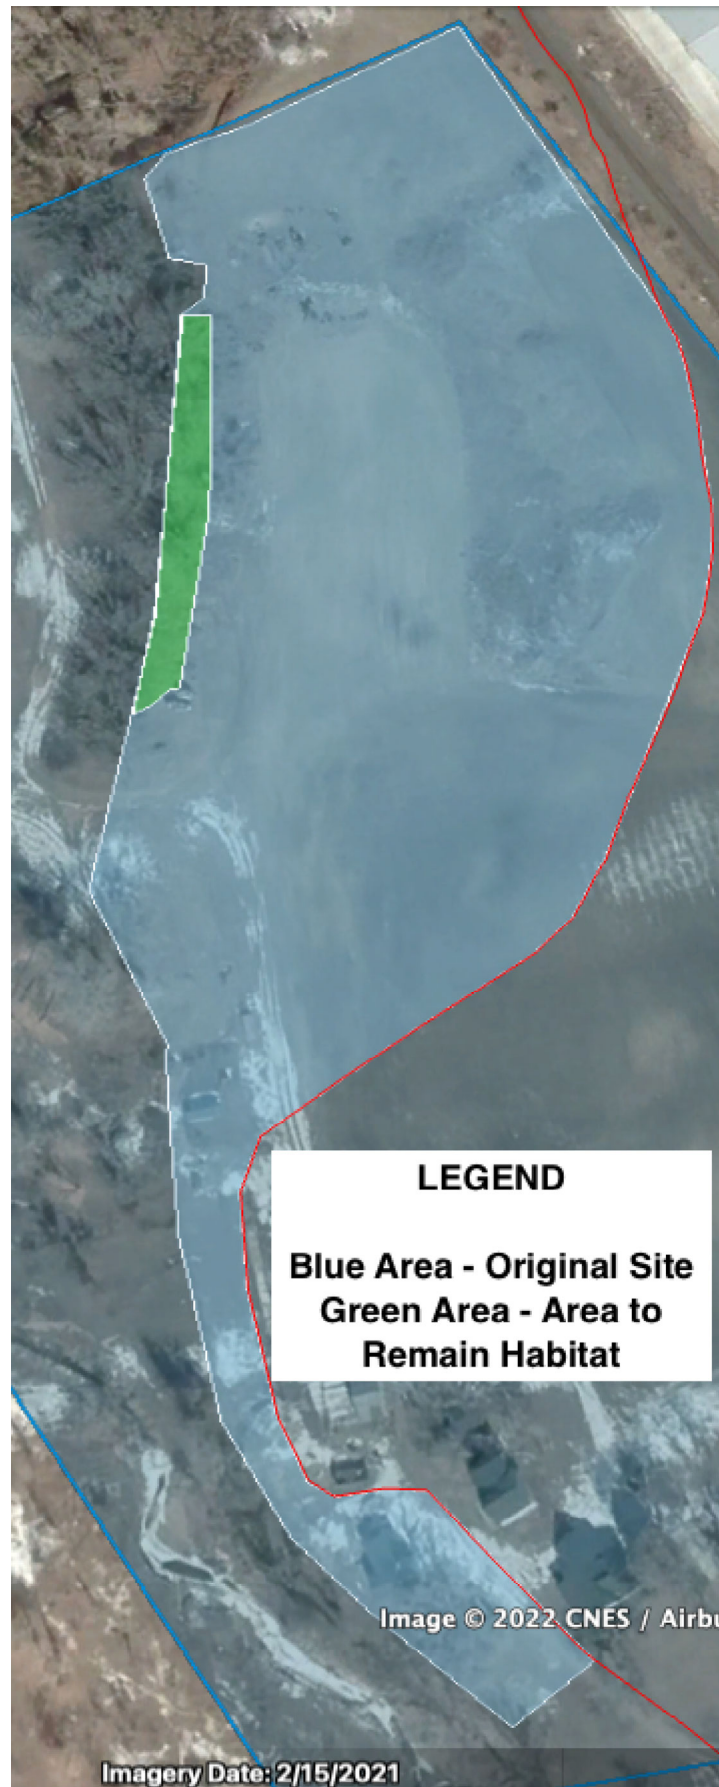
Attachment: Pine Canyon Ranch map designating suitable (green polygon) and unsuitable (blue) polygon Preble's mouse habitat

Given the extent of historic human alteration of the property, the Service concurs that any alterations to the designated 7.18 acres of property are unlikely to result in take of a listed species. A vegetated buffer area of 0.22 acre shall remain as recognized, suitable Preble's mouse habitat and will serve as a transitional zone between the degraded property and the riparian area.

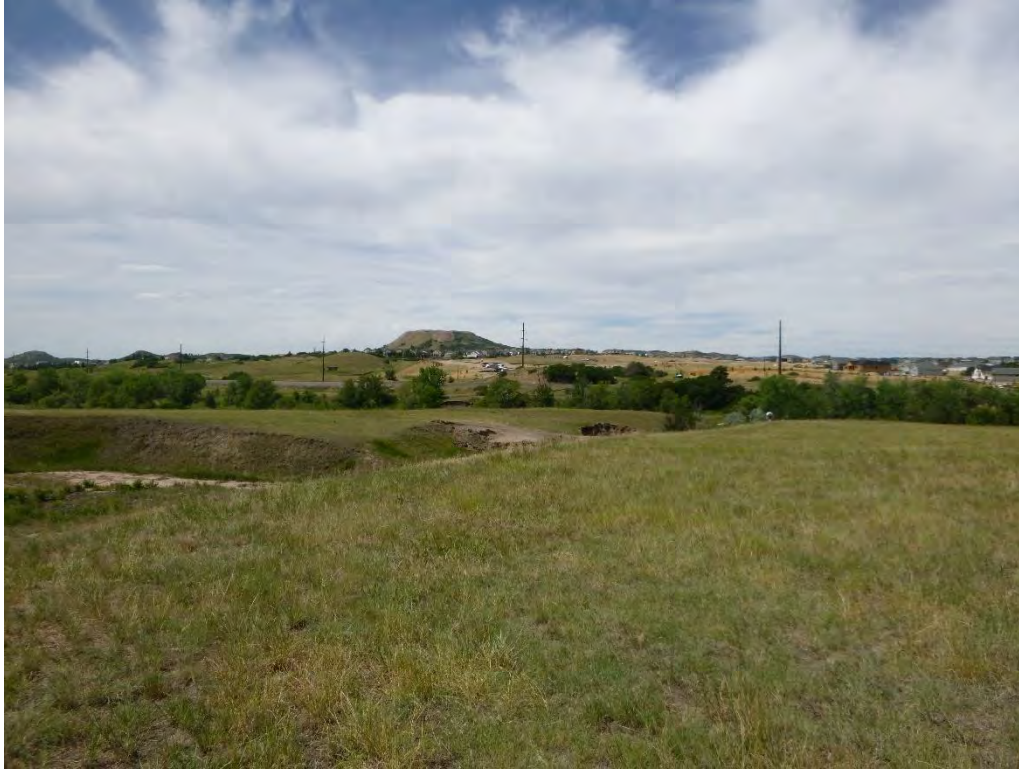
Figure 5. Site overview looking toward East Plum Creek, view to the southwest.

**Description:** The extensive open camp covers the north and south sides of an ephemeral drainage that flows irregularly into East Plum Creek to the west (Figure 5). The eastern half of the site is located on a broad fan deposited by the ephemeral drainage while the western portion of the site is located on the surface of the third terrace deposited by East Plum Creek. Impacts on the site include extensive plowing to the north and south of the ephemeral drainage, leaving only narrow intact portions of the site where it flanks the drainage. A sanitary sewer line and access road crosses north to south through the west portion of the site. Vegetation includes short prairie grasses. The ground visibility is about 60 percent. The elevation is 6,104 ft asl.

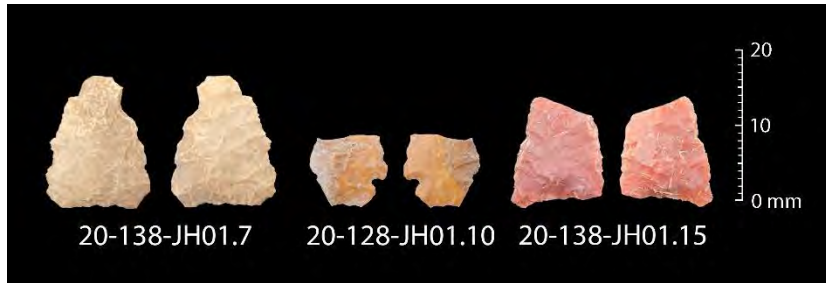
**Figure 6. Projectile points at JH01.**

ERO identified numerous nondiagnostic artifacts at the site including a drill fragment, a mano, modified flakes, and a biface fragment, with more than half of the assemblage consisting of scrapers (Table 2). ERO also recorded 62debitage. Diagnostic artifacts include two unnotched triangular projectile points and one tri-notched projectile point (FS7, FS10, and FS15; Figure 6) that date to the Middle Ceramic Period (AD 1150 to 1540) (Gilmore 1999:262). Open sites dating to this period are rare in Douglas County as most sites are known in rockshelter or cave contexts in the hogbacks.

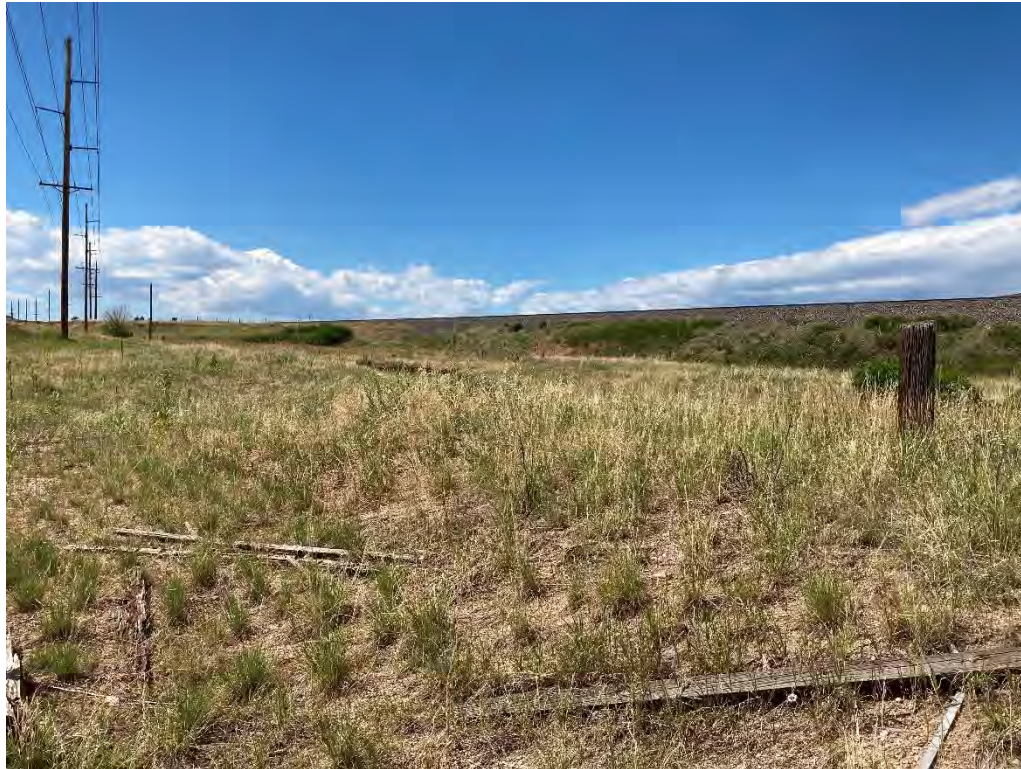
**Figure 7. Cut telegraph line, view to the southwest.**

The telegraph line has been cut down (Figure 7). Cut utility poles, stumps, and beams with wood insulator pins remain in the project area. The line was likely associated with the railroad and presumably follows the railroad further to the south.

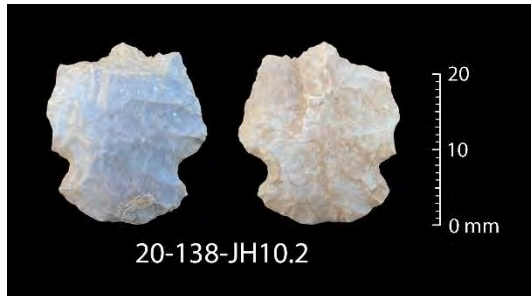
**Figure 8. FS2 - Archaic period projectile point.**

The site consists of 110 debitage and 6 tools (described in Table 4). A projectile point (FS2; Figure 8) is similar morphologically to Early Archaic projectile points associated with the Mount Albion Complex (Benedict and Olson 1978). The Early Archaic period lasted from 7500 to 5000 years BP (Tate 1999). Most artifacts are present on the northeast-facing slope of the landform (AC1).

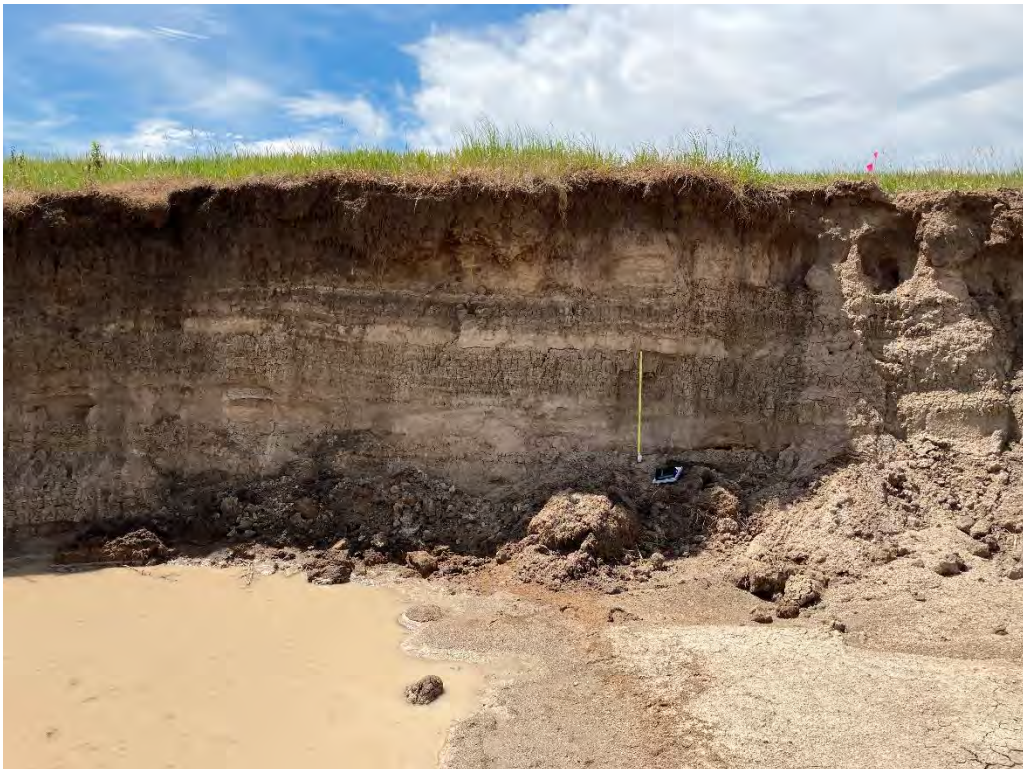
**JH01 - Overview of cut bank profile, tape set to 1 meter, view to the south.**  
**Photo Number: JH.60 Date: 6.29.20**

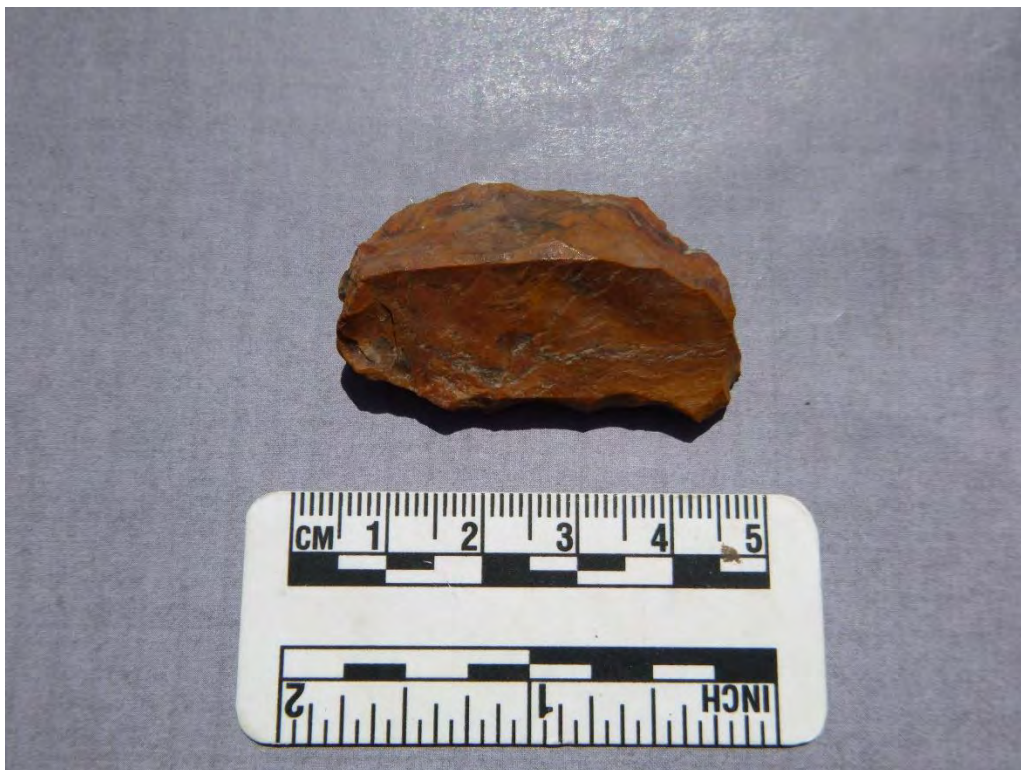
JH01 – FS1, DPW disto-lateral scraper.  
Photo Number: D3.107-0089 Date: 6.29.20

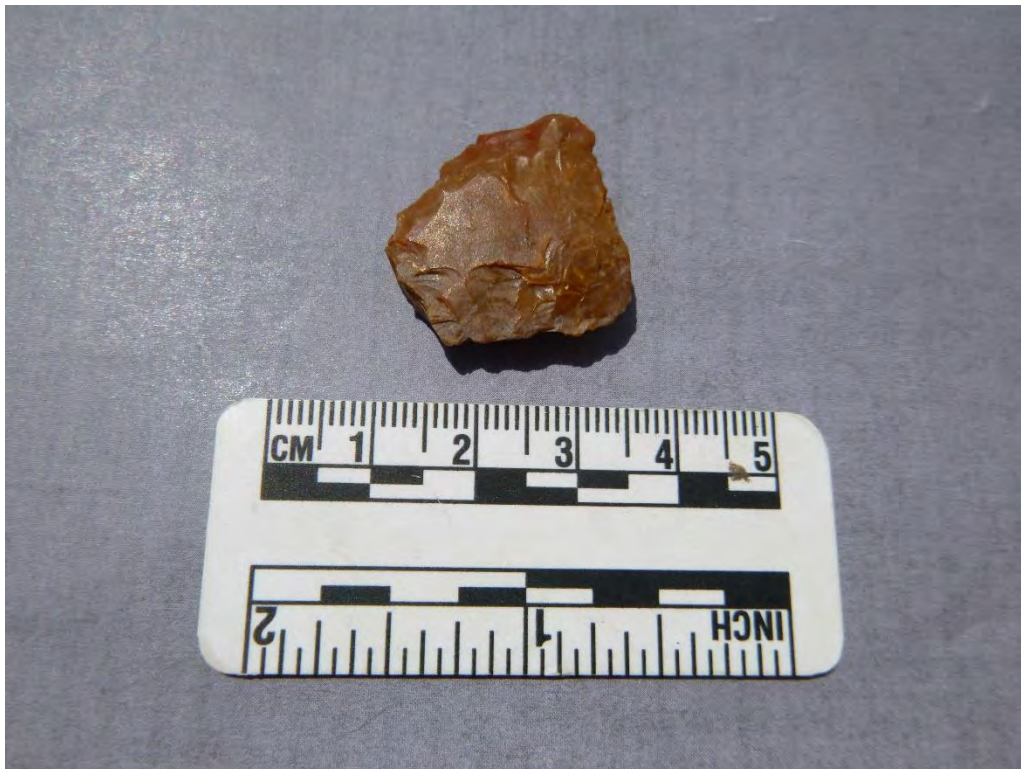
JH01 – FS2, chert drill fragment.  
Photo Number: D3.107-0091 Date: 6.29.20
