# **Land Suitability Analysis Report:**

## **Pine Canyon Planned Development**

February 19, 2025  
Rev 1 – April 9, 2025

**GEOLOGIC AND PRELIMINARY  
GEOTECHNICAL INVESTIGATION  
PINE CANYON DEVELOPMENT  
WEST OF FOUNDERS PARKWAY,  
EAST OF PRAIRIE HAWK DRIVE,  
SOUTH OF METZLER'S RANCH SUBDIVISION,  
AND NORTH OF THE WOODLANDS SUBDIVISION  
DOUGLAS COUNTY, COLORADO**

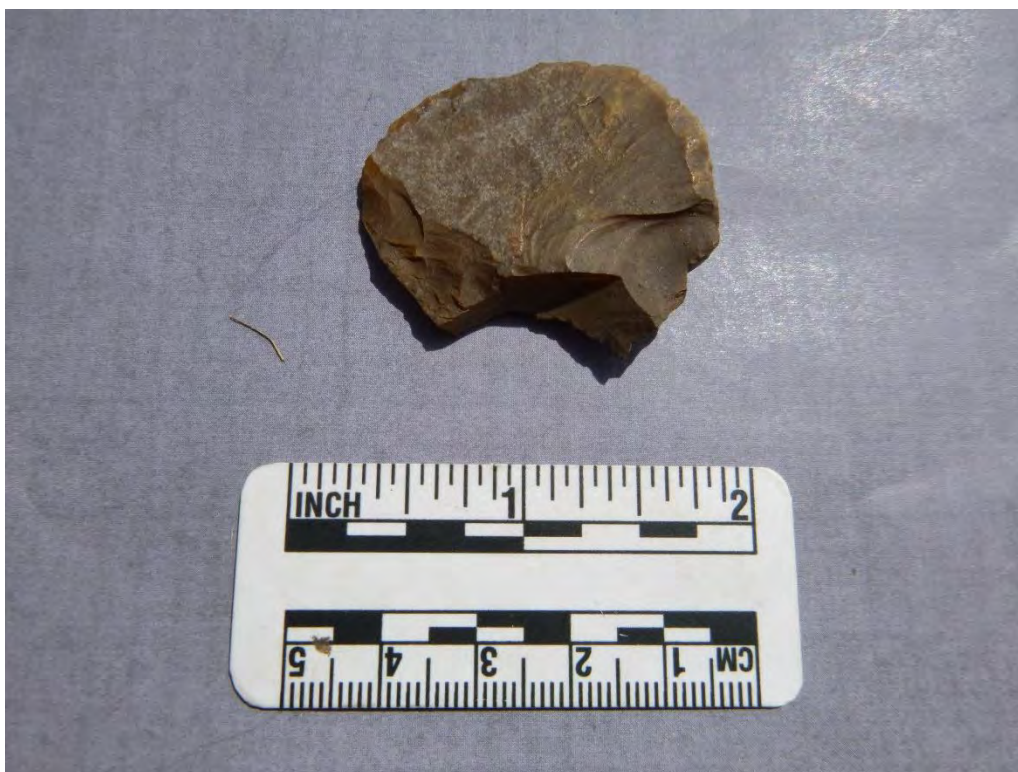
JH 01 – FS3, chert unilateral and unifacial side scraper.  
Photo Number: D3.107-0093 Date: 6.29.20

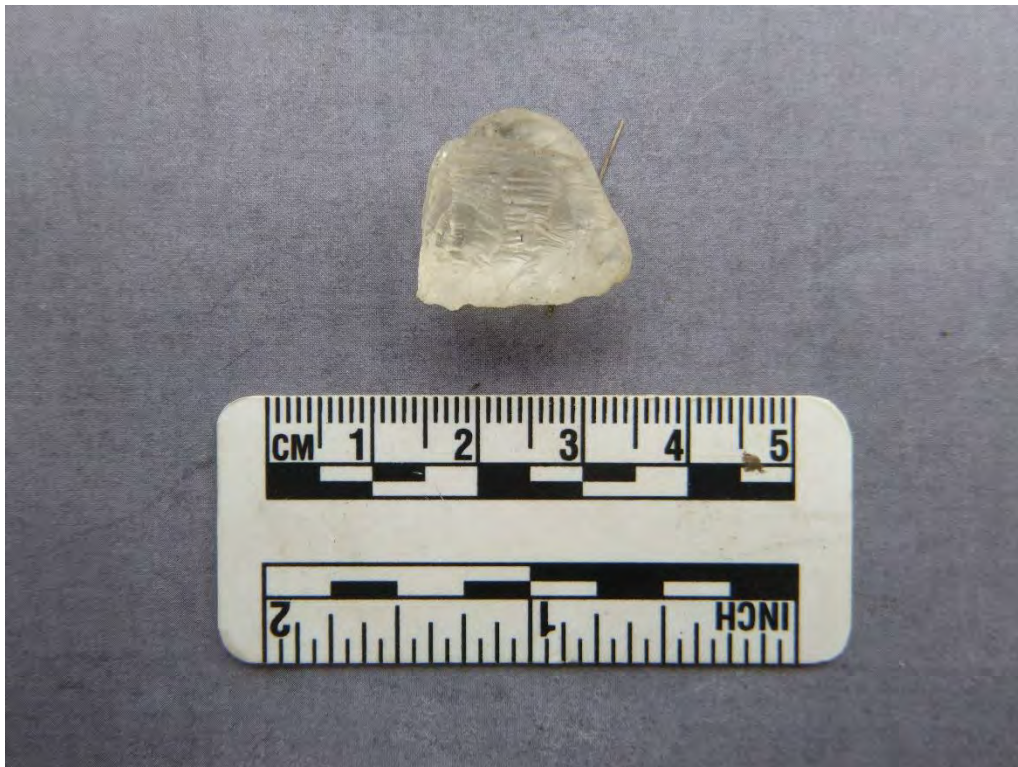
JH 01 – FS4, modified quartz crystal end scraper fragment.  
Photo Number: D3.107-0099 Date: 6.29.20

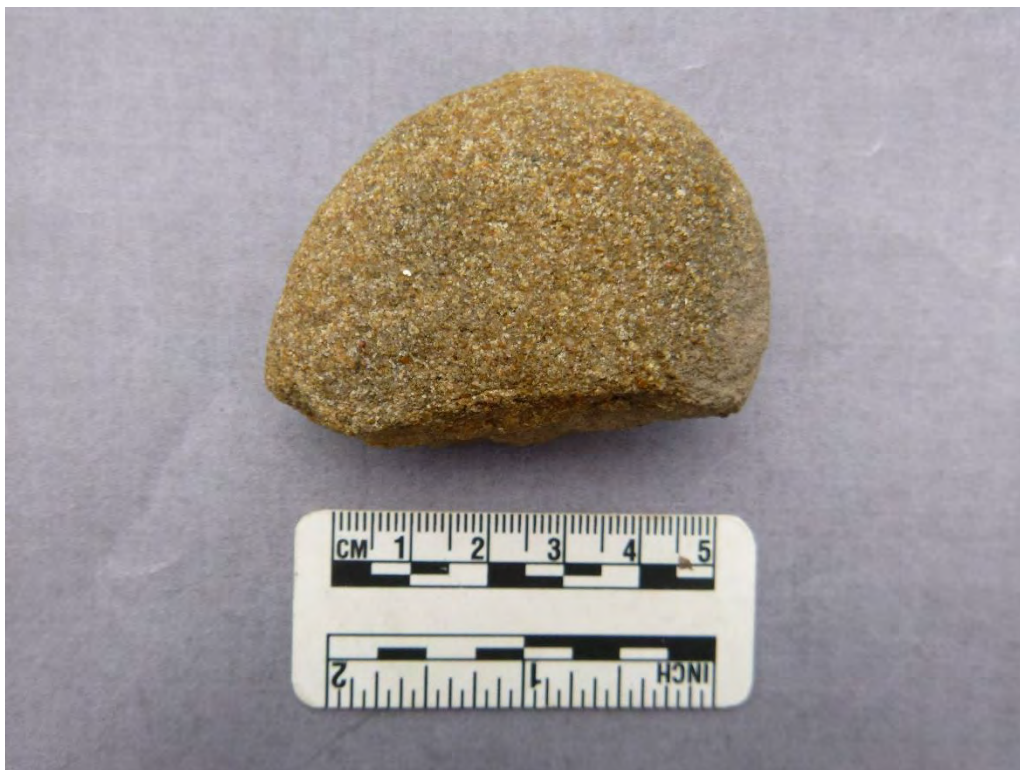
JH01 – FS5, sandstone mano.  
Photo Number: D3.107-0101 Date: 6.29.20

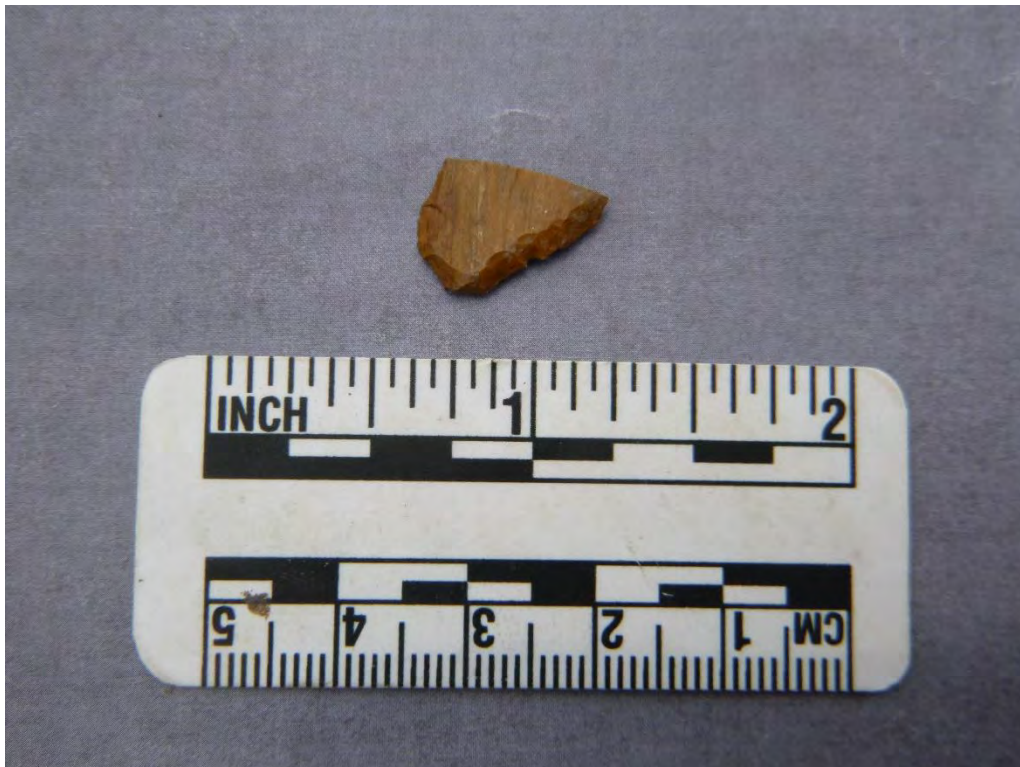
JH01 – FS6, DPW bilateral and unifacial modified flake.  
Photo Number: D3.107-0104 Date: 6.29.20
