**GEOLOGIC AND PRELIMINARY  
GEOTECHNICAL INVESTIGATION  
FOUNDERS VISTA, FILING NO. 1, 258 LOTS  
NORTHWEST OF NORTH RIDGE ROAD  
AND ENDERUD BOULEVARD  
CASTLE ROCK, COLORADO**

**Project No. DN50,536-115-R1**

**June 19, 2020**

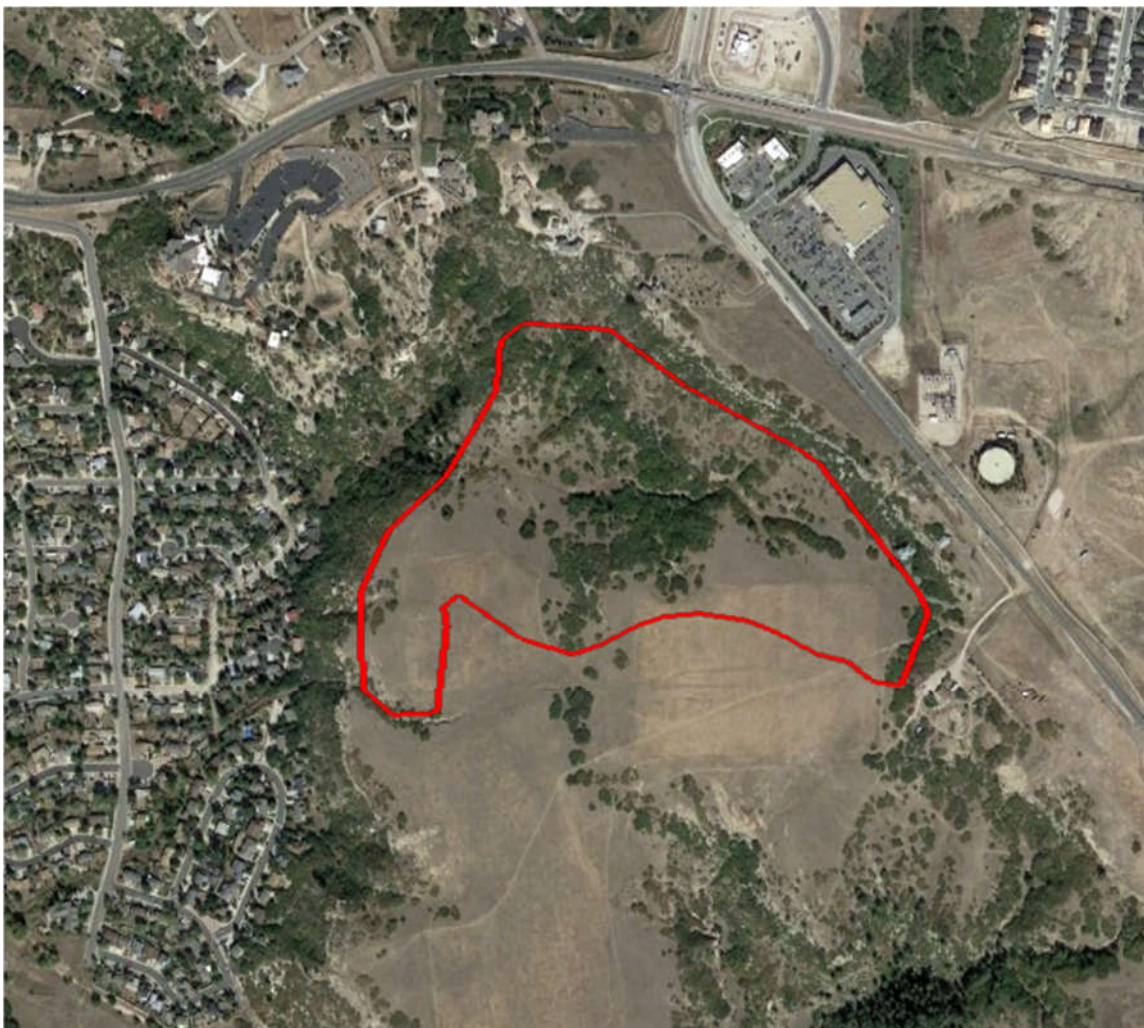
Photo 1 – Google Earth Aerial Image, October 2019

Founders Vista, Filing No. 1 is located northwest of North Ridge Road and Enderud Boulevard in Castle Rock, Colorado (Fig. 1 and Photo 1). Memmen's 2<sup>nd</sup> and 3<sup>rd</sup> Additions to Castle Rock residential developments are west. A water tank and retail/commercial developments are across North Ridge Road to the northeast. Vacant Memmen property is south. The property consists of a mesa with semi-rolling hills which generally slope to the west-south toward a drainage, with a few of southwesterly ephemeral drainages at the northern and south-central areas of the site. Locally, some parts slope toward the drainages. A moderately steep slope is present along the southwest edge of the mesa that leads down the drainage. Outcrops and boulders were noted around the northwest and northeast perimeters and in the south-central area. The ground surface is covered with grasses, weeds and bushes, with scrub oak and trees around the low-lying drainages. Historically, the southern edge of the site may have been used for agricultural or livestock purposes, but the remaining portion has been undeveloped.

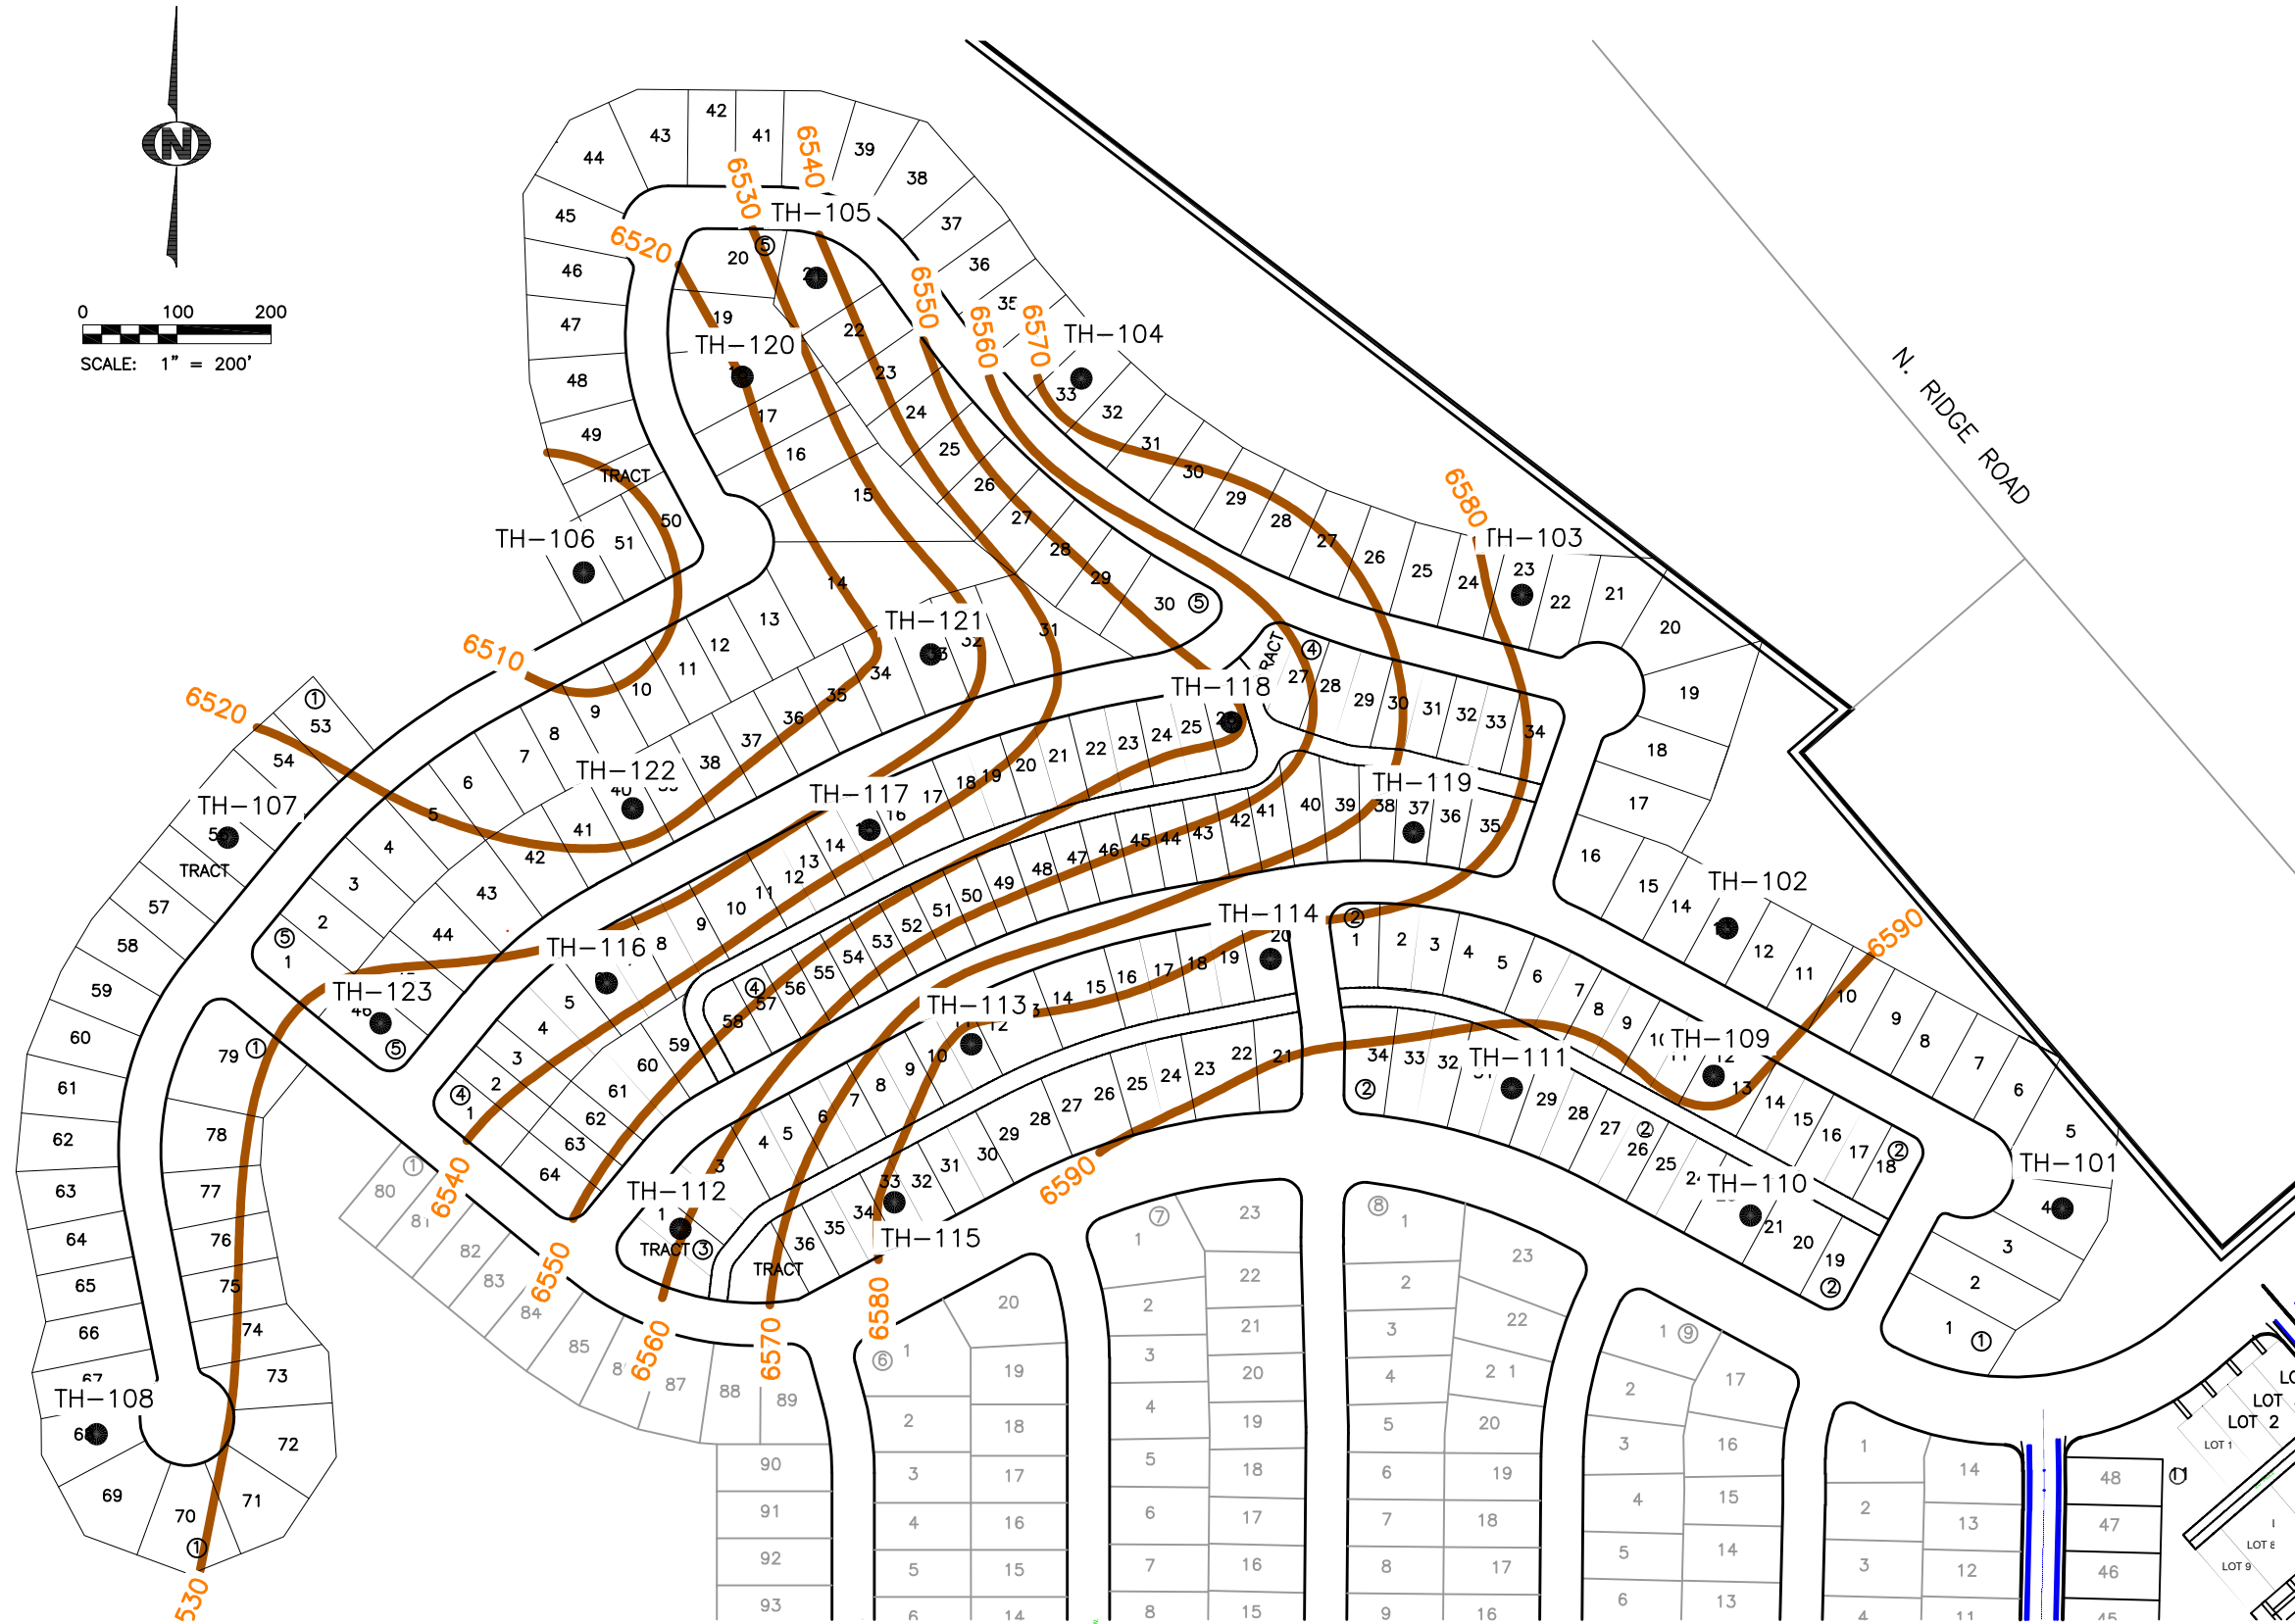
6590 ESTIMATED TOP OF SANDSTONE  
ELEVATION (FEET)

Although cemented and very hard sandstone are not typically considered geologic hazards, their presence implies excavation into the material will be difficult. Rock outcrops are present at various locations around the northeast and northwest perimeters and south-central end. In addition to visible outcrops, our borings revealed very hard, cemented sandstone within 8 feet of the ground surface in 17 of the 23 borings, or about three-quarters (i.e., TH-102 through TH-108, TH-111, TH-113 through TH-115, and TH-118 through TH-123).
